Commercial Building Thermographic Surveys

SAMPLE REPORT

Pixel Thermographics Ltd

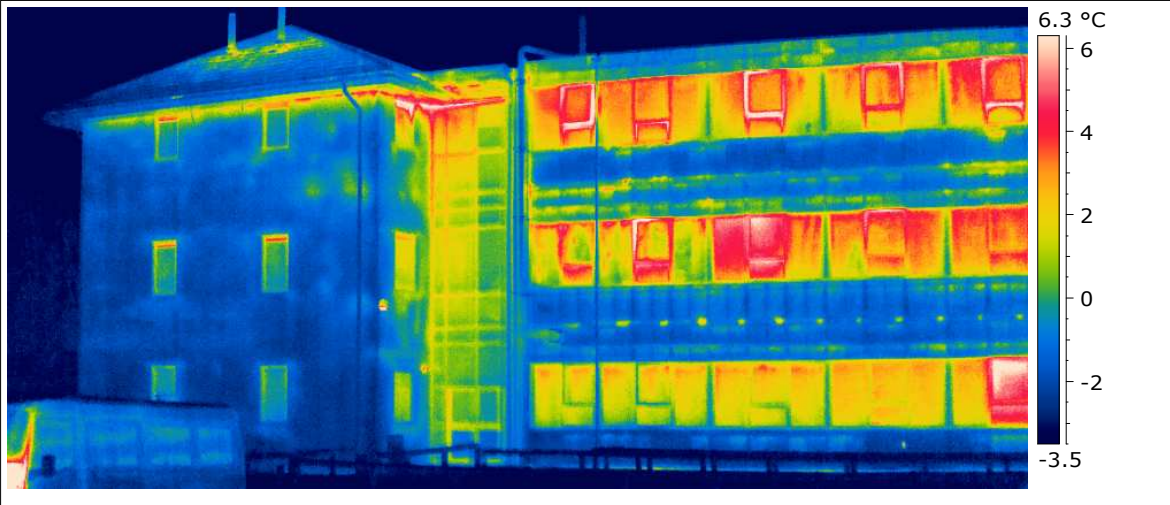
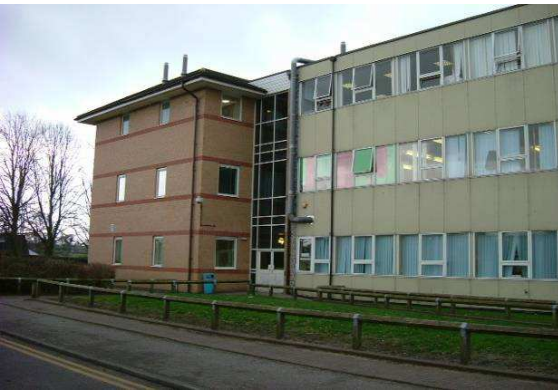
Area: School Building - Old & New Construction Types

Thermal image highlights differences in insulation standards between the walls of the old construction (right) and the new extension (left).

Surveys can highlight discontinuous, missing or ineffective insulation.

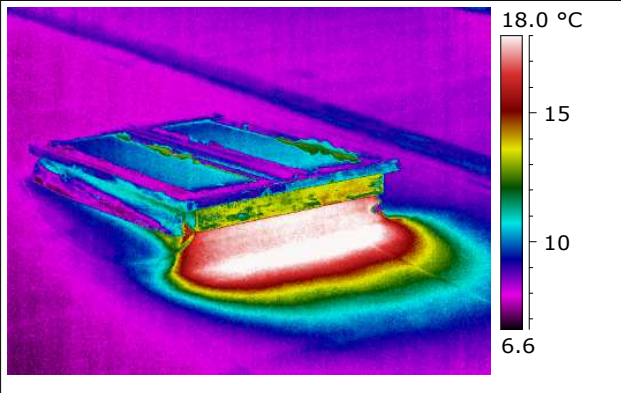
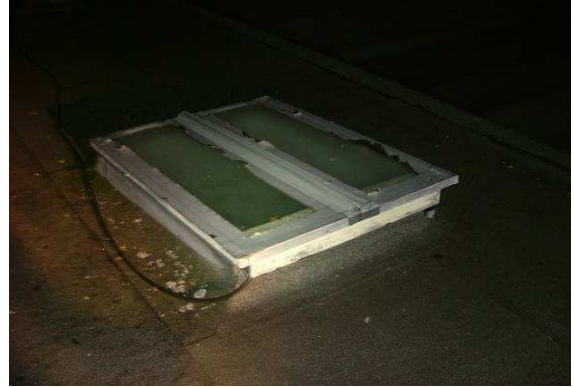
Area: School Building - Air Leakage From Skylight

Air leakage noted from skylight of school roof.

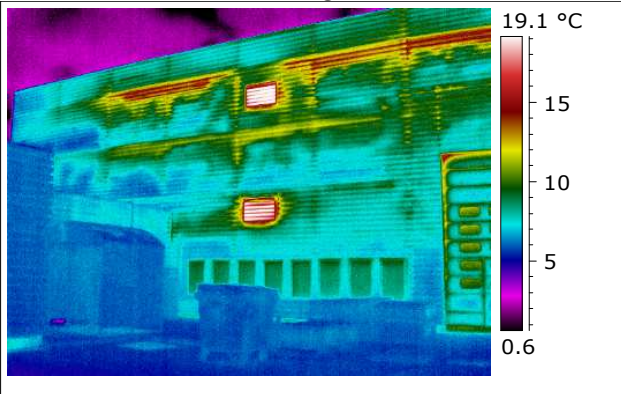
Area: Commercial Building - Discontinuous Insulation

Air movement through fabric of warehouse unit indicates significant heat losses.

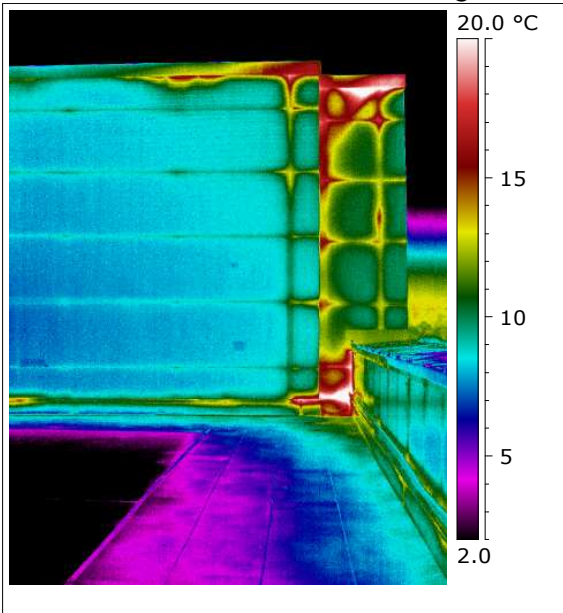
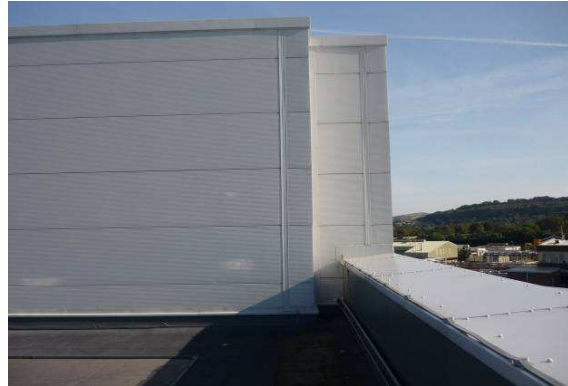
Area: Industrial Premises - Air Leakage

The image above highlight air leakage paths throughout the fabric of the building resulting in significant heat losses.

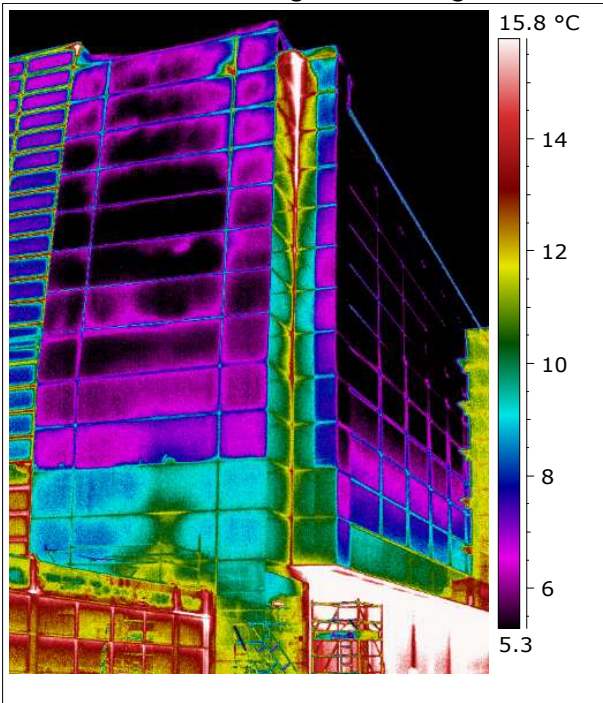
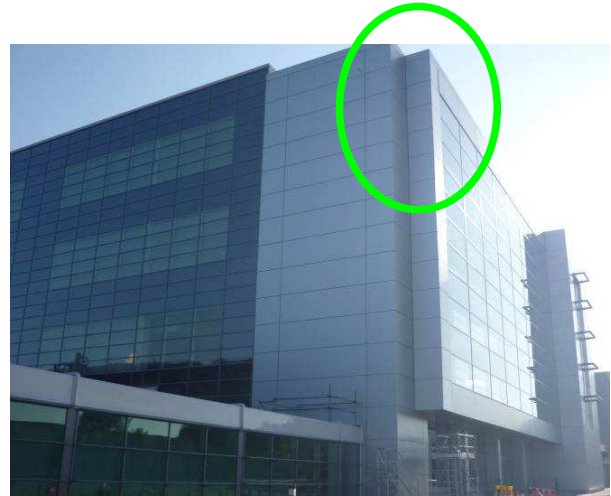
Area: Industrial Building - Air Leakage

Using only the highest resolution thermal imaging cameras we are able to inspect leakage buildings and pick out defects at distance such as air leakage from this fabric at the top of this building.

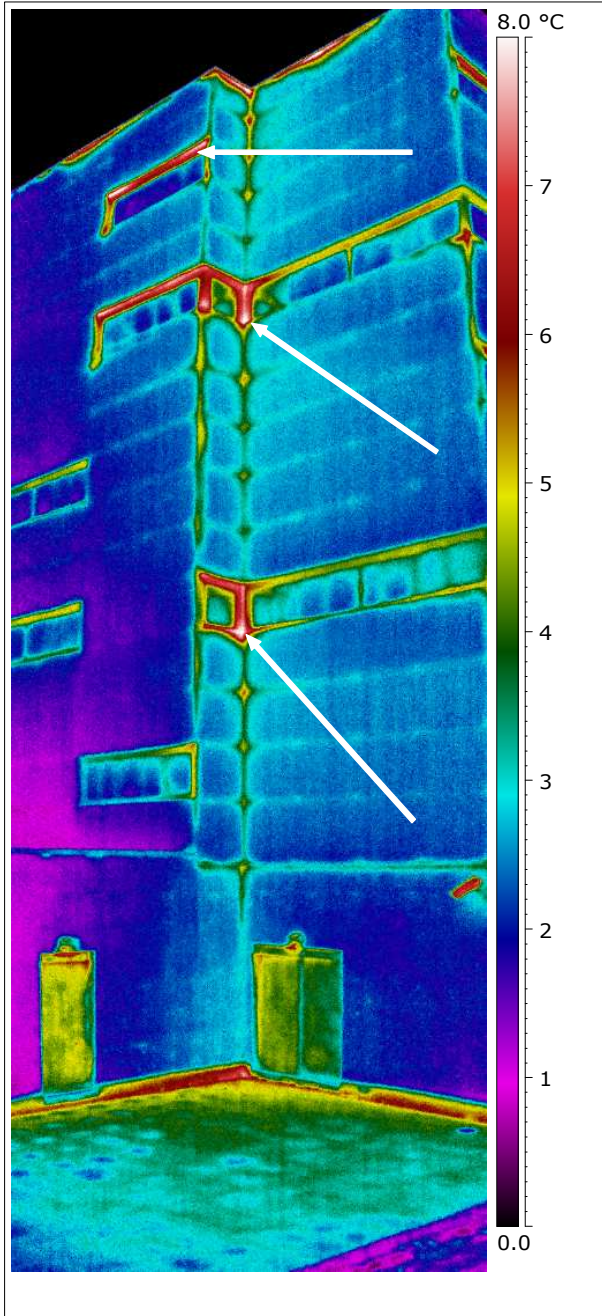
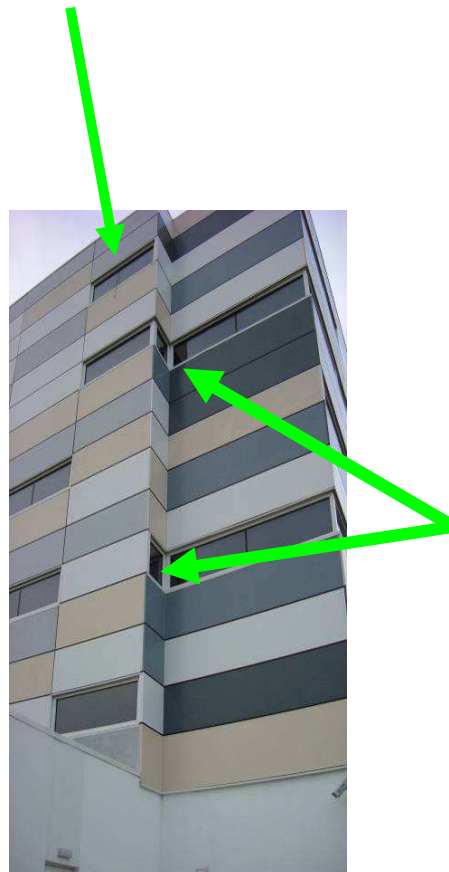
Area: Hotel - Defective Window Frames

Thermal image highlights defective window frames within this area – likely to be caused by defective sealing.

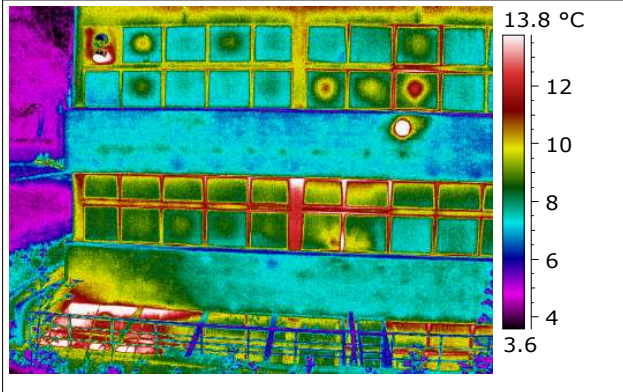
Area: University Building - Faulty Double Glazing

The round anomalies within some of the windows of the images above indicate failed double glazing systems.

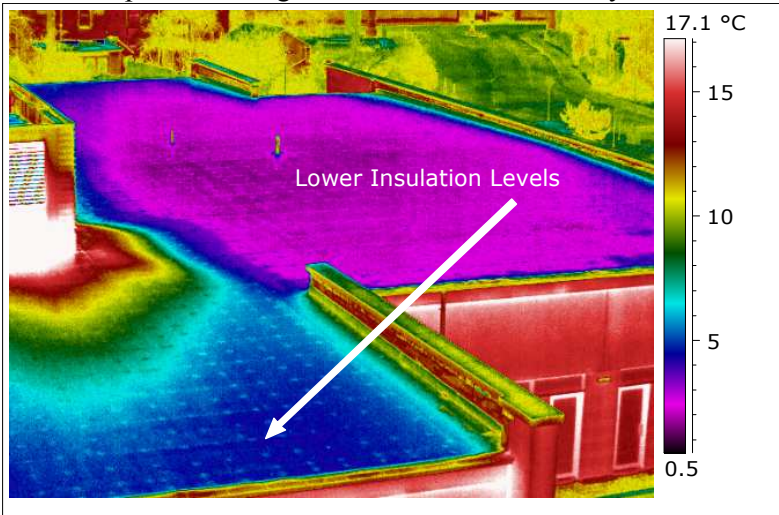
Area: Hospital Building - Roof Insulation Anomaly

The thermal image highlights different insulating performance levels of this hospital roof with the area to the left radiating and therefore losing more heat.

The warm area around the ventilation extract should be ignored.

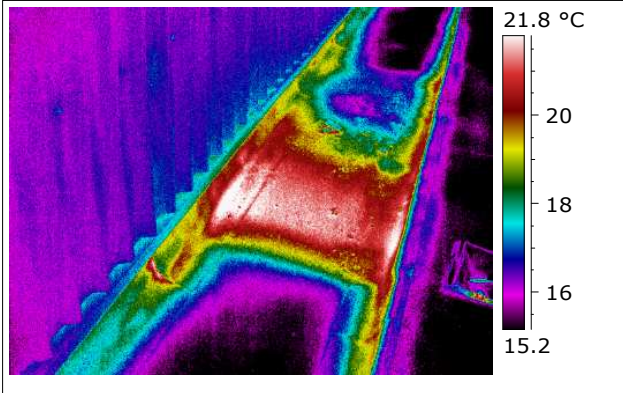
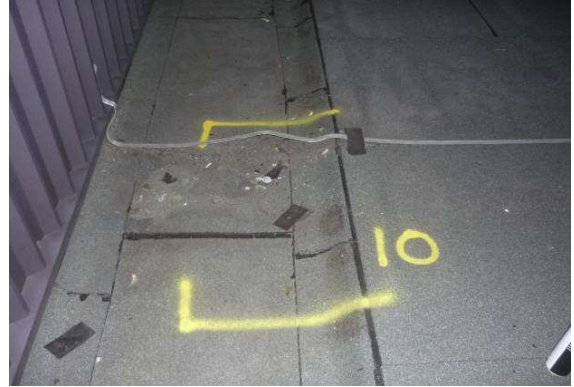
Area: Supermarket - Water Leak in Roof Gulley

Water ingress within the roof gully is able to be detected during thermographic surveys and is an extremely powerful way of locating assessing roof leaks across roofing systems.

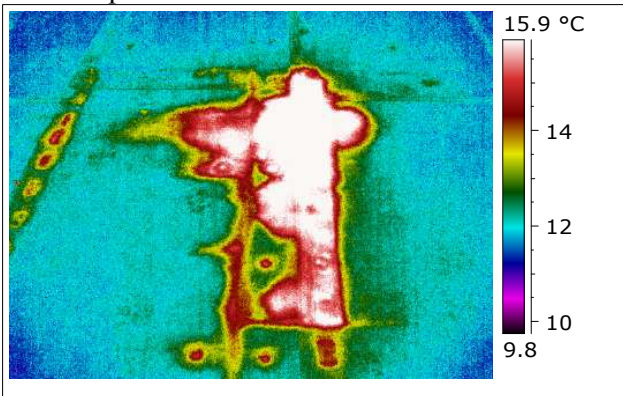
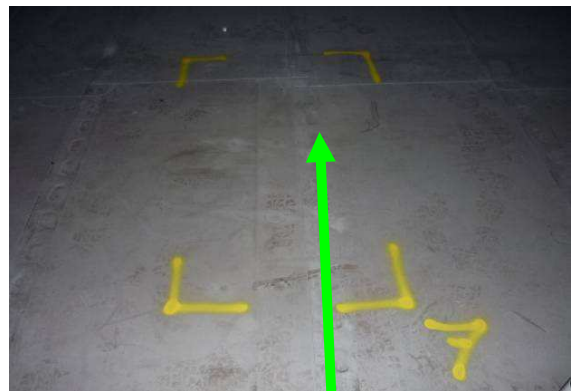
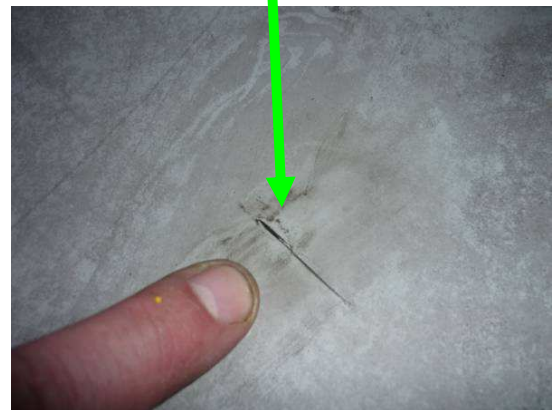
Area: Supermarket - Flat Roof Leak

This flat roof leak was located and identified during a survey. Once the water ingress is located is usually straight forward to locate the source such as the slit in the membrane in the image above.

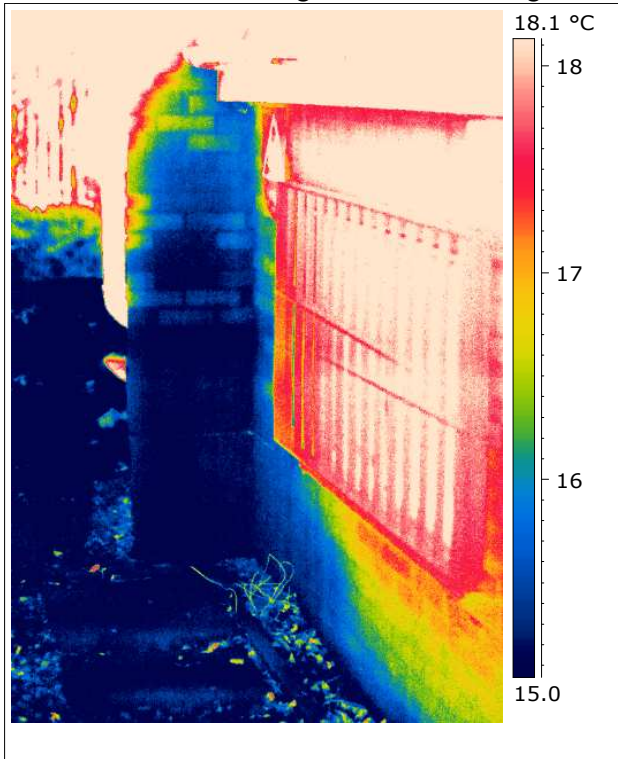
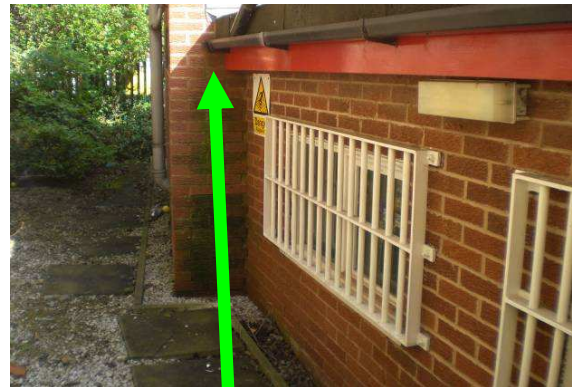
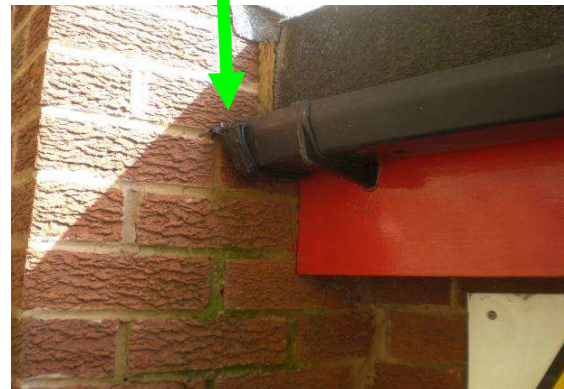
Area: Post Office Sorting Office - Water Ingress in Wall

Water ingress or damp penetration surveys on commercial buildings are non destructive and extremely powerful in locating the source.

The client here had spent thousands of pounds excavating earth to locate the source of internal damp when in fact we easily located the source as being from a defective gutter end cap.
