Residential Building Thermographic Survey

Sample Report

January 2011

Pixel Thermographics Ltd

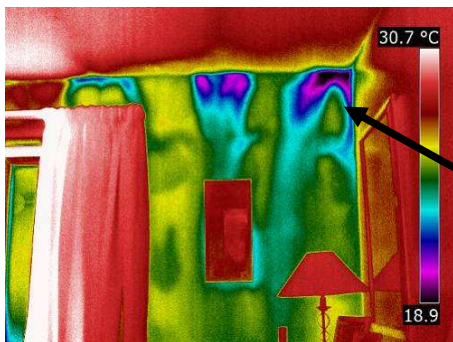
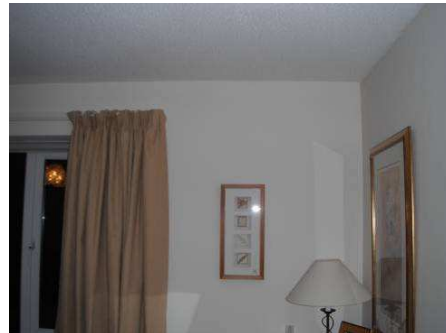
The survey highlighted significant cooling within the property due to cold air movement behind plasterboard walls. This air appears to enter behind the walls from within the loft where it is suspected that the tops of the plasterboard walls are not sealed.

Cold air movement behind walls

This cold air movement will significantly cool the affected areas. The tops of the plasterboard walls should be sealed or blocked off within the attic area to prevent this cooling effect.

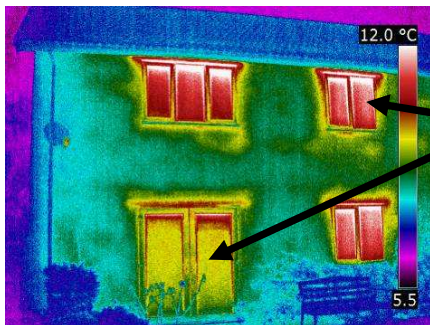
The double glazed units within the property appear to be less effective in terms of insulating performance than expected. The windows may have lost the gas or vacuum originally present and therefore result in higher heat losses.

Higher heat loss from windows compared to patio door.

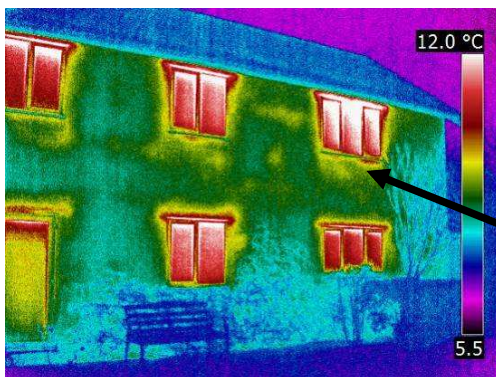
The external part of the survey has highlight possible gaps in the cavity wall insulation where the insulation may have sagged or settled over time.

Possible gaps in cavity wall insulation are highlighted as warmer areas of wall.

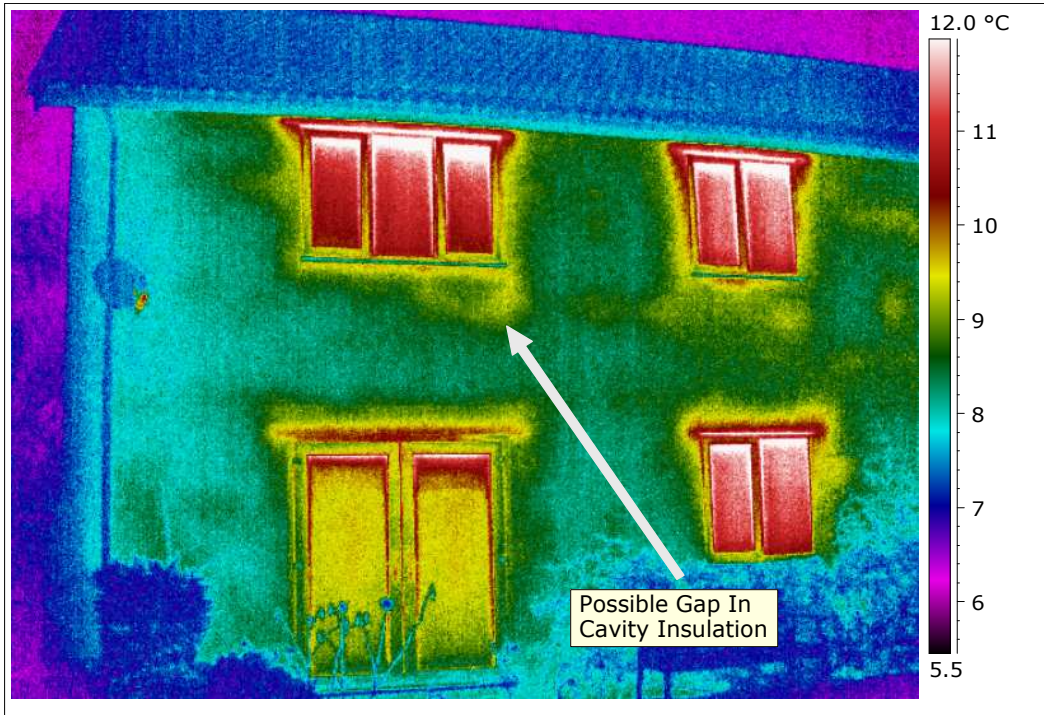
Area: External - South Elevation - Left

Thermal image highlights possible gaps in cavity wall insulation – particularly underneath and to the side of the windows where insulation may have settled over time.

The windows exhibit conductive heat losses which are higher than expected for double glazed units. These windows may have reduced insulating performance due to possible loss of gas or vacuum.

Thermal bridging noted above windows & patio door where support beams have not been insulated effectively and act as conductors for heat to be lost

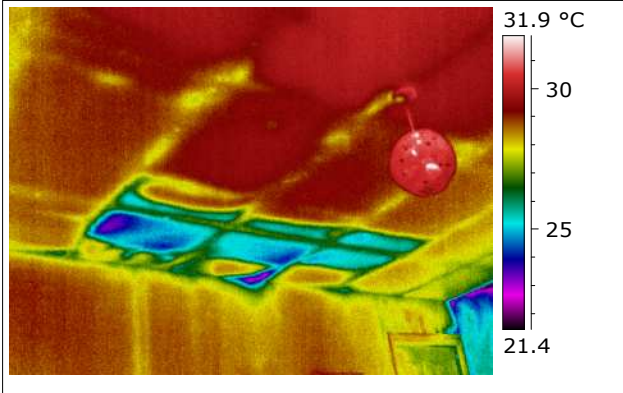
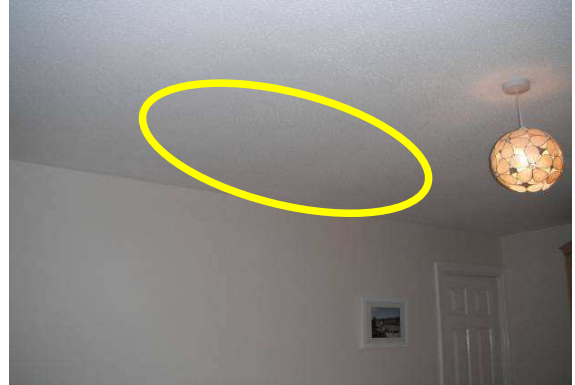
Area: 1st Floor - Master Bedroom - Ceiling

Loft insulation in this area appears consistent and effective except in the area directly below the water tank area.

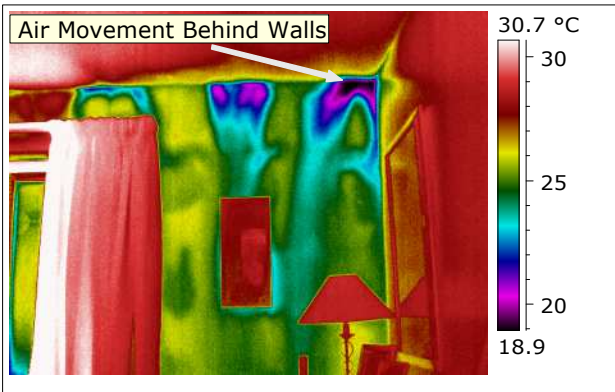
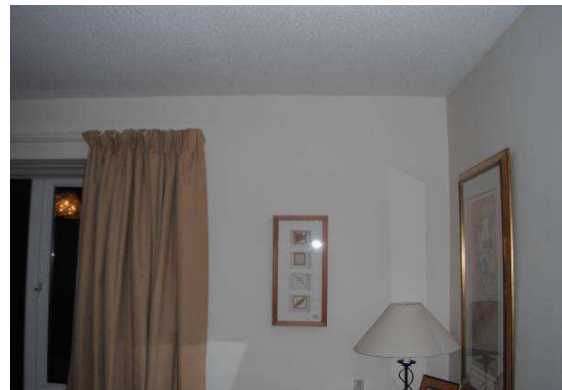
Area: 1st Floor - Master Bedroom - Wall

The cool (darker) areas on the walls indicate cold air movement behind the plasterboard walls. This cold air enters from within the loft area and results in significant cooling of the area. Any gaps at the top of the plasterboard walls should be suitably blocked to prevent this air movement.

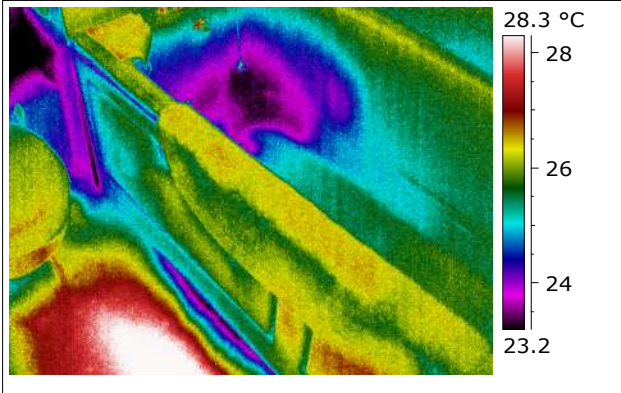
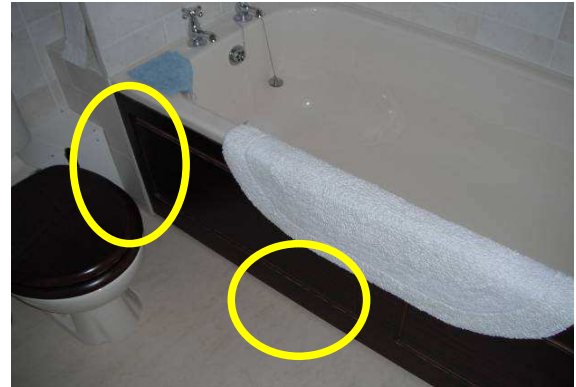
Area: 1st Floor - Master Bathroom - Bath Panels

Cool air appears to enter the room via the side and base of the bath panel. This air is likely to enter via the wall penetrations (concealed) where the pipework enters the room behind the bath. This should be sealed using suitable silicone sealant.

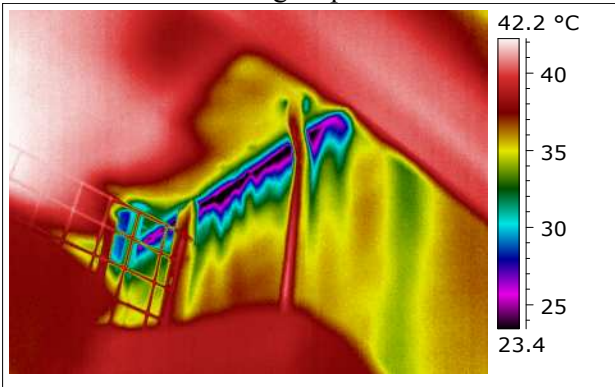
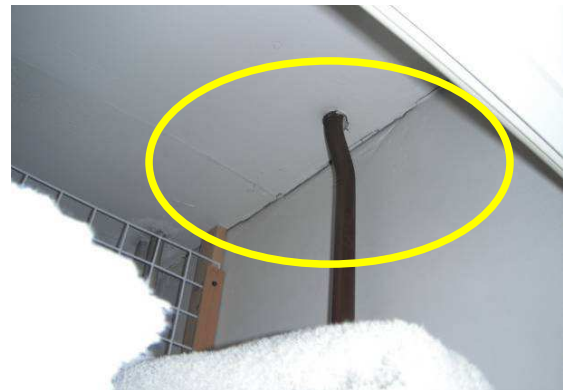
Area: 1st Floor - Airing Cupboard - Wall

Cool air enters the room via the gap between the wall and the ceiling. This gap should be suitably sealed.

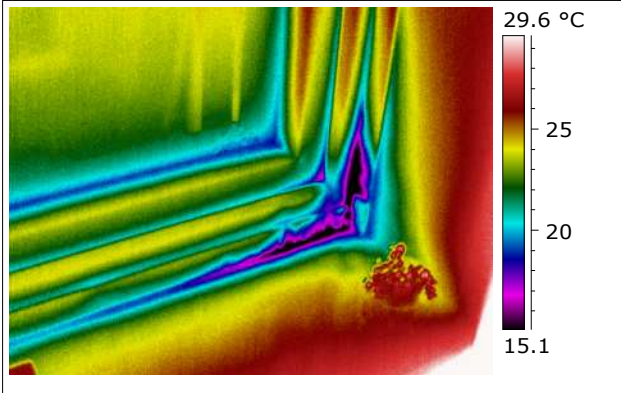
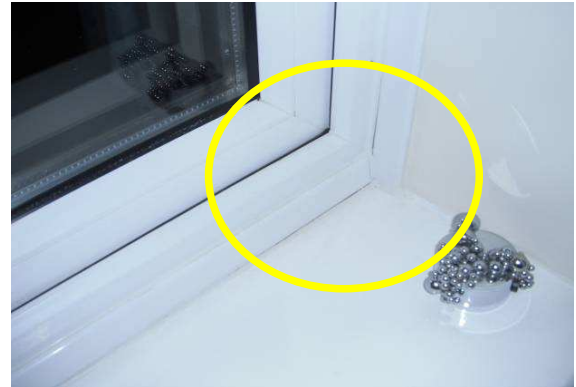
Area: 1st Floor - Bedroom 4 - Right Window

The cool (dark) areas indicate direct cold air entry into the room.
This air appears to enter via the outside of the frame and via a visible gap in the silicone sealant. This sealant should be removed and resealed.

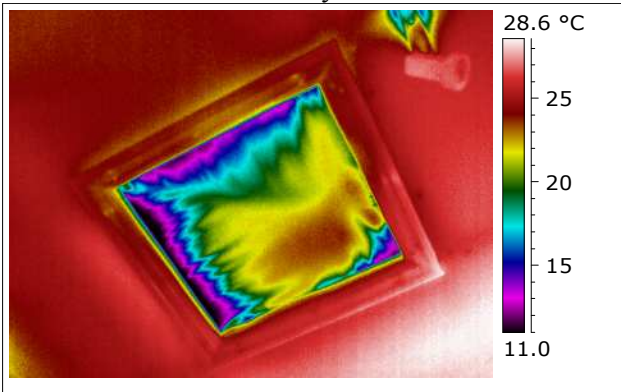
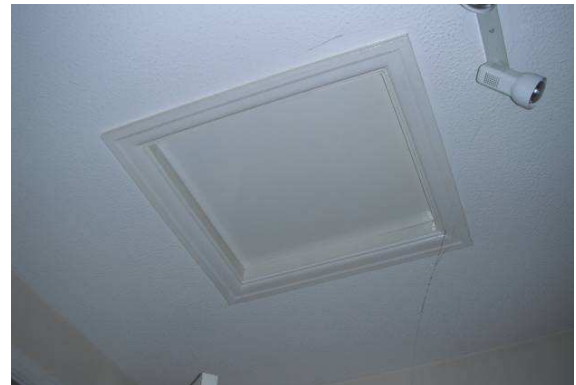
Area: Ground Floor - Study - Loft Access Hatch

Air entry into the room noted from the loft access hatch.
A draught excluder could be fitted to prevent this cold air entry.

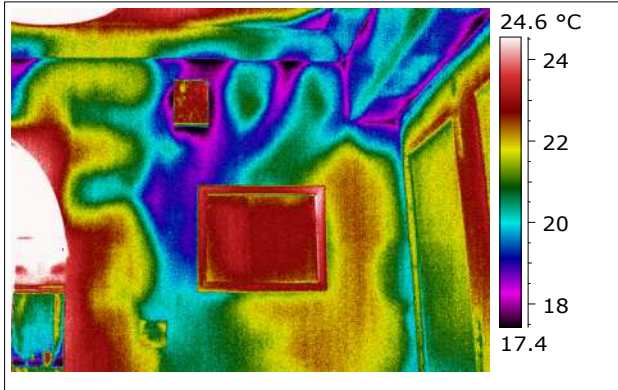
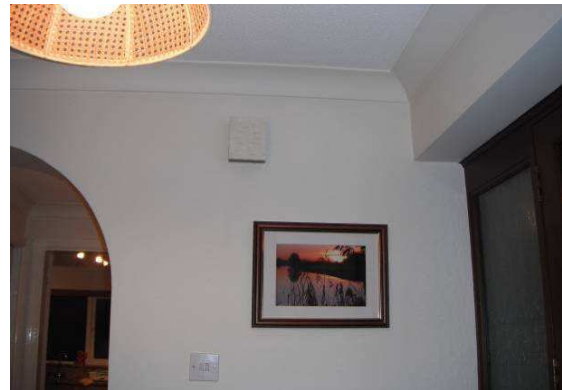
Area: Ground Floor - Entrance Hall - Wall

The cool (darker) areas indicate cold air movement behind the plasterboard walls. This cold air appears to originate from the porch area and preventing this cold air from entering the wall would help reduce heat losses in this area.

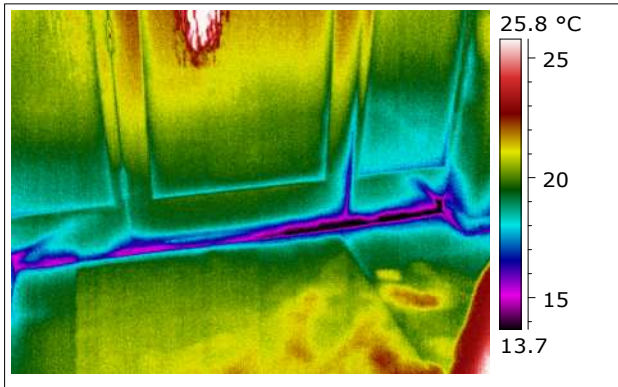
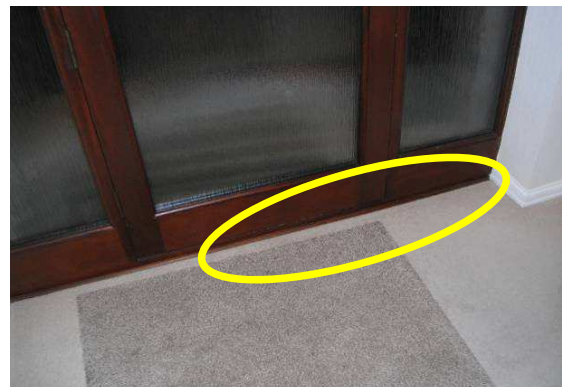
Area: Ground Floor - Entrance Hall - Front Door Frame

The cool (dark) areas indicate direct cold air entry into the room. This air appears to enter via the outside of the frame. The area directly behind the frame should be inspected and sealed appropriately.

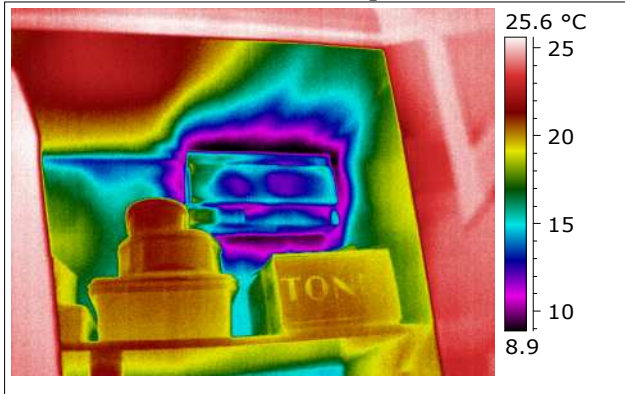
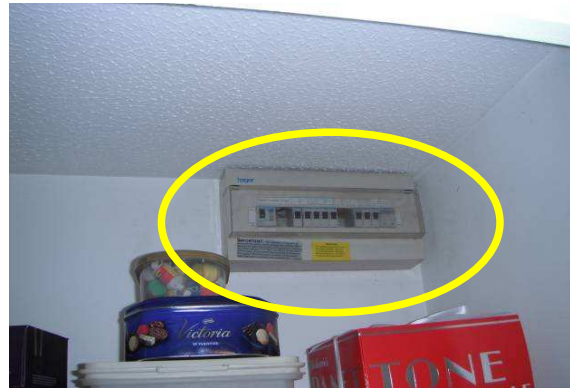
Area: Ground Floor - Boot Cupboard - Electrical Board

The cool (dark) areas indicate direct cold air entry into the room.
This air appears to enter via the cable penetration in the wall behind which should be sealed where possible.

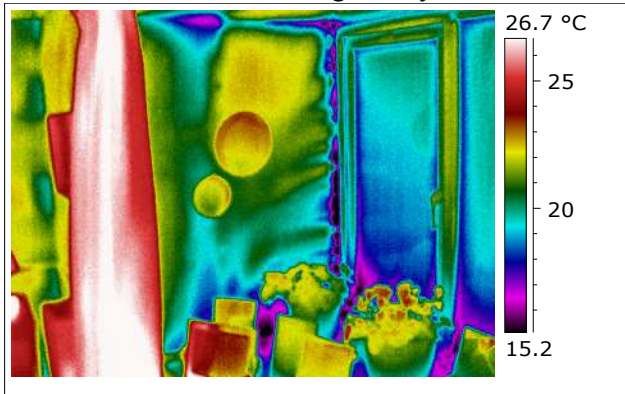
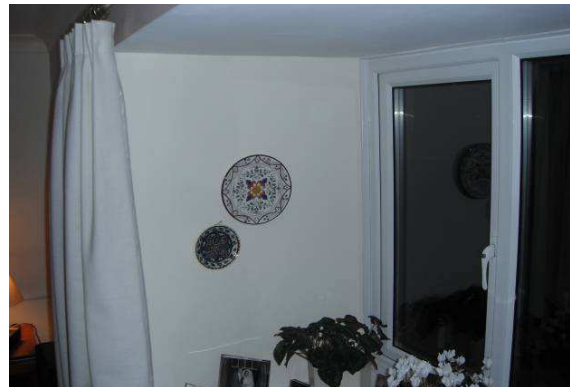
Area: Ground Floor - Lounge - Bay Window

The thermal image highlights several anomalies.
Significant direct air ingress is noted via the sides of the window frame which appears to be poorly sealed.
Additionally, air appears to move behind the sides of the dormer construction plasterboard walls. Air appears to enter from the top and bottom. These areas should be inspected externally to locate any gaps which should then be effectively sealed.

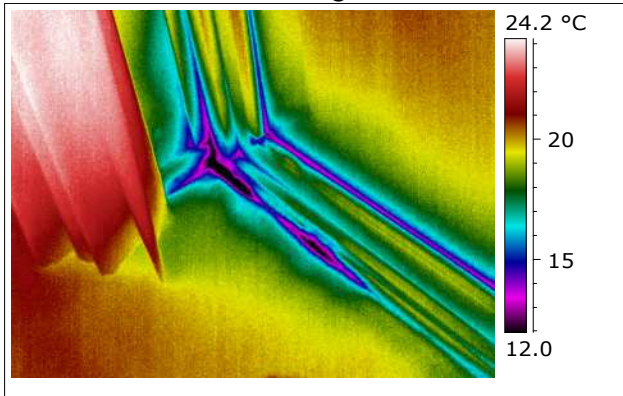
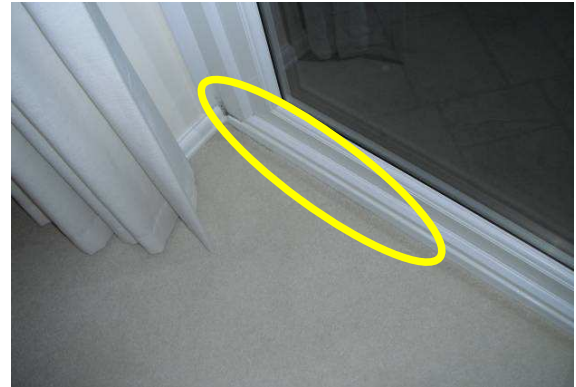
Area: Ground Floor - Lounge - Patio Door

Air ingress noted from the frame at the base of the door.
The area directly outside this point should be inspected and sealed appropriately.

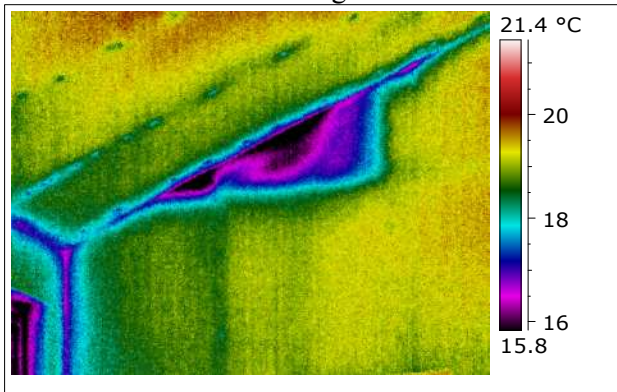
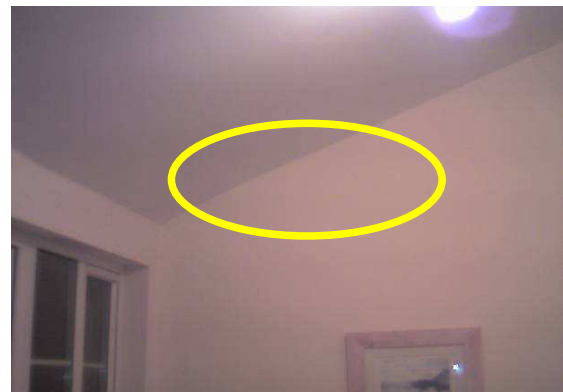
Area: Ground Floor - Lounge - Wall

The thermal image highlights a missing section of insulation at the top of the wall towards the patio door.
