Thermographic Water Leak Investigation at

Residential Property

January 2011

Pixel Thermographics Surveyor

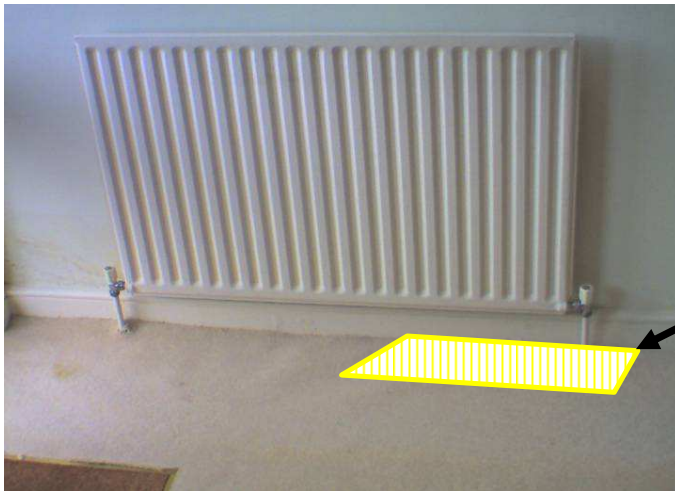
The survey has highlighted an area of floor within the entrance hall of the property with a thermal anomaly which is indicative of a sub-floor water leak from the central heating system.

*Area of floor to be excavated to
expose the leak site.*

The digital image below shows the radiator and an area of floor has been highlighted which should be excavated to expose the location of the suspected leak site.

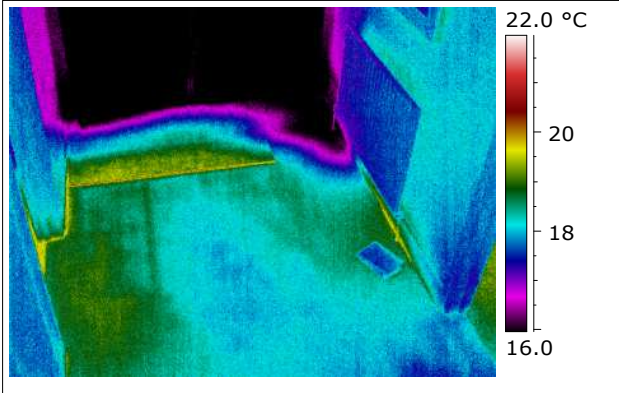
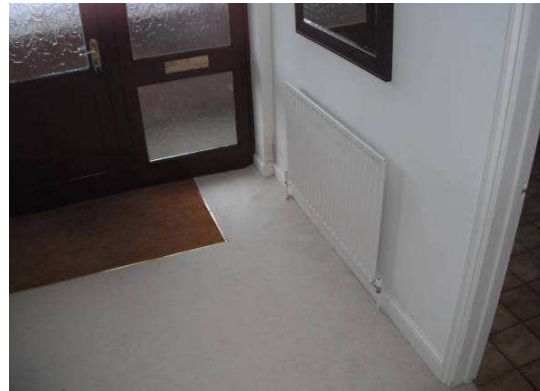
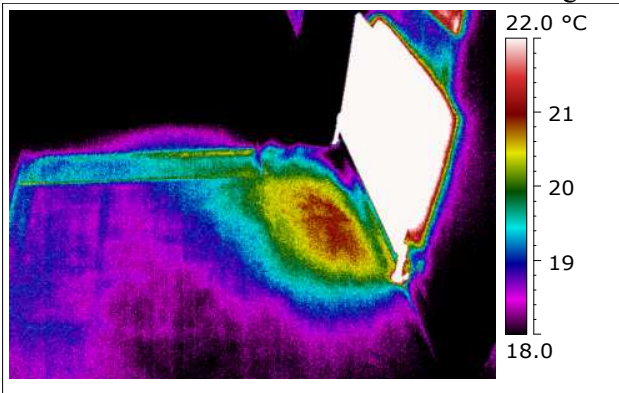
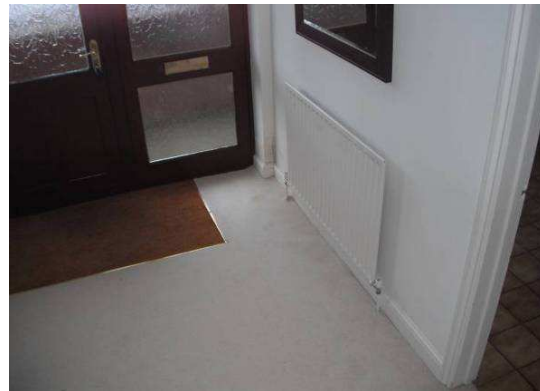
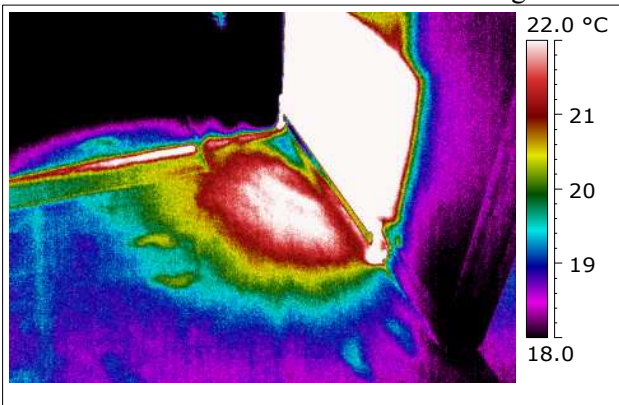
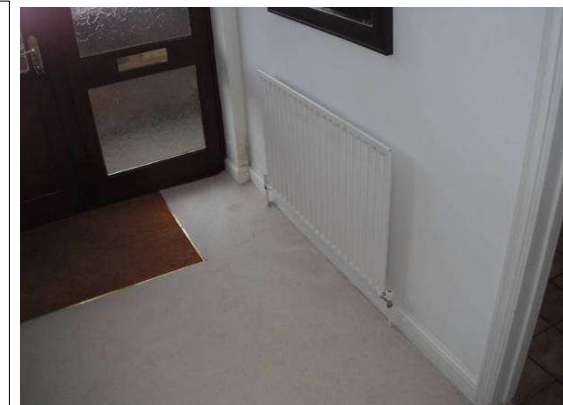
The sequence of images clearly shows the growth of an irregular thermal anomaly in front of the radiator over a period of time indicating the presence of a sub-floor water leak from the heating system.

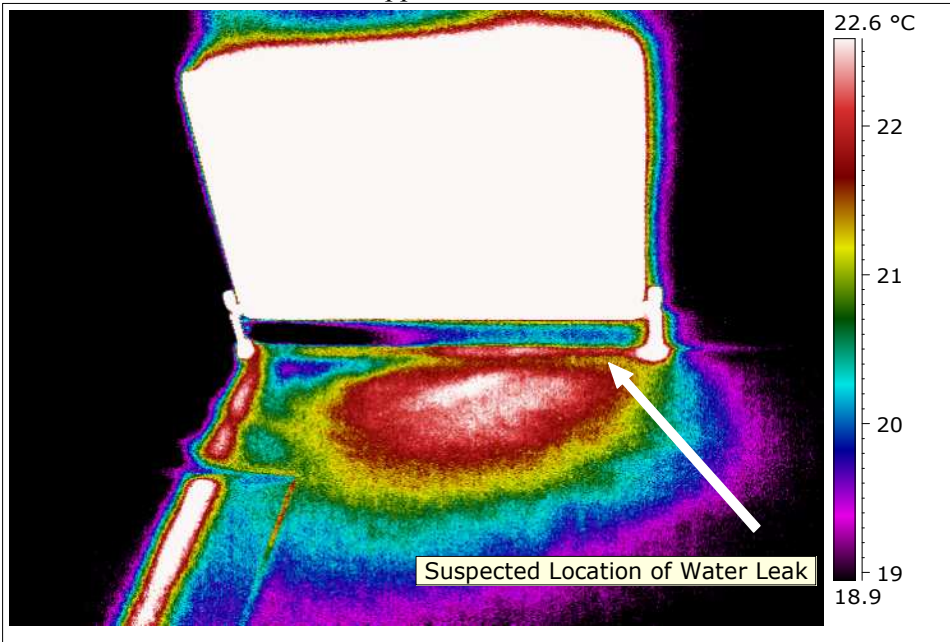
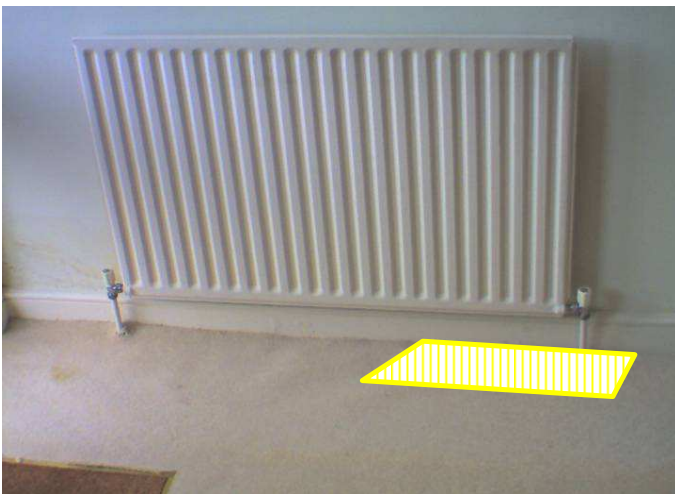
The thermal image highlights an area of floor showing with a thermal anomaly which is indicative of the presence of a water leak.

The shape and growth of this area during the survey indicates that the location of the actual water leak is from the feed pipe to the radiator (right hand side).

It is recommended that the area of floor highlighted in the above image is excavated to expose the pipework to allow a repair to be carried out.

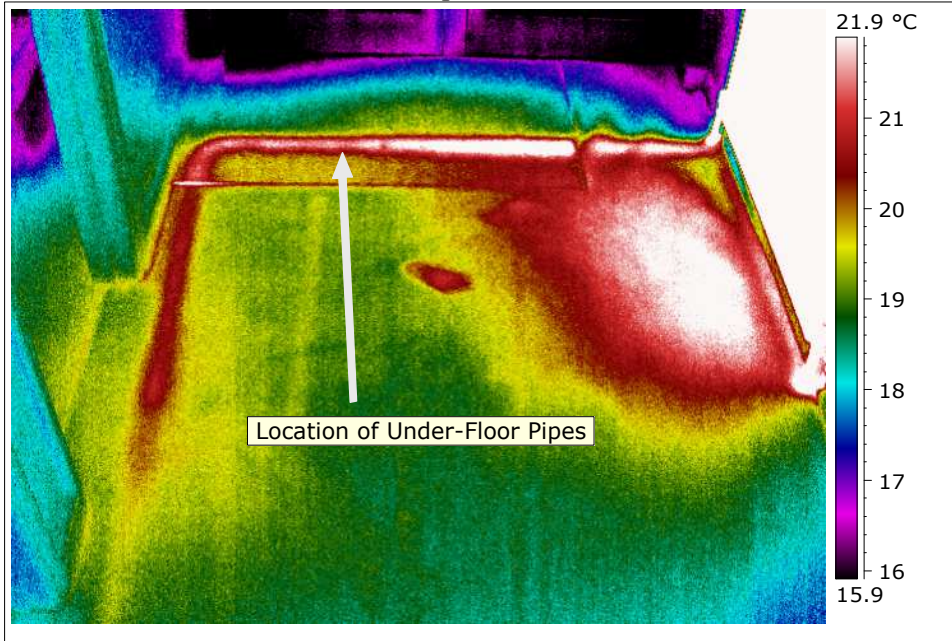
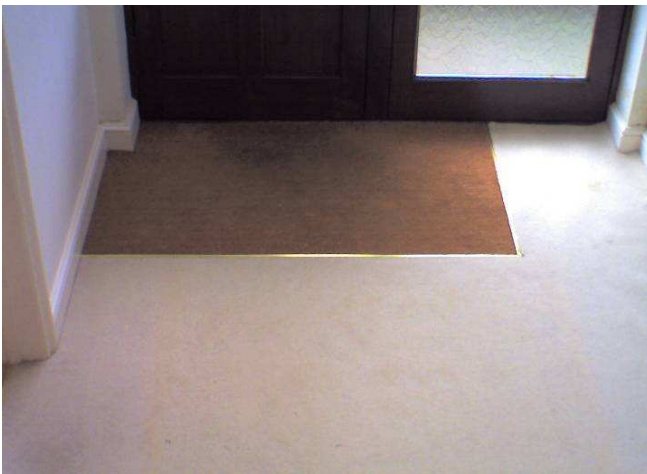
Area: Entrance Hall - Location of Pipes

Thermal image provided for information to show the location of the under-floor heating pipes which can be seen as the warm (white / red) line.

Note: Leak site is also visible in this image.

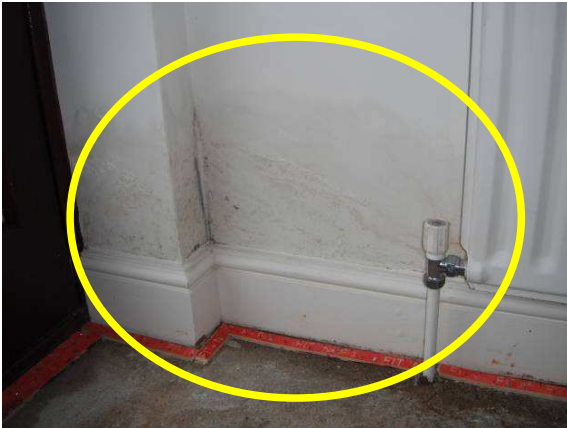
Digital images showing water damage to base of walls where moisture appears to have been drawn up via a capillary action from the damp floor

Fig.1 Water Damage at Base of Wall in Hall

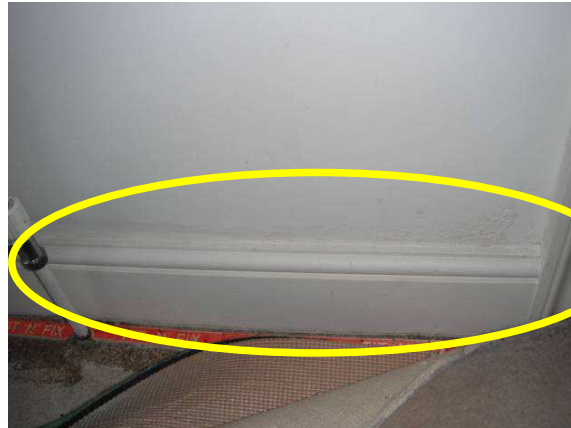
Fig.2 Water Damage at Base of Wall in Hall

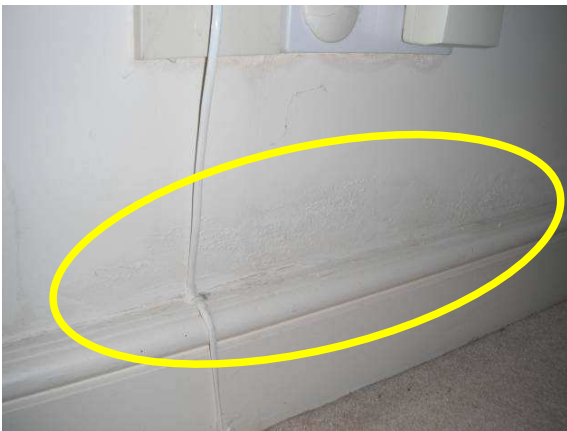
Fig.3 Water Damage at Base of Wall in Hall

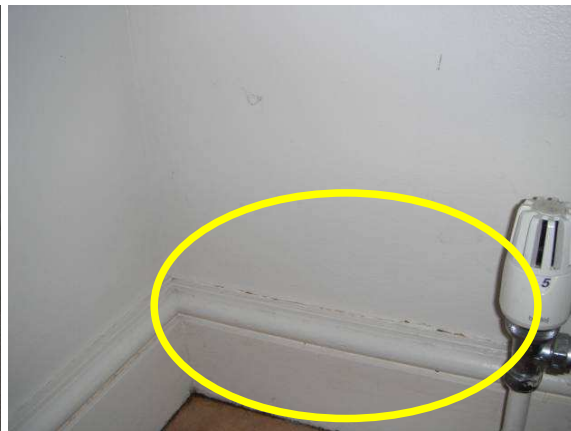
Fig.4 Water Damage at Base of Wall in Dining Room
