Marine Electrical Thermographic Survey

Sample Report

August 2010

Pixel Thermographics Surveyor

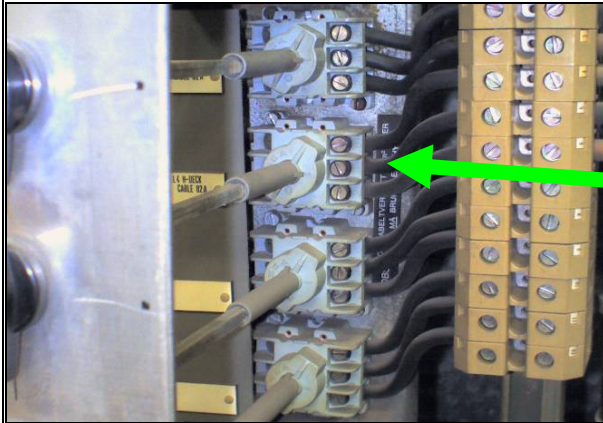
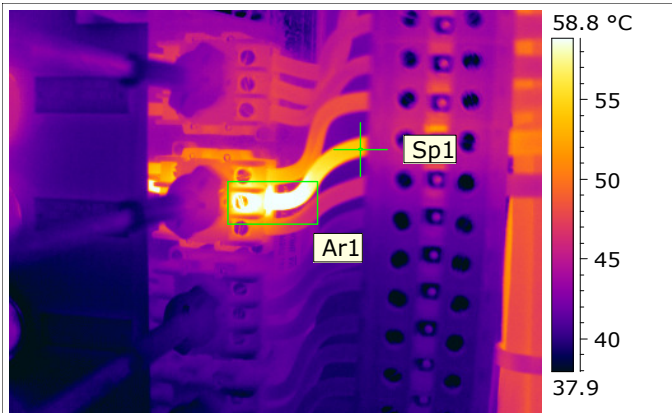
Location	Main Control Room
Equipment	Main Switchboard (Aft)
Type	Panel 14 - Isolator Phase 2 Connection

Object Parameters	Value
Atmospheric Temperature	25.0 °C
Emissivity	0.95
Object Distance	1.5 m
Reflected Apparent Temperature	25.0 °C
Image File name	IR_6723.jpg
Sp1 Temperature	53.9 °C
Ar1 Max. Temperature	71.4 °C
Difference Ar1 - Sp1	17.5 °C
Fault Rating	Priority 2

Elevated temperature noted on isolator outgoing phase 2 connection.

Current measurements indicate that imbalanced load is not the cause of this anomaly.

Likely cause of heat rise is a poor or loose connection.

Recommendation is to inspect, clean and remake off this connection.

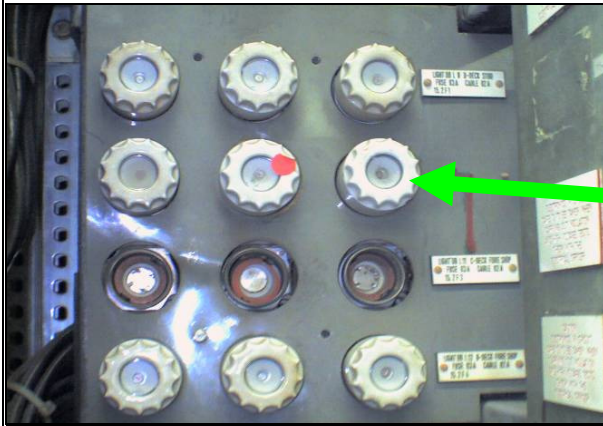
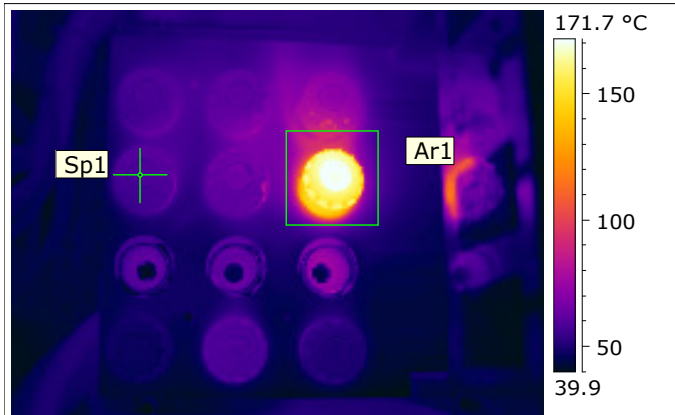
Location	Main Control Room
Equipment	Main Switchboard (Aft)
Type	Panel 15 - Bottle Fuse - Lighting Board L11 Phase 3

Object Parameters	Value
Atmospheric Temperature	25.0 °C
Emissivity	0.95
Object Distance	1.5 m
Reflected Apparent Temperature	25.0 °C
Image File name	IR_6727.jpg
Sp1 Temperature	58.9 °C
Ar1 Max. Temperature	193.8 °C
Difference Ar1 - Sp1	134.9 °C
Fault Rating	Priority 1

Significantly elevated surface temperatures noted on bottle fuse carrier.

Likely causes of heat rise include dirty or pitted conductive surface, loose or poorly fitted fuse carrier or poor outgoing connection at rear.

Recommendation is to remove the carrier, replace the fuse, check all surfaces are clean and re-install the carrier ensuring it is tight.

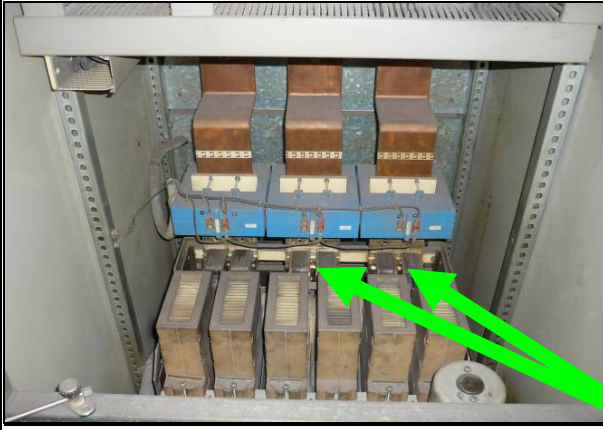
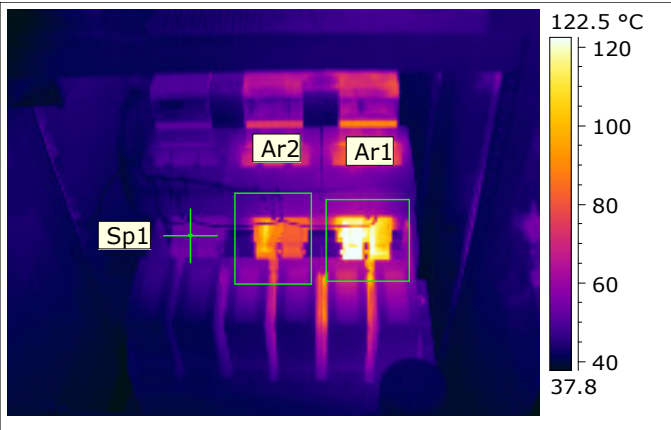
Location	Main Control Room
Equipment	Main Switchboard (Central)
Type	Panel 5 - Main Breaker - Phase 2 & 3

Object Parameters	Value
Atmospheric Temperature	25.0 °C
Emissivity	0.95
Object Distance	1.5 m
Reflected Apparent Temperature	25.0 °C
Image File name	IR_6731.jpg
Sp1 Temperature	53.4 °C
Ar1 Max. Temperature	163.9 °C
Ar2 Max. Temperature	111.6 °C
Difference Ar1 - Sp1	110.5 °C
Fault Rating	Priority 1

Significantly elevated temperatures noted on the contacts of Phases 3 and 2 of the circuit breaker.

Likely cause of this heat rise is poor or dirty connections between the breaker and the contact.

Recommendation is to remove and completely clean the connections and contacts of phases 2 and 3.

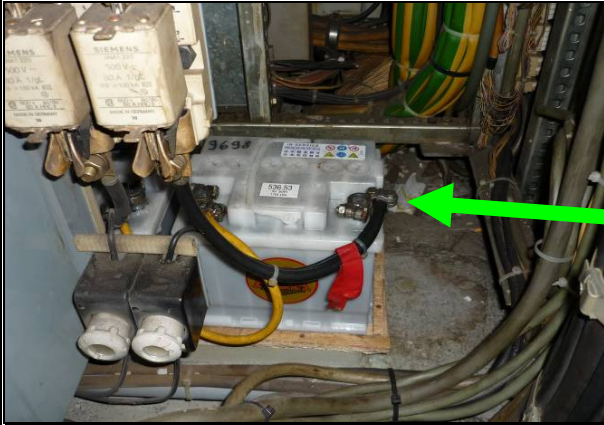
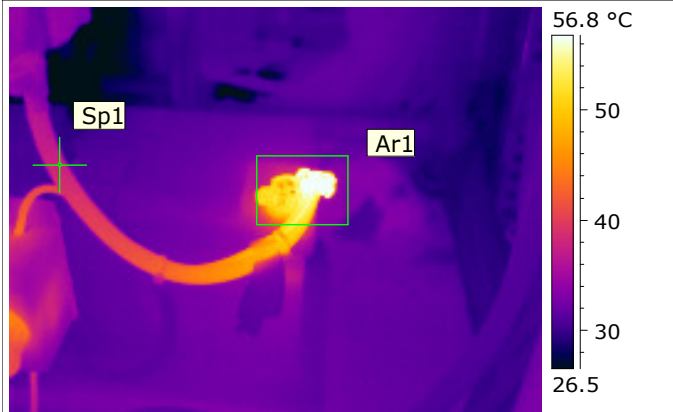
Location	Main Control Room
Equipment	Main Switchboard (Central)
Type	24V Simos Alarms Negative Battery Connection

Object Parameters	Value
Atmospheric Temperature	25.0 °C
Emissivity	0.95
Object Distance	1.5 m
Reflected Apparent Temperature	25.0 °C
Image File name	IR_6733.jpg
Sp1 Temperature	37.9 °C
Ar1 Max. Temperature	61.3 °C
Difference Ar1 - Sp1	23.5 °C
Fault Rating	Priority 2

Elevated temperature noted on battery negative connection.
Likely cause of heat rise is a poor or loose connection.
Recommendation is to inspect, clean and re-tighten this connection.

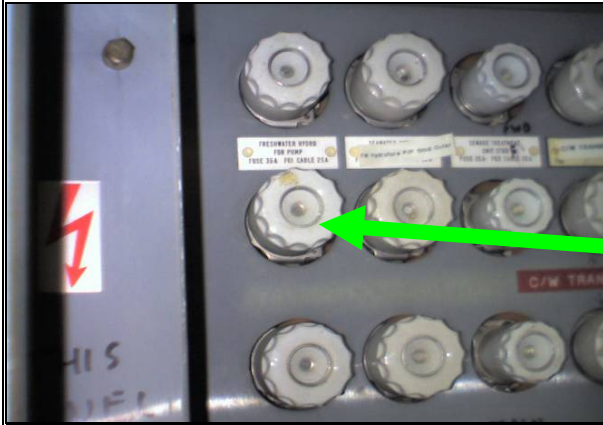
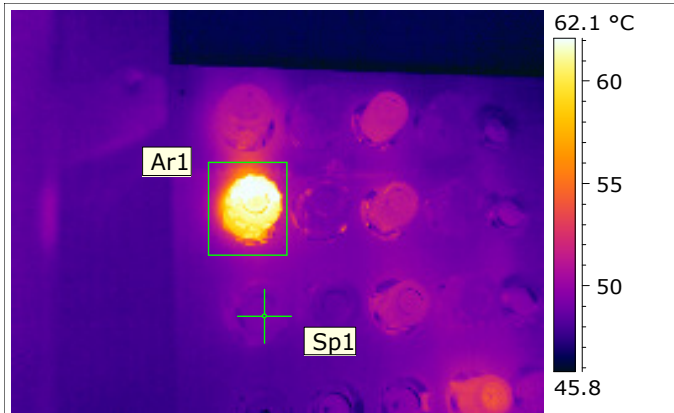
Location	Generator Room
Equipment	DB Engine Panel 2
Type	Bottle Fuse - Fresh Water Hydro FGR Pump - Phase 2

Object Parameters	Value
Atmospheric Temperature	36.5 °C
Emissivity	0.95
Object Distance	1.5 m
Reflected Apparent Temperature	36.5 °C
Image File name	IR_6754.jpg
Sp1 Temperature	49.3 °C
Ar1 Max. Temperature	64.5 °C
Difference Ar1 - Sp1	15.2 °C
Fault Rating	Priority 2

Elevated surface temperatures noted on bottle fuse carrier.

Likely causes of heat rise include dirty or pitted conductive surface, loose or poorly fitted fuse carrier or poor outgoing connection at rear.

Recommendation is to remove the carrier, replace the fuse, check all surfaces are clean and re-install the carrier ensuring it is tight.

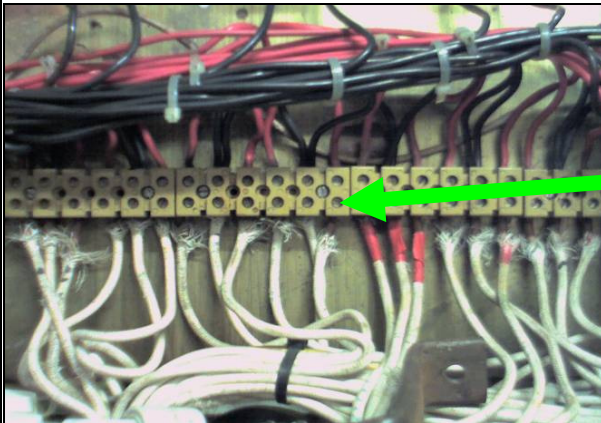
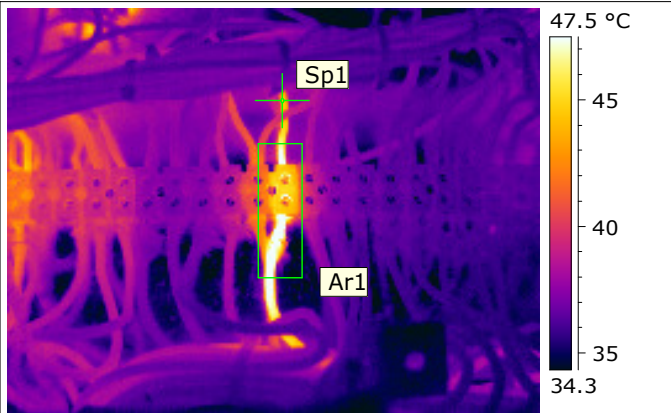
Location	Level 7 - Galley
Equipment	Hot Plate Control Panel
Type	Termination in Base of Panel

Object Parameters	Value
Atmospheric Temperature	32.3 °C
Emissivity	0.95
Object Distance	1.5 m
Reflected Apparent Temperature	32.3 °C
Image File name	IR_6774.jpg
Sp1 Temperature	44.4 °C
Ar1 Max. Temperature	54.9 °C
Difference Ar1 - Sp1	10.6 °C
Fault Rating	Priority 2

Elevated temperature noted on terminal connection.
Likely cause of heat rise is a poor or loose connection.
Recommendation is to inspect, clean and remake off this connection.
