Thermographic Roof Leak Survey

Sample Report

October 2009

Pixel Thermographics Surveyor

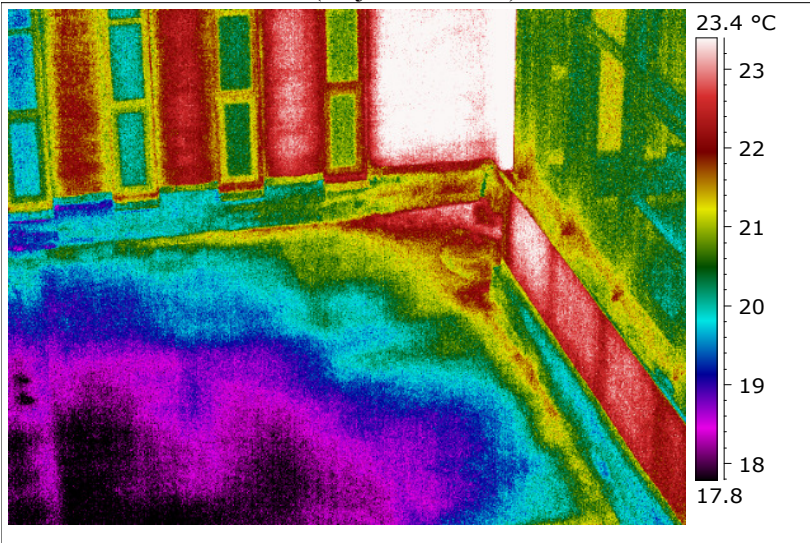
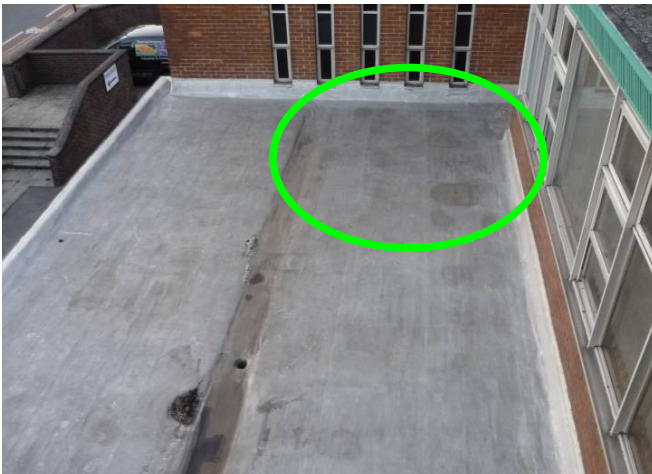
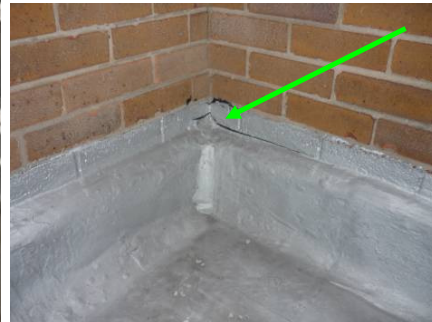
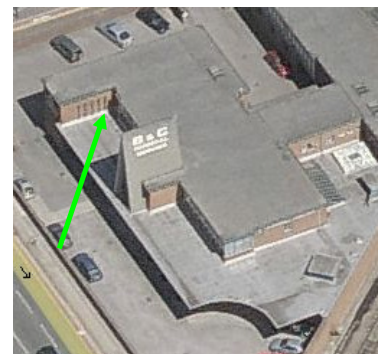
Area: Area 1 - West Side (Adj Main Road)

The warm area of roof indicates water ingress in this area.
Closer inspection revealed a significant split in the membrane (see photo above right) which is the likely entry point for this water.

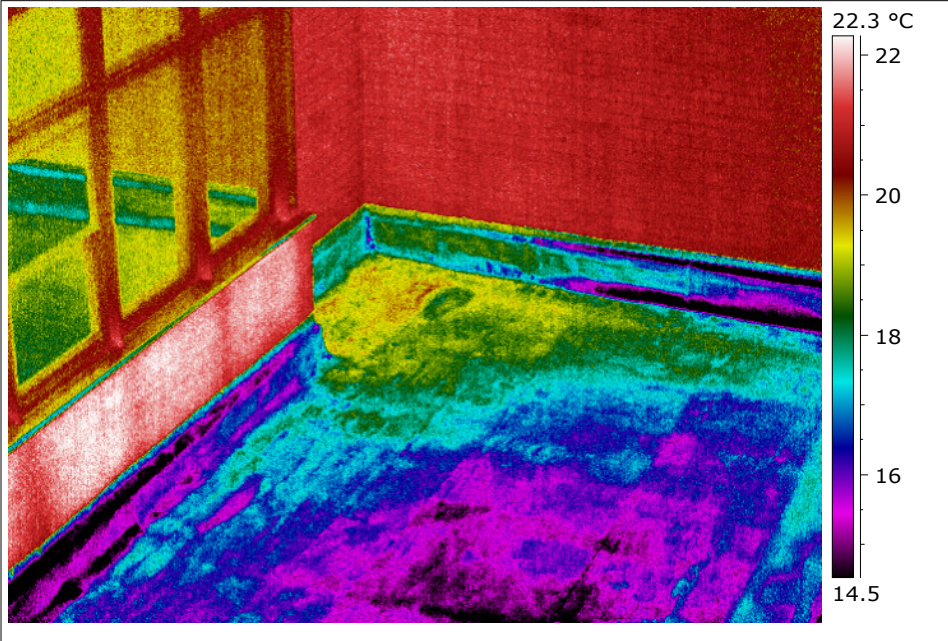
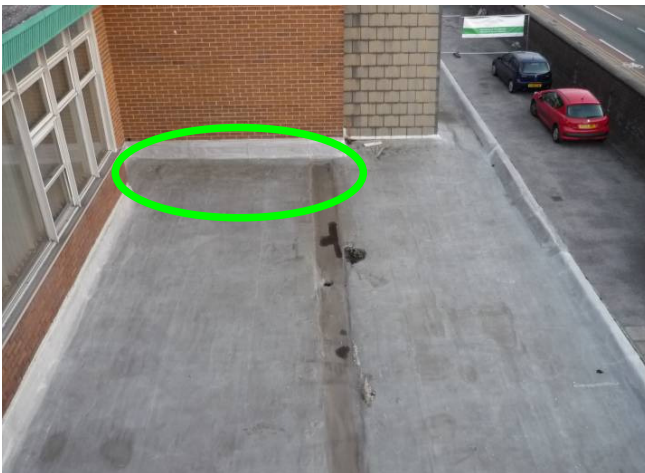
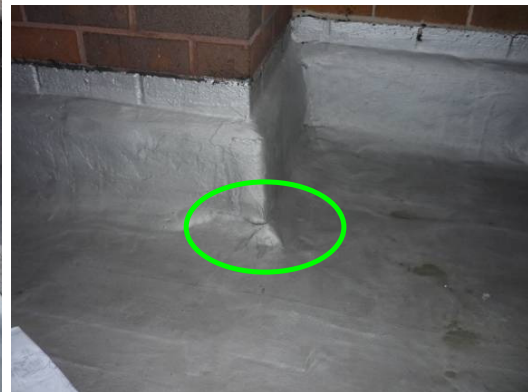
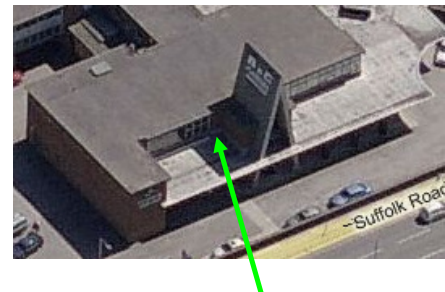
Area: Area 1 - West Side (Adj Main Road)

The warm area of roof indicates water ingress in this area which extends into the gully.
Closer inspection revealed a split in the membrane (see photo above right) at the corner detail which is the likely source of the water.

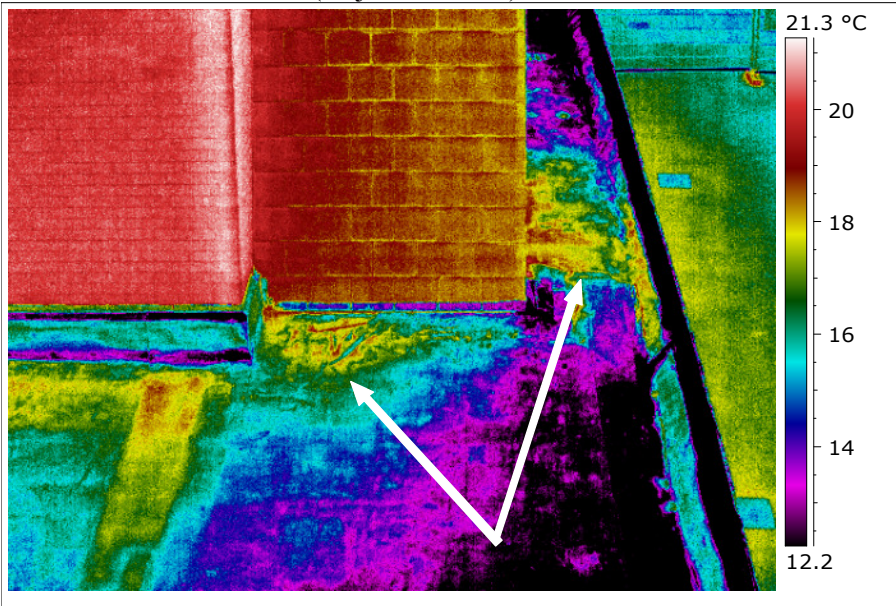
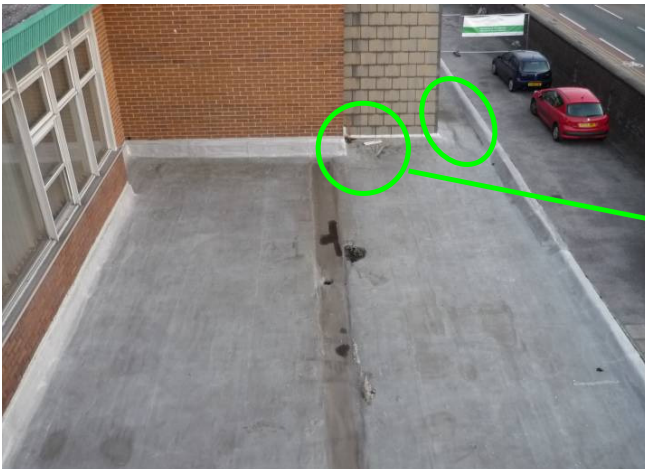
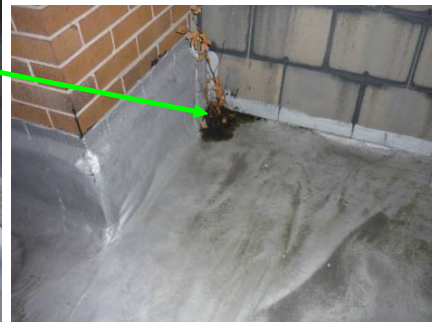
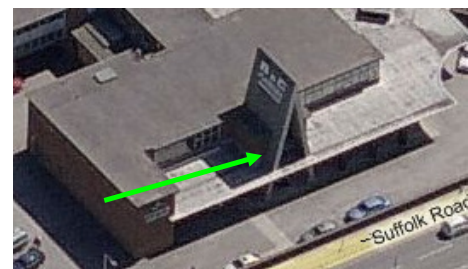
Area: Area 1 - West Side (Adj Main Road)

The two arrowed warm areas in the thermal image indicate separate areas of water ingress.

Closer inspection revealed that the left hand area is likely to be caused by a rooting plant which has grown in the corner details (see photo above right).

The right hand area of water ingress is covered in more detail on the next page.

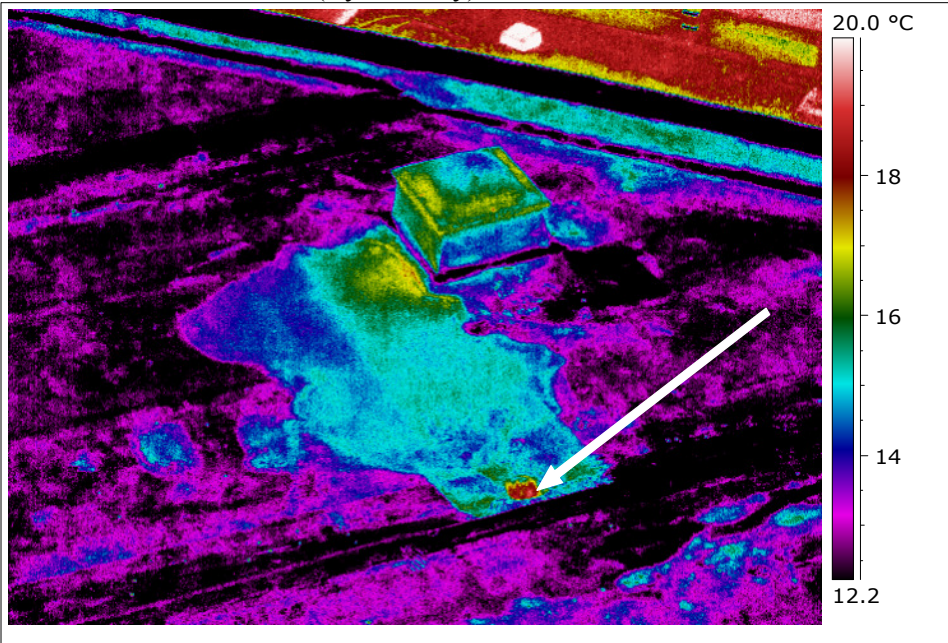
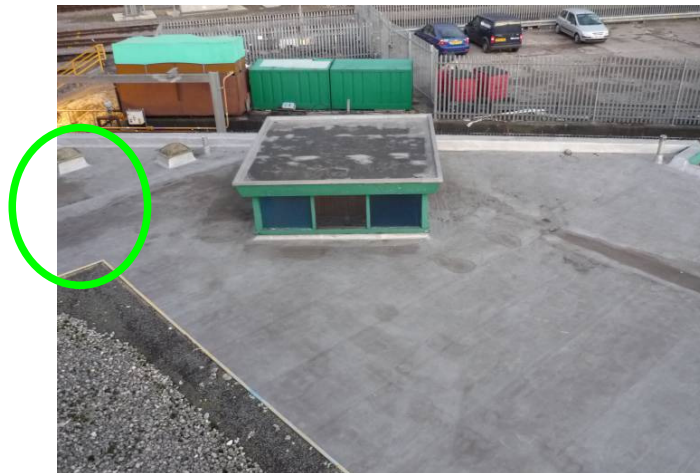
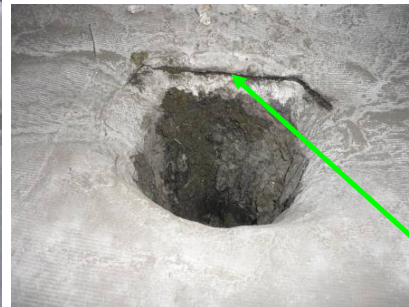
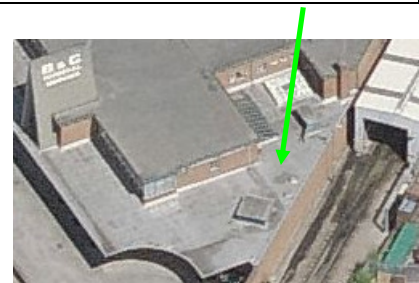
Area: Area 1 - South End (By Railway)

Warm area indicates water ingress beneath the surface.

Closer inspection revealed a split to the membrane close to the drain outlet (see photo above right) which is the likely source of this water.
