Thermographic Commercial Building Survey

SAMPLE REPORT

Pixel Thermographics Ltd

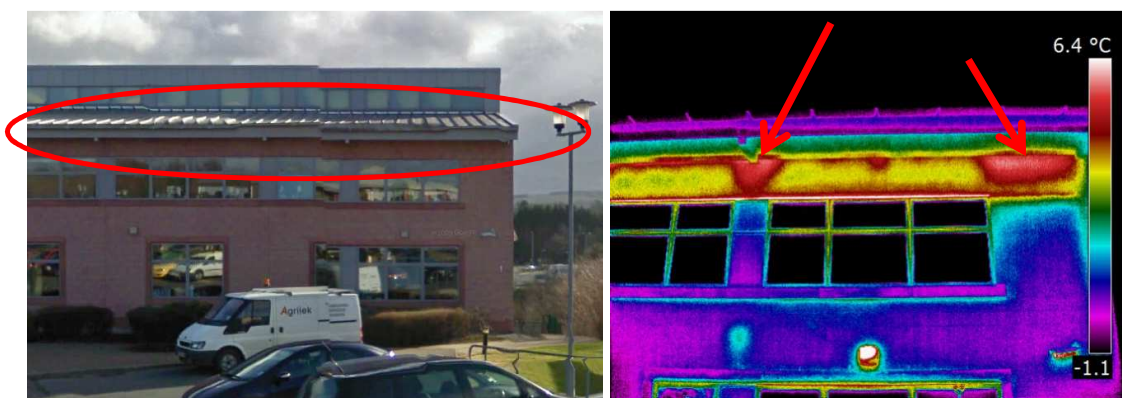
The Lower roof edge section (shown circled in the photograph below) shows significant signs of air movement. This means that warm air is leaking from the building and also cold air is entering the building.

Thermal image above shows warm (red) areas on the external brickwork. This indicates air leakage from the building and appears to occur where the roof support beams penetrate the walls.

External close visual inspection and sealing of any gaps will help reduce this cold air ingress and improve the comfort in the top floor area.

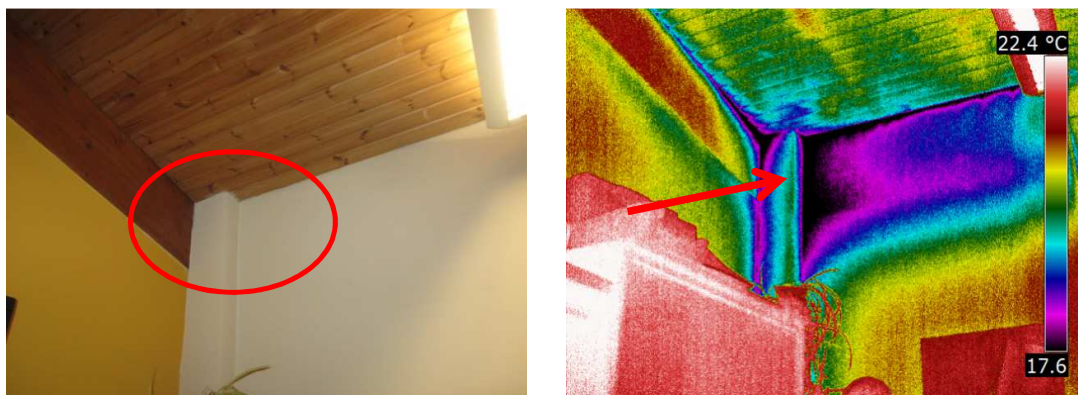
In the same area internally, significant cold air movement (darker colours) was identified. This occurs where cold air from a prevailing wind is forced into the building.

This effect was noted throughout the whole perimeter of the roof system and is causing considerable cooling of the building (particularly in the upper floor).

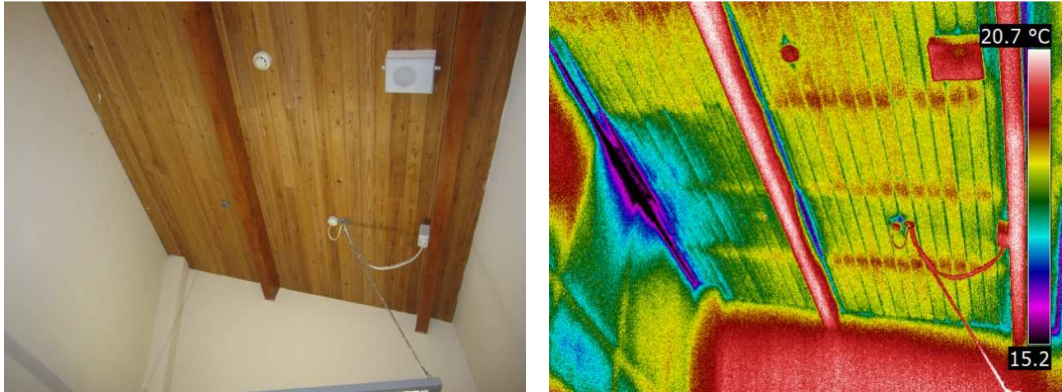
At the rear of the property, the staff kitchen and Area Managers office are both suffering from significant air ingress from the roof edge detail. This is highlighted in the images below:

The cold (dark) area in the thermal image above clearly shows how cold air enters from the roof edge and drops down the wall.

Recommended action is to carry out external visual inspection of roof edge details and seal any gaps to prevent the cold air ingress.

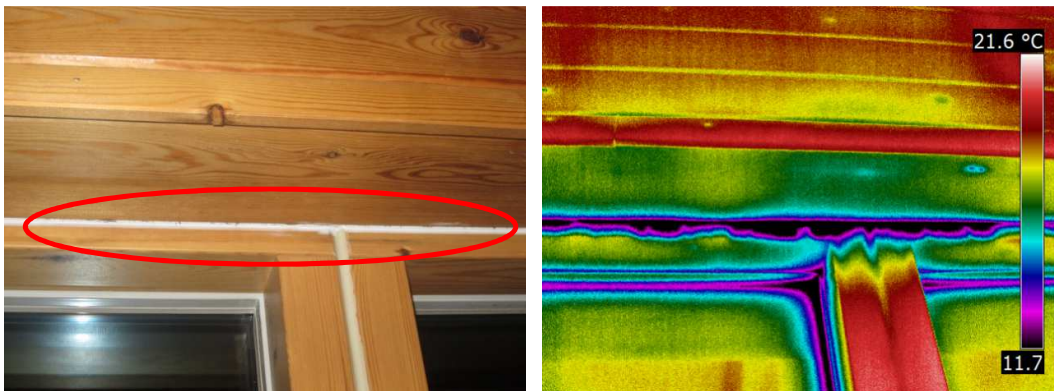
Many of the windows within the building have developed cracks and visible gaps around the frames.

The gaps / cracks are allowing cold air to enter the areas which significantly cool the rooms and result in heating having to work harder.

Even though sealant is present, this has failed and is not providing a seal.

This type of issue was noted throughout the property.

An extensive operation of sealing window frames internally using suitable silicone sealant would greatly reduce the cooling effects of this cold air entry.

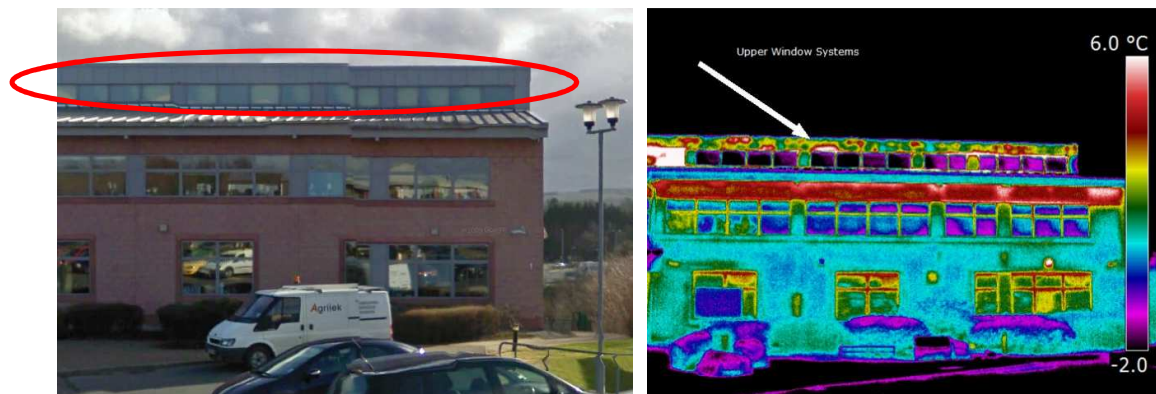
The upper roof area also shows signs of air leakage and cold air ingress into the top floor area.

Warm air leakage and cold air entering the office area significantly cools the office area.

Visual external inspection of the areas around these windows and sealing of any gaps will greatly reduce the cold air ingress into the room.

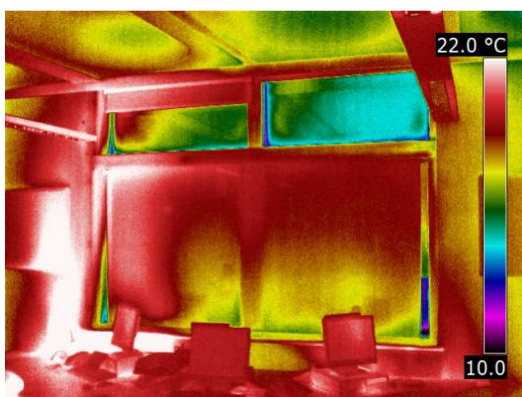
It was noted that where secondary glazing has been installed on the motorway side of the building that it makes a significant improvement in reducing cold air ingress from relatively poor window seals. Extending the use of secondary glazing or replacing windows would bring about further improvements in air ingress within the facility.

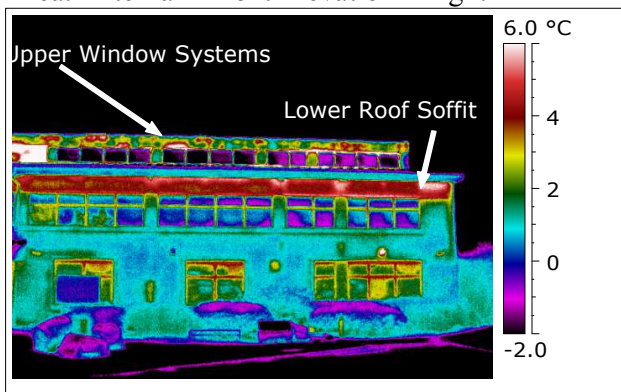
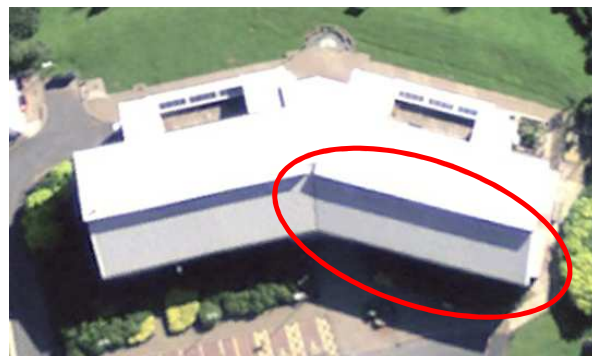
Area: External - Front Elevation - Right

Thermal image highlights air leakage from 2 distinct areas.
The cladding around the upper window systems shows leakage which is likely to be caused by defective or incomplete seals.
The lower roof area leakage is analysed further in the image below.

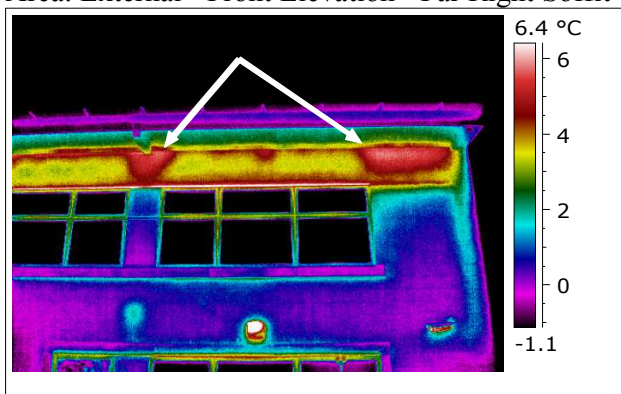
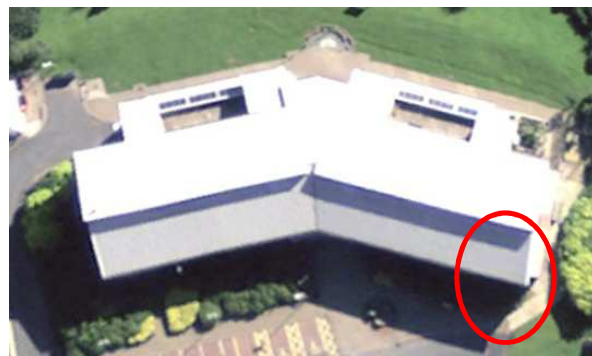
Area: External - Front Elevation - Far Right Soffit

Air leakage noted from the underside of the soffit (roof overhang). Air appears to originate from the roof support structural beam penetrations.
Recommendation is to inspect these areas throughout the perimeter of the roof and seal any gaps.
Note that this air leakage will result in air ingress (draughts) inside the building.
Air leakage also noted from window frames (see later pages in report for internal inspection).

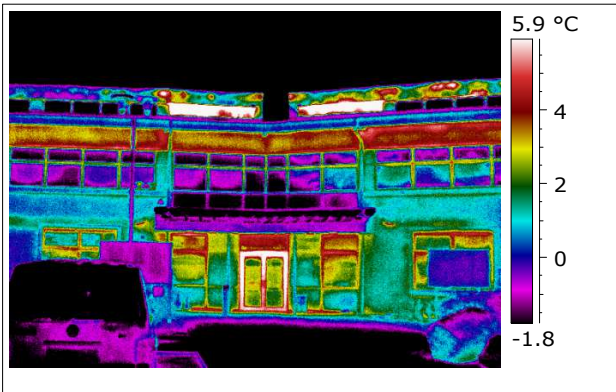
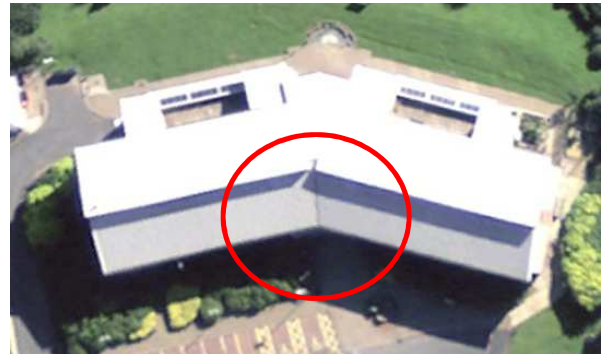
Area: External - Front Elevation - Centre

Warm (white) areas should be ignored as these are extract vents.
Air leakage noted from cladding above upper windows.
Leakage also noted from lower roof support beams.
Recommendation is to inspect these areas throughout the perimeter of the roof and seal any gaps.
Note that this air leakage will result in air ingress (draughts) inside the building.
Air leakage also noted from window frames (see later pages in report for internal inspection).

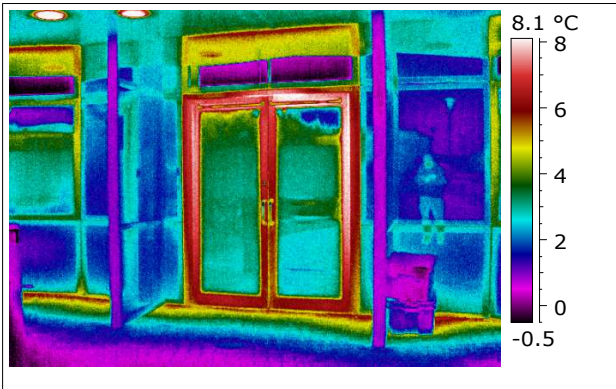
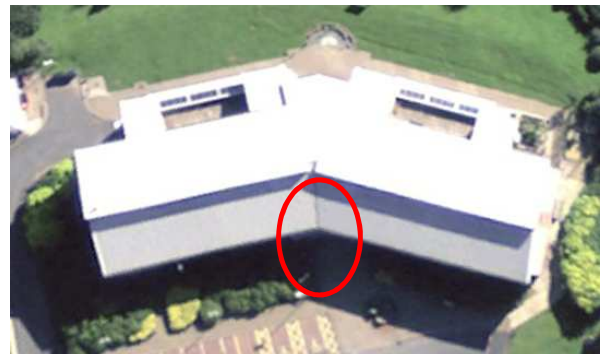
Area: External - Front Elevation - Main Entrance

Air leakage from exterior door system which could have improved draught exclusion.

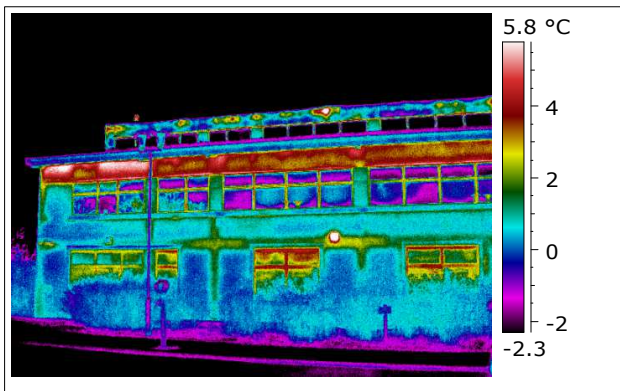
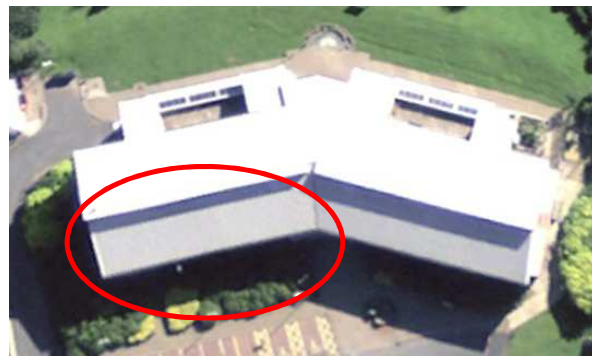
Area: External - Front Elevation - Left

Further evidence of air leakage on high level cladding and main roof support beam penetrations.

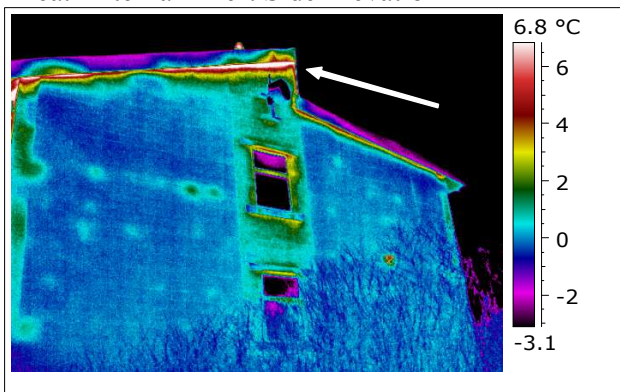
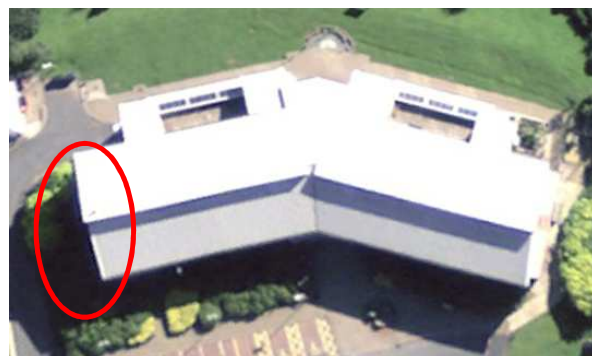
Area: External - Left Side Elevation

Air leakage noted at high level detail.
Inspection and sealing as appropriate required.

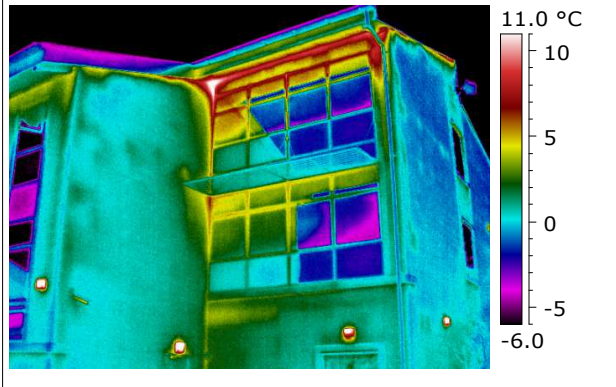
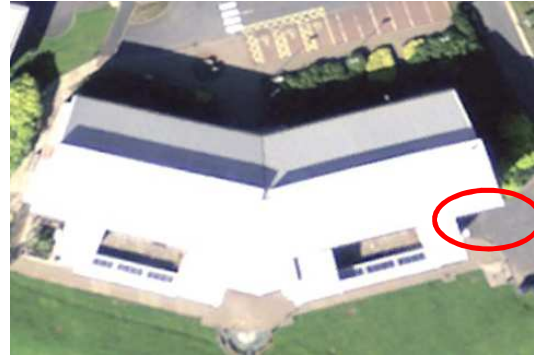
Area: External - Rear Elevation - Far Right

Air leakage noted from underside of roof / soffit area where it is suspected that seals are not effective. See image below for closer view.

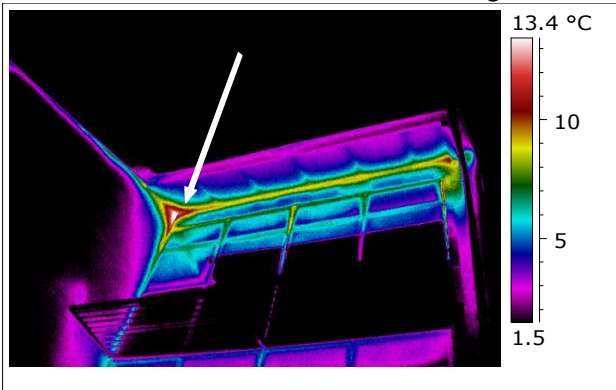
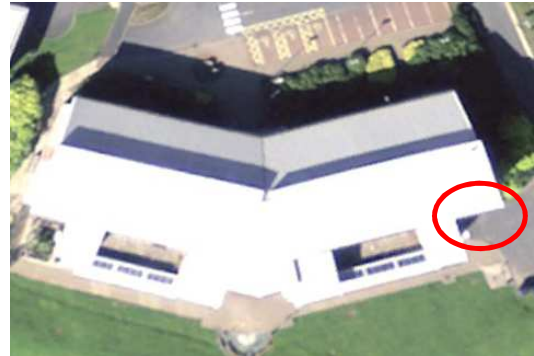
Area: External - Rear Elevation - For Right

Air leakage noted from underside of roof / soffit area where it is suspected that seals are not effective. This will result in air ingress (draughts) into the building with a prevailing wind. Inspection and sealing any gaps recommended.

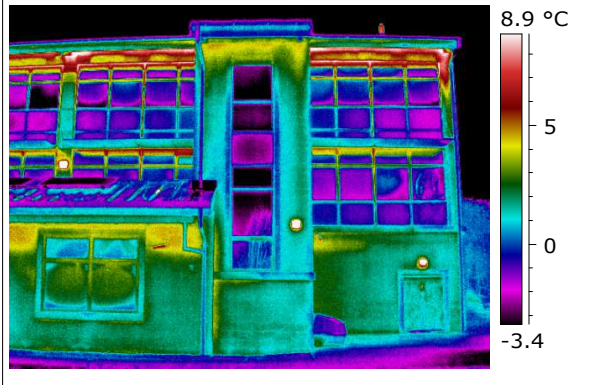
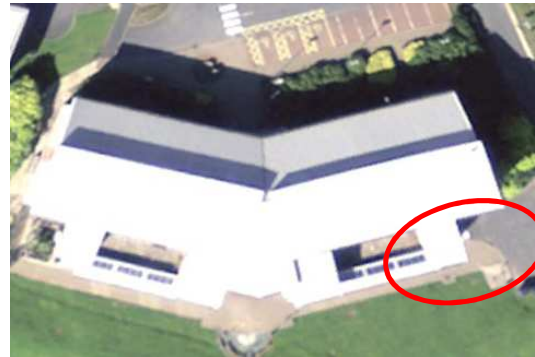
Area: External - Rear Elevation - Right

Air leakage noted again at underside of roof where support beams penetrate walls.
Inspection and sealing recommended.

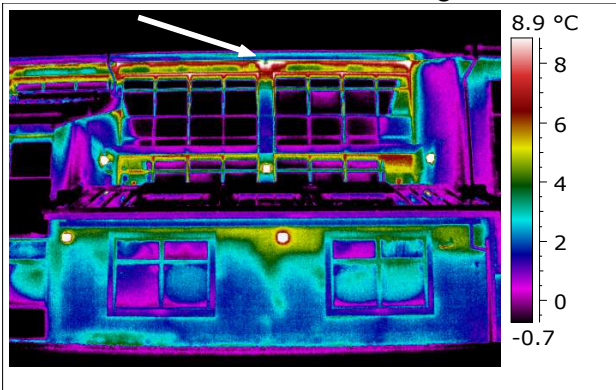
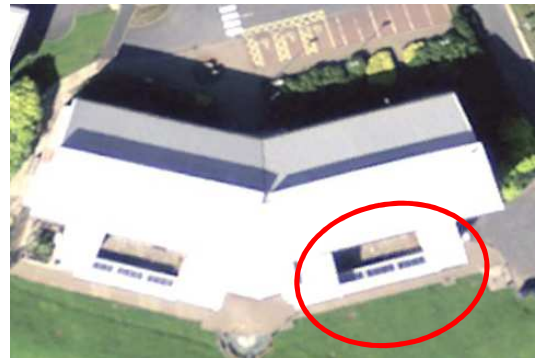
Area: External - Rear Elevation - Right of Centre

Air leakage noted again at underside of roof where support beams penetrate walls.
Inspection and sealing recommended.

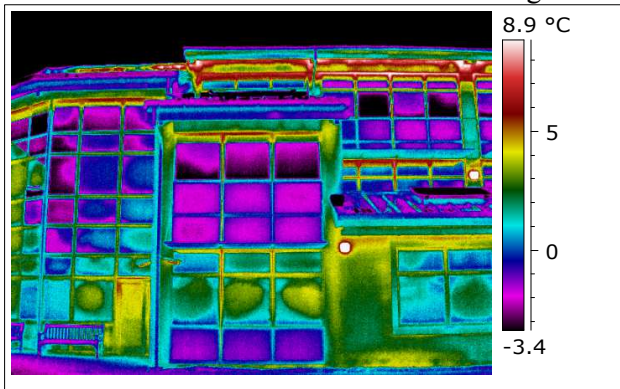
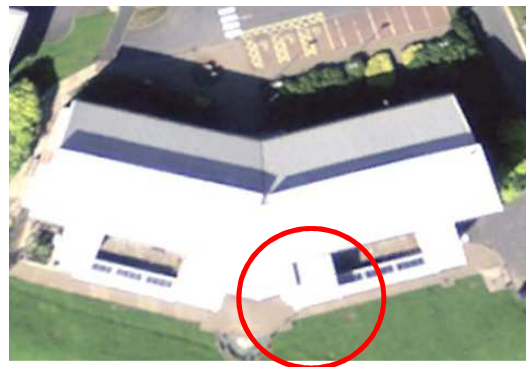
Area: External - Rear Elevation - Centre Right

Air leakage noted again at underside of roof where support beams penetrate walls.
Inspection and sealing recommended.

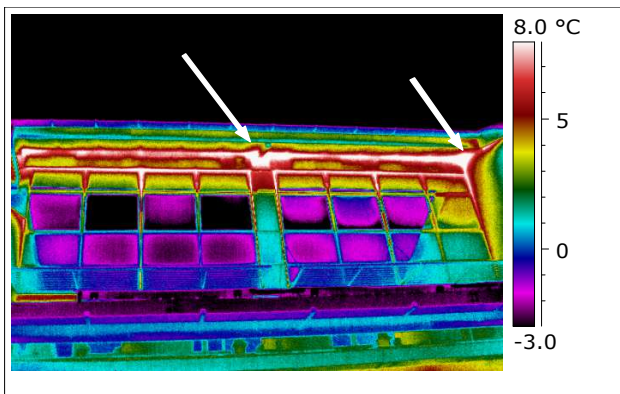
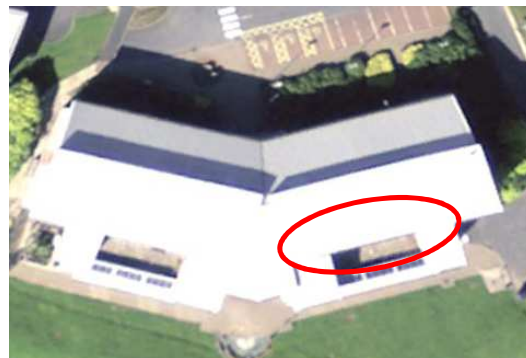
Area: External - Rear Elevation - Centre - Soffit

Image further highlights the air leakage from underside of roof where support beams penetrate.

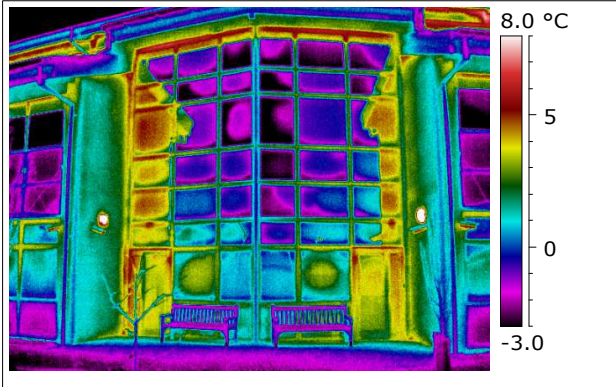
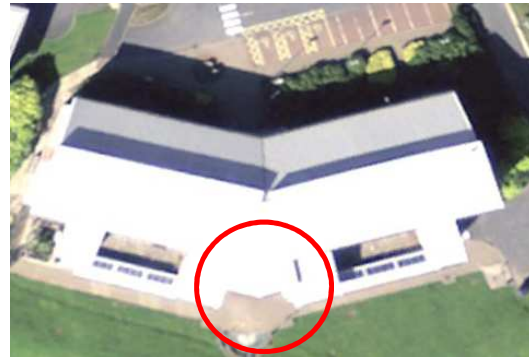
Area: External - Rear Elevation - Centre Left

Air leakage noted from exit doors and along top edge of window structure.

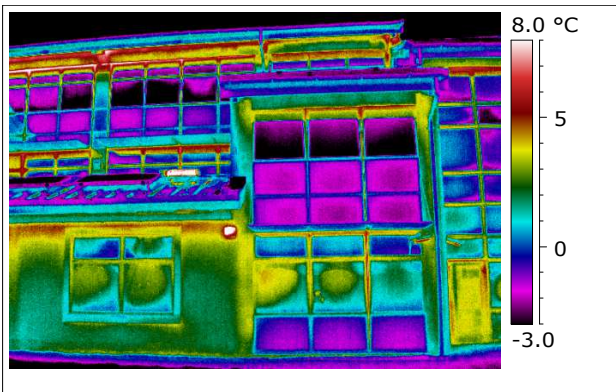
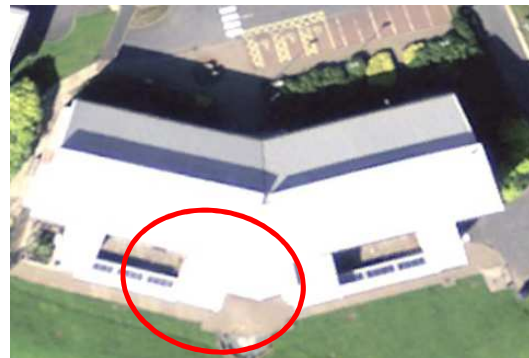
Area: External - Rear Elevation - Left of Centre

Air leakage noted again at underside of roof where support beams penetrate walls.
Inspection and sealing recommended.

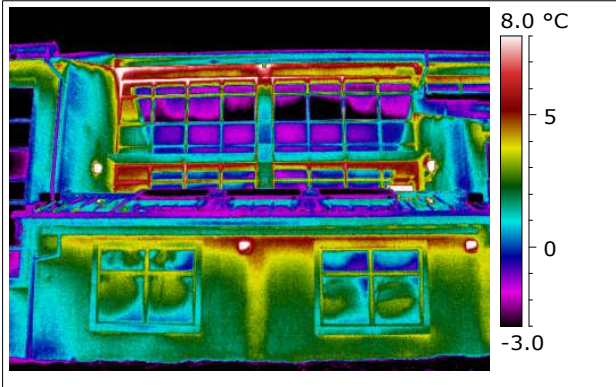
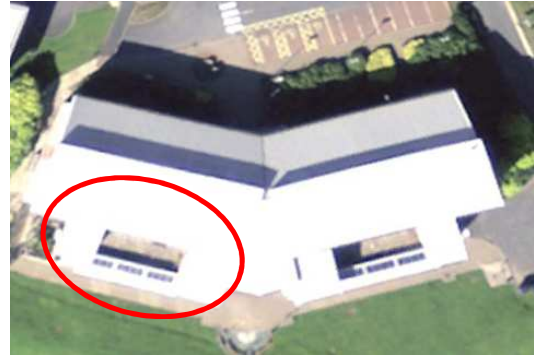
Area: External - Rear Elevation - Left

Air leakage noted again at underside of roof where support beams penetrate walls. Inspection and sealing recommended.

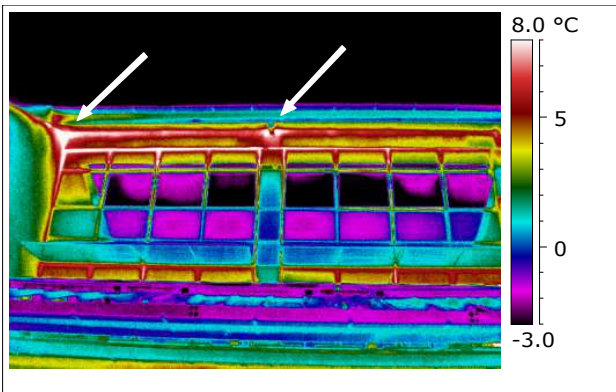
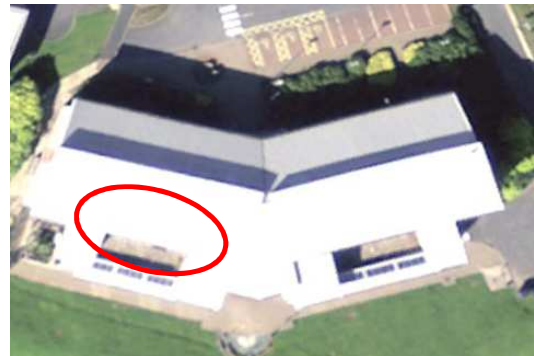
Area: External - Rear Elevation - Left - Soffit

Image further highlights the air leakage from underside of roof where support beams penetrate.

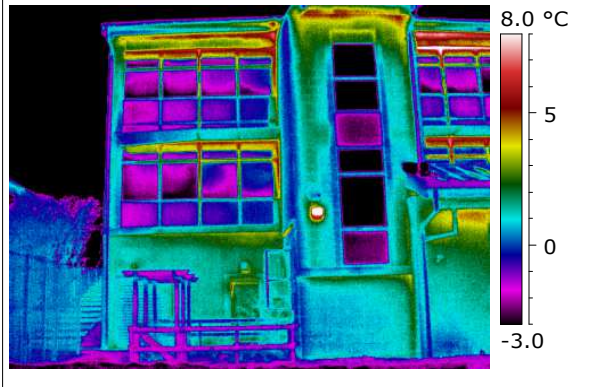
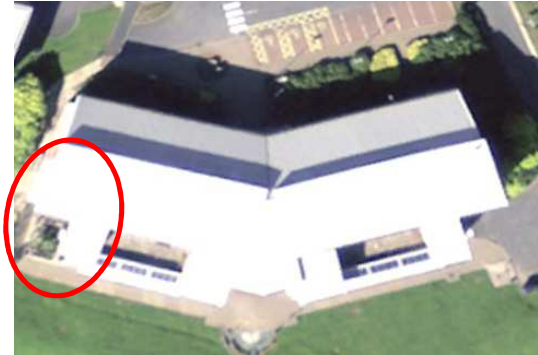
Area: External - Rear Elevation - Far Left

Air leakage noted again at underside of roof where support beams penetrate walls.
Inspection and sealing recommended.

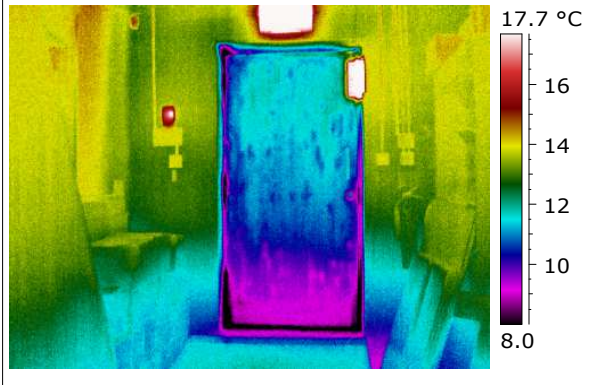
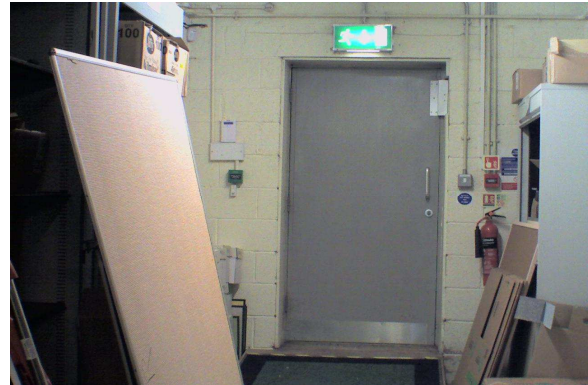
Area: Lower Ground Floor - Storage Room - Door

Door is poorly sealed – better draught exclusion would reduce cold air ingress into the area.

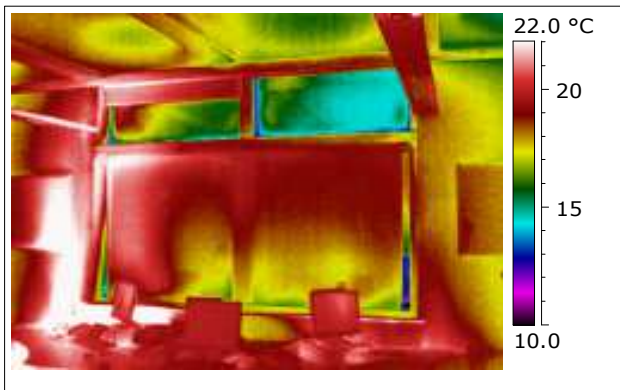
Area: Lower Ground Floor - Cornwell Breakout Room - Window

Secondary glazing installed on the motorway side of the building (lower windows only) greatly reduces air ingress into the rooms (as well as reduces noise from motorway).

Image above demonstrates improvement in thermal performance.

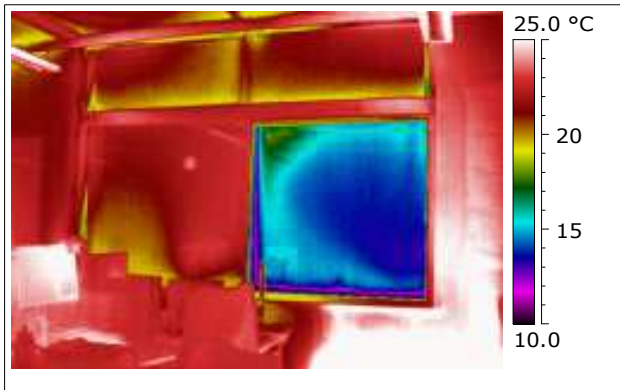
Area: Lower Ground Floor - Cornwell Breakout Room - Window

Image provided to demonstrate the significantly improved thermal performance of the window systems with secondary glazing installed. This greatly reduces air ingress from windows.

Image above shows an open secondary glazed unit.

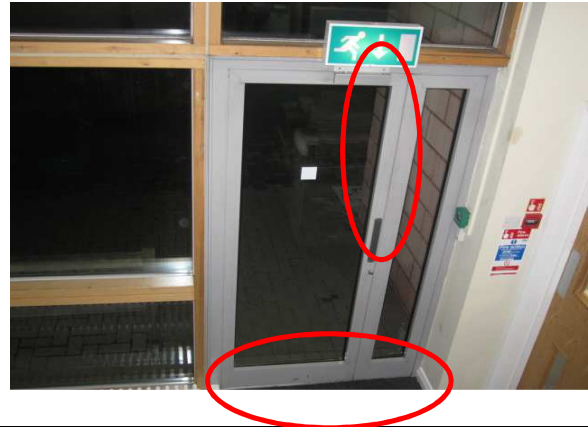
Area: Lower Ground Floor - Atrium - Rear Exit Door

Exit door is very poorly sealed and results in significant air ingress into the atrium area.

Draught exclusion required to reduce the cold air ingress.

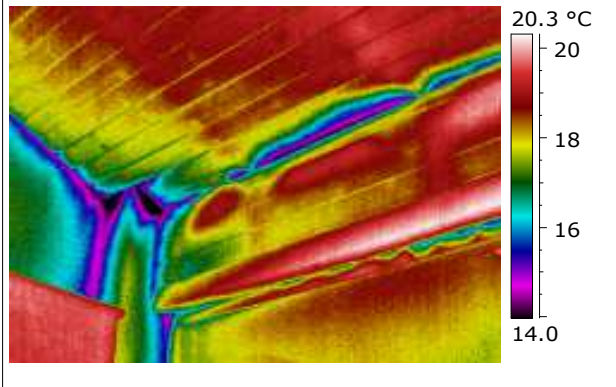
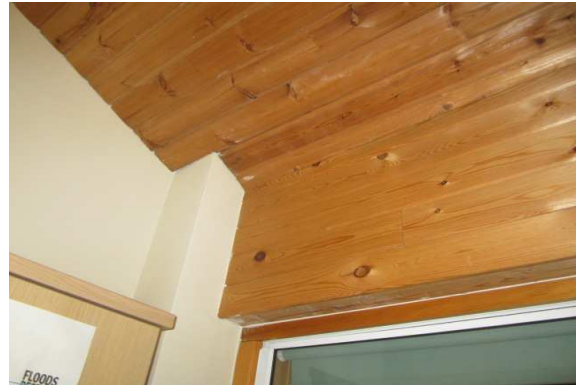
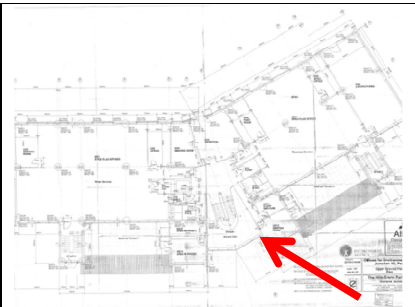
Area: Upper Ground Floor - Staff Kitchen - Ceiling

Cold air ingress noted at ceiling level from wooden paneling.

Ingress appears to occur at the roof line of the building where the support beams penetrate the walls. External inspection and sealing of the roof overhang and roof support beams would greatly reduce cold air ingress and the resultant cooling effects.

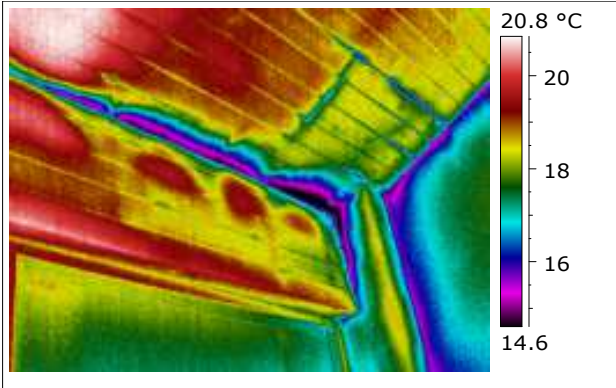
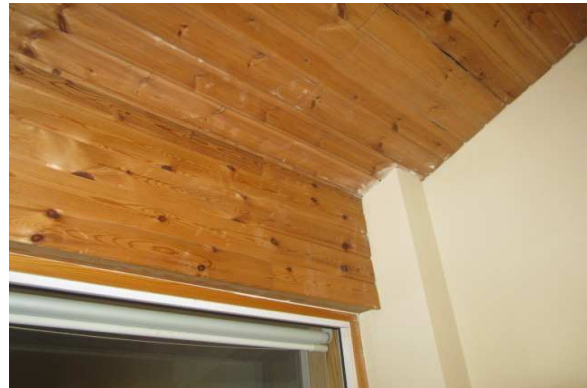
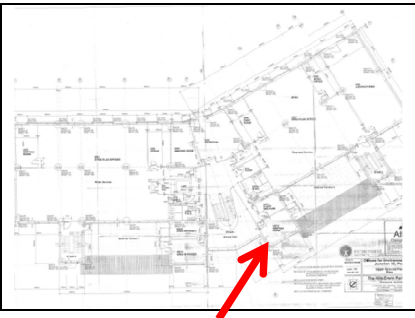
Area: Upper Ground Floor - Staff Kitchen - Ceiling

Cold air ingress noted at ceiling level from wooden paneling.

Ingress appears to occur at the roof line of the building where the support beams penetrate the walls. External inspection and sealing of the roof overhang and roof support beams would greatly reduce cold air ingress and the resultant cooling effects.

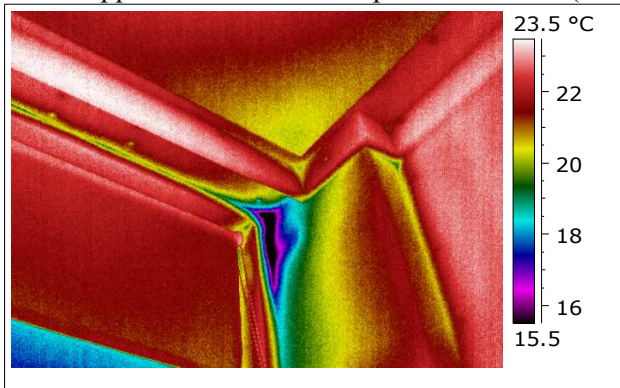
Area: Upper Ground Floor - Open Plan Office (UG7) - Window Frames

Visible gaps around window frames allow cold air to enter the room.

Applying suitable silicone sealant around the edges of window frames will greatly reduce the cold air and the cooling effects of this air.

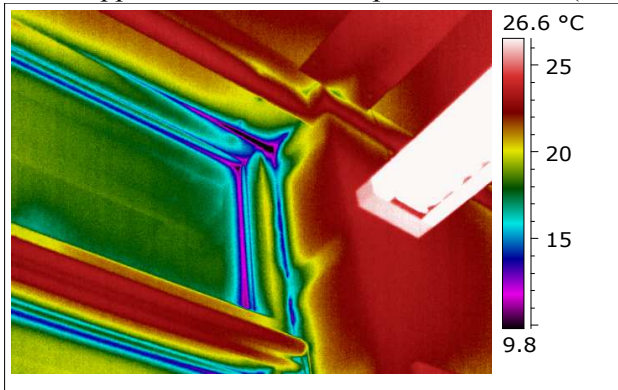
Area: Upper Ground Floor - Open Plan Office (UG7) - Window Frames

Visible gaps around window frames allow cold air to enter the room.

Applying suitable silicone sealant around the edges of window frames will greatly reduce the cold air and the cooling effects of this air.

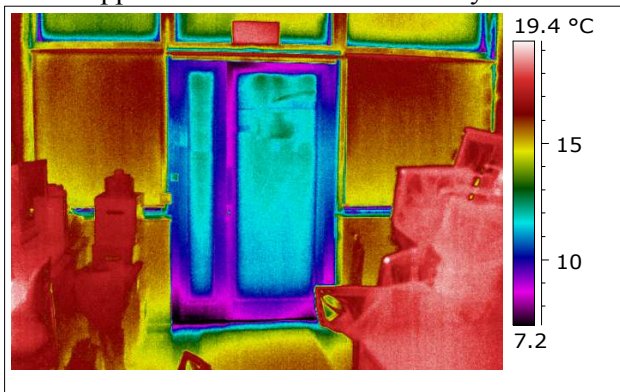
Area: Upper Ground Floor - Laboratory - Door

Door is poorly sealed – better draught exclusion would reduce cold air ingress into the area.

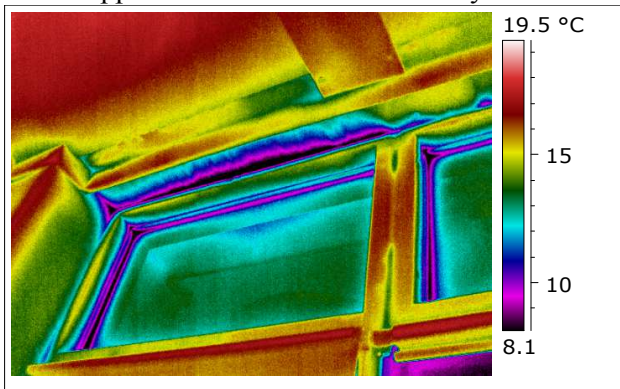
Area: Upper Ground Floor - Laboratory - Window Frames

Visible gaps around window frames allow cold air to enter the room.

Applying suitable silicone sealant around the edges of window frames will greatly reduce the cold air and the cooling effects of this air.

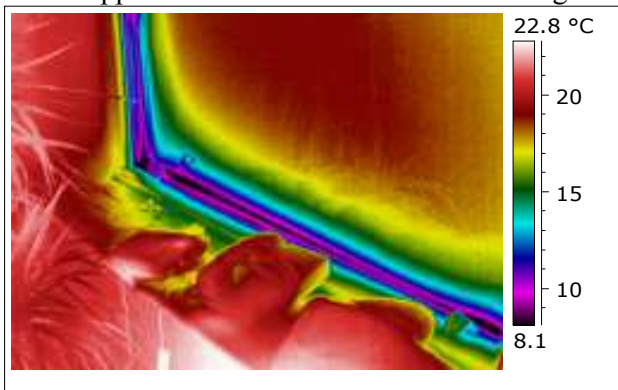
Area: Upper Ground Floor - Coniston Meeting Room - Window Frames

This window is typical of all windows throughout the building and highlights that the seals do not perform particularly well and allow air to enter the room.

The secondary glazing installed on the motorway side of the building greatly reduces the cooling effects of this air ingress.

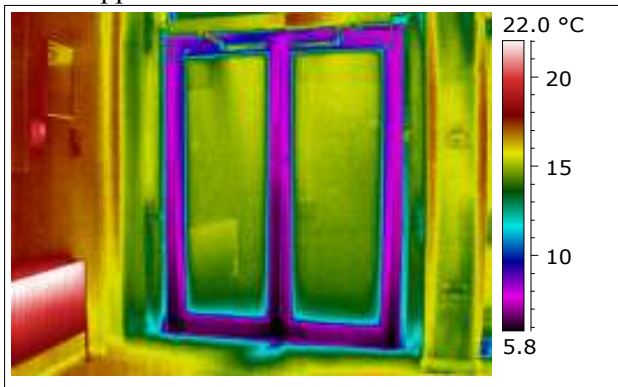
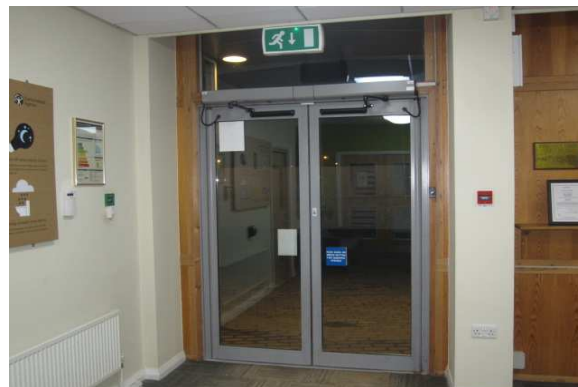
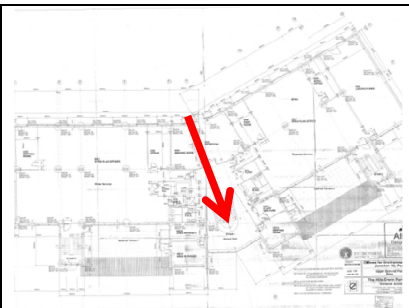
Area: Upper Ground Floor - Main Entrance Doors

Cold air ingress noted on main entrance doors which appear poorly sealed.

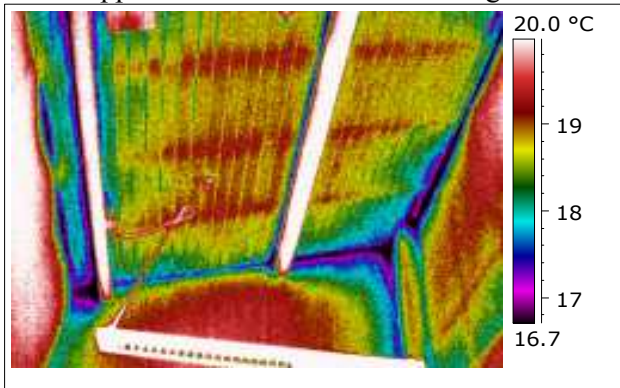
Area: Upper Ground Floor - Area Manager Office (UG15) - Ceiling

Thermal image highlights significant cold air ingress (shown as dark colours) from the roof paneling.

Air entering the roof systems should be prevented and realistically can only be done externally by visual inspection of edge / corner details and for sealing to take place where gaps are present.

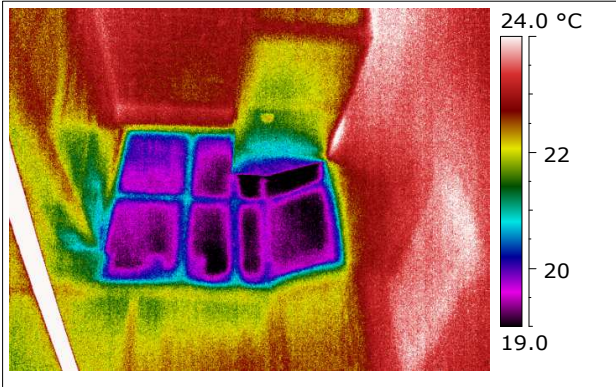
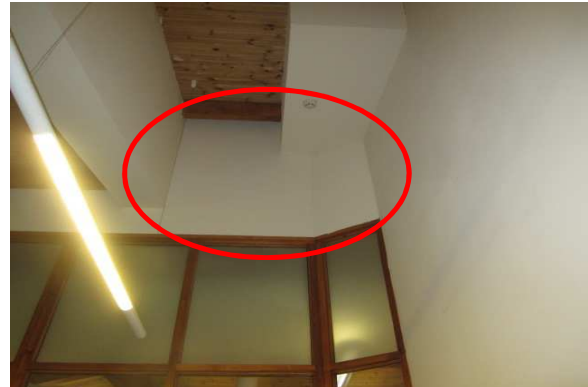
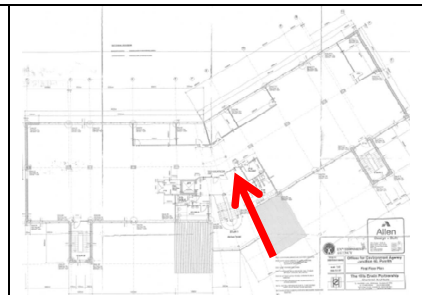
Area: First Floor - Top of Stairs - Upper Wall

Thermal image highlights suspected missing insulation in this section of the upper wall.

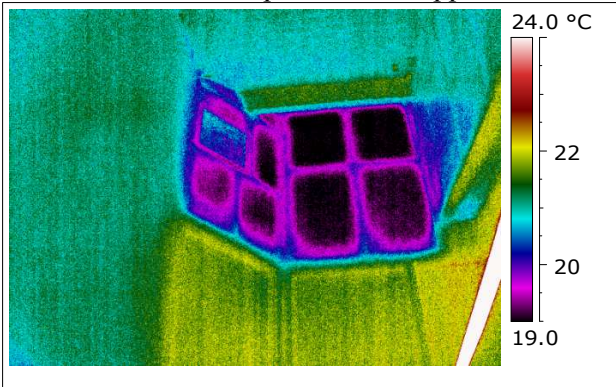
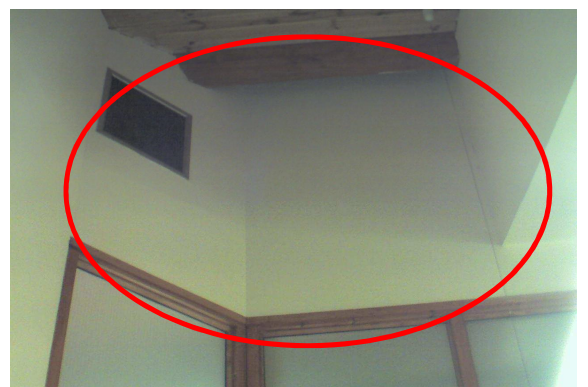
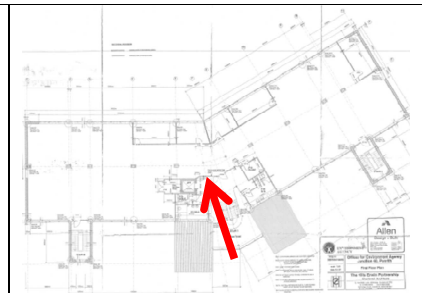
Area: First Floor - Top of Stairs - Upper Wall

Thermal image highlights suspected missing insulation in this section of the upper wall.

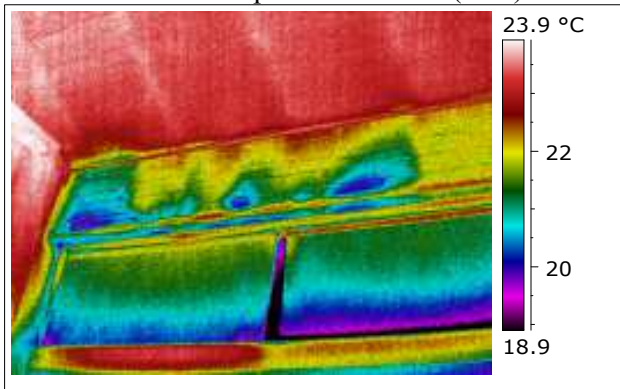
Area: First Floor - Upon Plan Office (East) - Window Frames

The thermal image highlights cold air ingress into wood paneling above the windows.

Air is suspected as entering via the roof support beam penetrations (see external imaging on earlier pages of this report).

Inspecting and sealing gaps outside would greatly reduce the cold air ingress and the cooling effects.

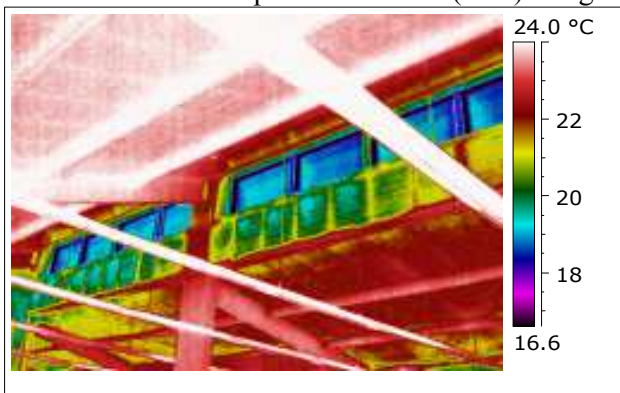
Area: First Floor - Upon Plan Office (East) - High Level Windows

The thermal image highlights cold air movement behind the wooden high level paneling.
