SOLAS Compliance Thermographic Survey

Engine Room Equipment

SAMPLE REPORT

Pixel Thermographics Ltd

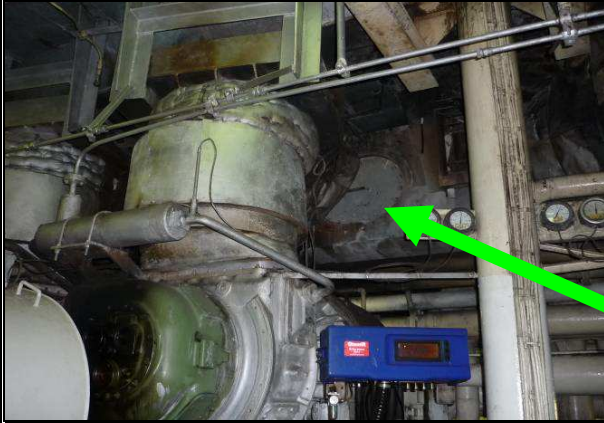
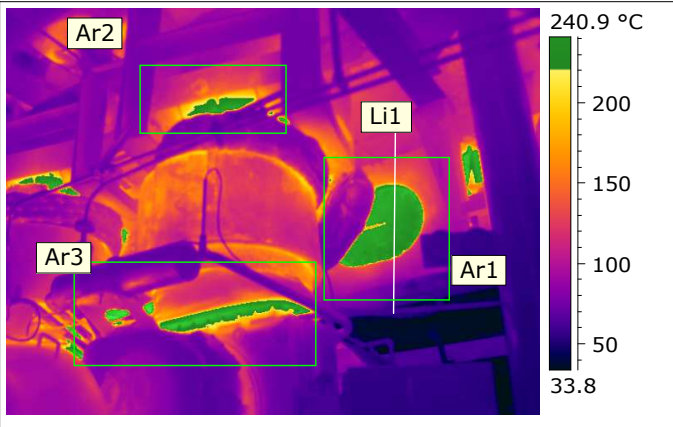
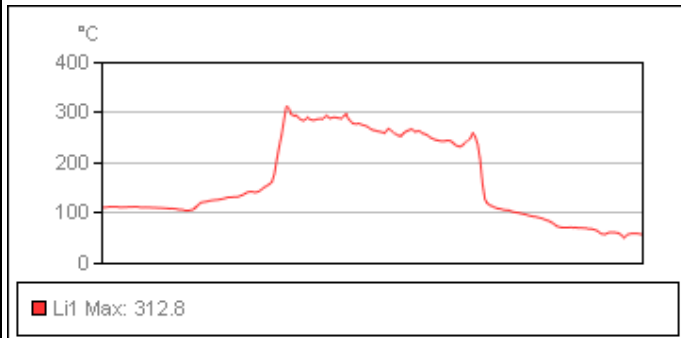
Location	Main Engine Room
Equipment	Port Engine
Type	Turbo Charger (STBD Side) & Exhaust Duct

Object Parameters	Value
Date	06/08/2010
Image Time	08:27:14
Atmospheric Temperature	44.0 °C
Ar1 Max. Temperature	342.9 °C
Ar2 Max. Temperature	294.1 °C
Ar3 Max. Temperature	429.3 °C
Emissivity	0.95
Object Distance	4.0 m
Reflected Apparent Temperature	59.6 °C
Image File name	IR_6806.jpg

Priority 1

Temperatures in excess of the upper limit of 220°C are highlighted in green.

Missing or damaged / defective insulation appears to be the cause of the high surface temperatures.

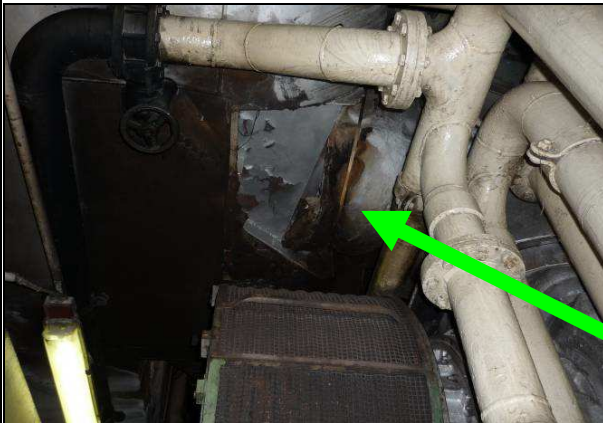
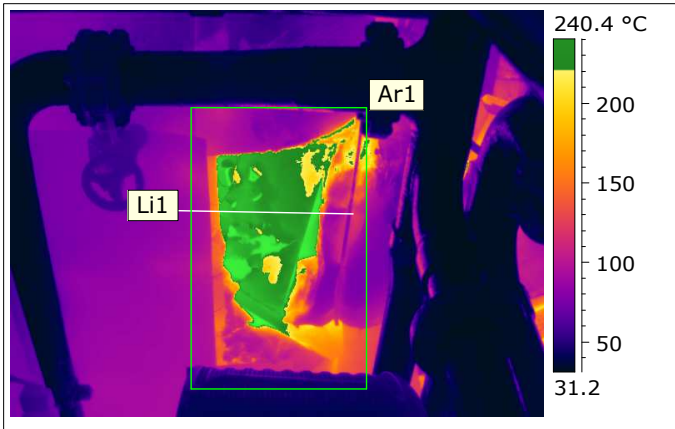
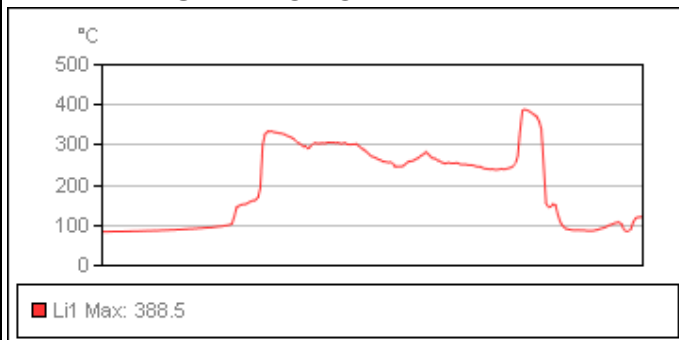
Location	Main Engine Room
Equipment	Port Engine
Type	Exhaust Duct After Turbo Charger

Object Parameters	Value
Date	06/08/2010
Image Time	08:33:07
Atmospheric Temperature	44.0 °C
Ar1 Max. Temperature	413.9 °C
Emissivity	0.95
Object Distance	4.0 m
Reflected Apparent Temperature	59.6 °C
Image File name	IR_6812.jpg

Priority 1

Temperatures in excess of the upper limit of 220°C are highlighted in green.
 Damaged / defective insulation appears to be the cause of the high surface temperatures.

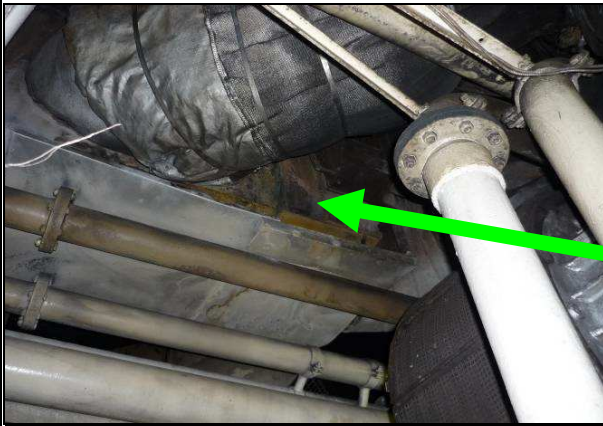
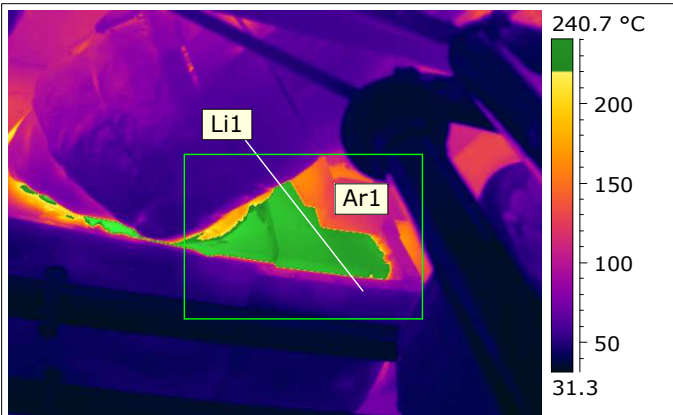
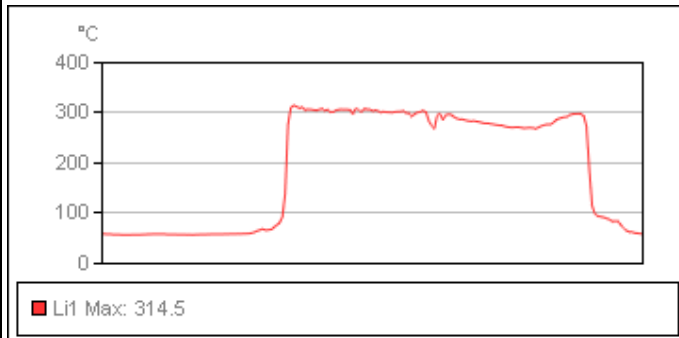
Location	Main Engine Room
Equipment	Central Engine
Type	Exhaust Ductwork

Object Parameters	Value
Date	06/08/2010
Image Time	08:31:14
Atmospheric Temperature	44.0 °C
Ar1 Max. Temperature	353.7 °C
Emissivity	0.95
Object Distance	4.0 m
Reflected Apparent Temperature	59.6 °C
Image File name	IR_6810.jpg

Priority 1

Temperatures in excess of the upper limit of 220°C are highlighted in green.

Missing insulation appears to be the cause of the high surface temperatures.

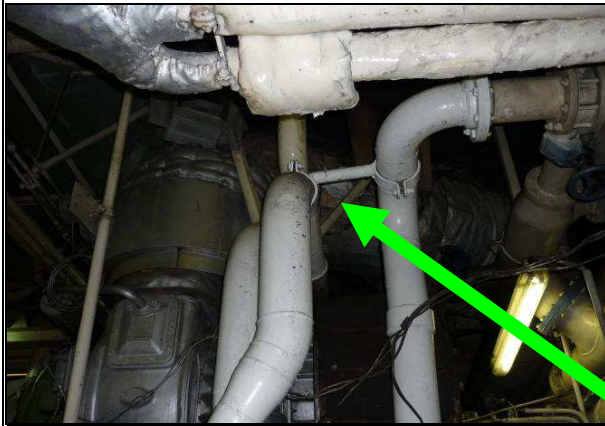
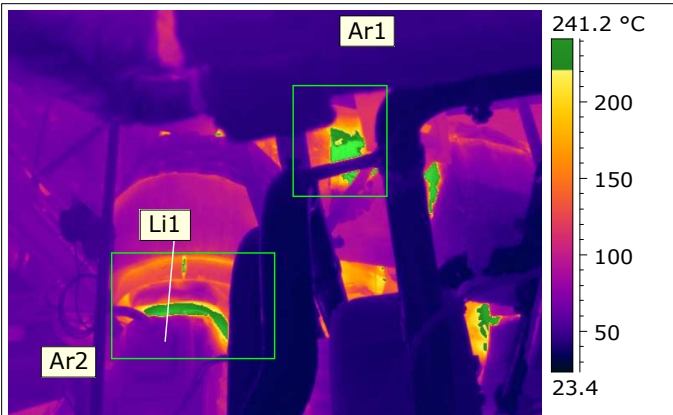
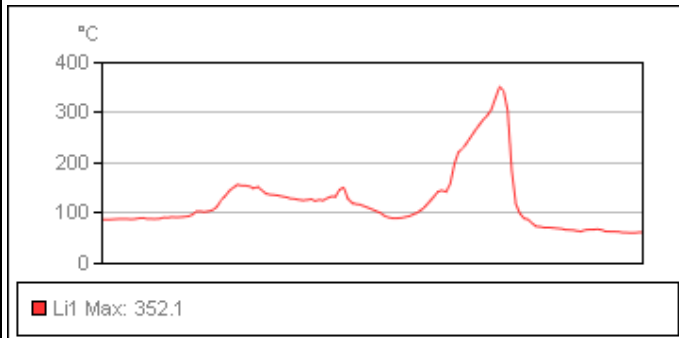
Location	Main Engine Room
Equipment	Central Engine
Type	Exhaust From Super Charger (STBD Side)

Object Parameters	Value
Date	06/08/2010
Image Time	08:35:37
Atmospheric Temperature	44.0 °C
Ar1 Max. Temperature	381.6 °C
Ar2 Max. Temperature	361.2 °C
Emissivity	0.95
Object Distance	4.0 m
Reflected Apparent Temperature	59.6 °C
Image File name	IR_6814.jpg

Priority 1

Temperatures in excess of the upper limit of 220°C are highlighted in green.

Missing or damaged / defective insulation appears to be the cause of the high surface temperatures.

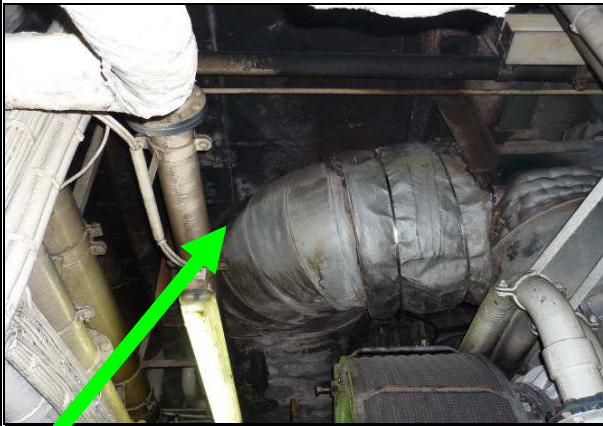
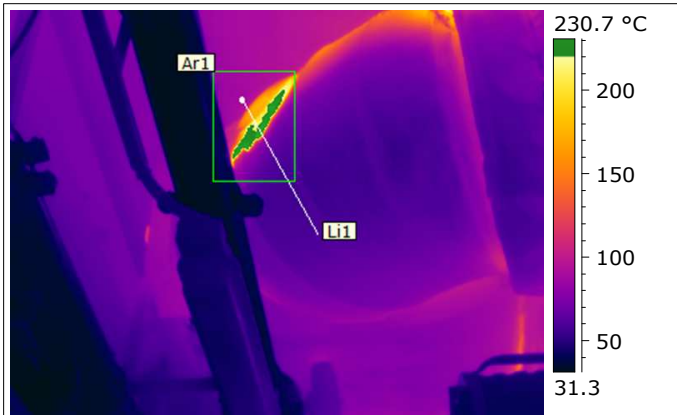
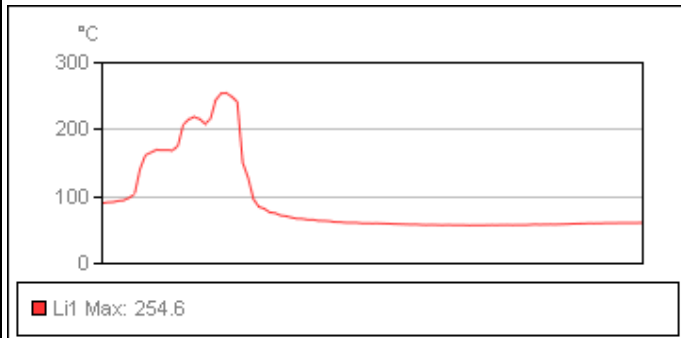
Location	Main Engine Room
Equipment	STBD Engine
Type	Exhaust Duct from Turbo Charger

Object Parameters	Value
Date	06/08/2010
Image Time	08:39:45
Atmospheric Temperature	44.0 °C
Ar1 Max. Temperature	274.5 °C
Emissivity	0.95
Object Distance	4.0 m
Reflected Apparent Temperature	59.6 °C
Image File name	IR_6820.jpg

Priority 1

Temperatures in excess of the upper limit of 220°C are highlighted in green.

Missing or damaged / defective insulation appears to be the cause of the high surface temperatures.

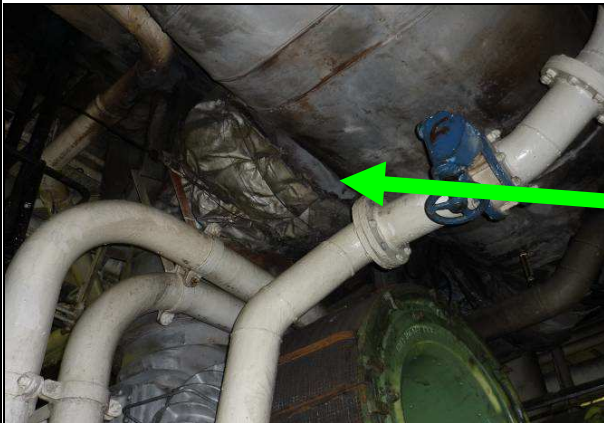
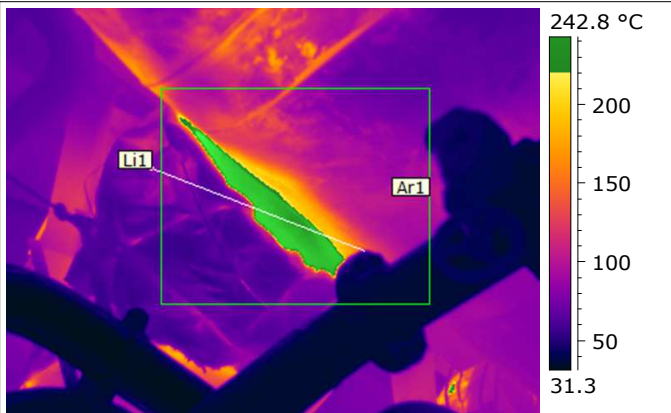
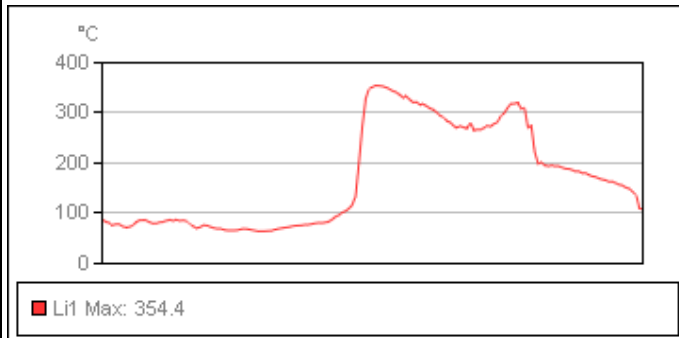
Location	Main Engine Room
Equipment	STBD Engine
Type	Exhaust From Turbo Charger (STBD)

Object Parameters	Value
Date	06/08/2010
Image Time	08:41:08
Atmospheric Temperature	44.0 °C
Ar1 Max. Temperature	411.3 °C
Emissivity	0.95
Object Distance	4.0 m
Reflected Apparent Temperature	59.6 °C
Image File name	IR_6822.jpg

Priority 1

Temperatures in excess of the upper limit of 220°C are highlighted in green.

Missing or damaged / defective insulation appears to be the cause of the high surface temperatures.

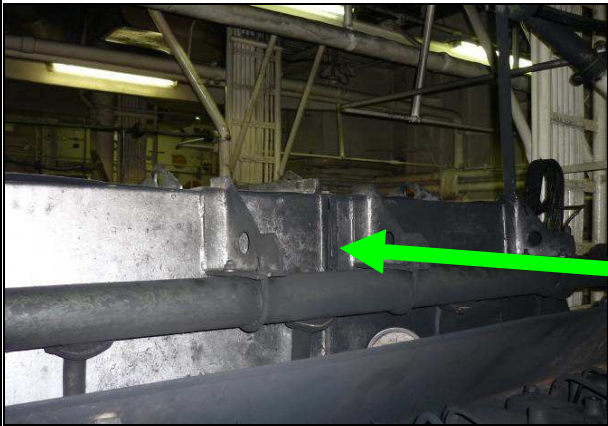
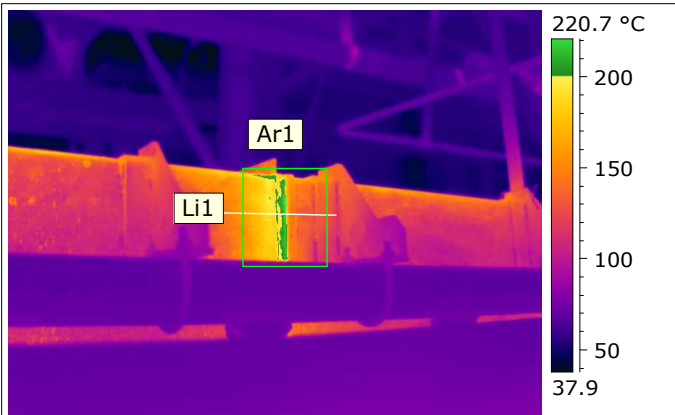
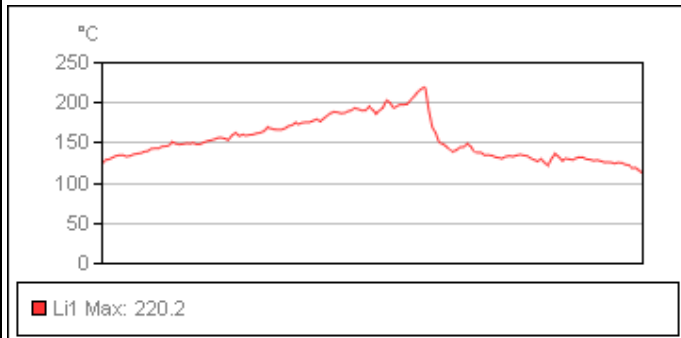
Location	Generator Room
Equipment	Port Generator
Type	Top of Generator (Port Side)

Object Parameters	Value
Date	06/08/2010
Image Time	08:50:05
Atmospheric Temperature	44.0 °C
Ar1 Max. Temperature	227.2 °C
Emissivity	0.95
Object Distance	4.0 m
Reflected Apparent Temperature	59.6 °C
Image File name	IR_6828.jpg

Priority	2
-----------------	----------

Temperatures approaching the upper limit of 220°C are highlighted in green.

Leakage via a visible gap in the casing appears to be the cause of the high surface temperature.

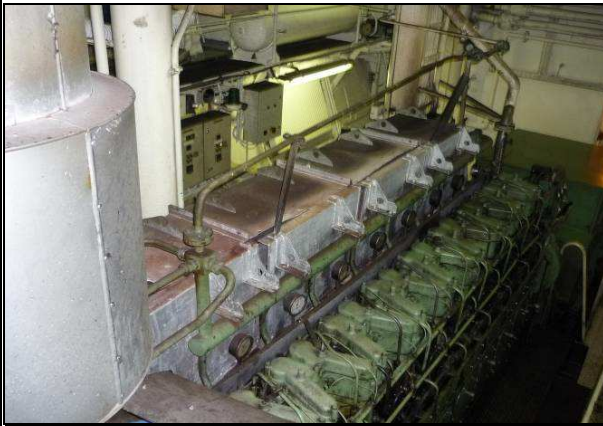
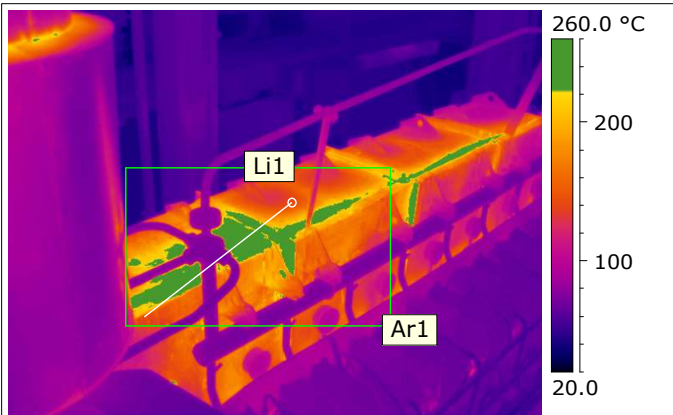
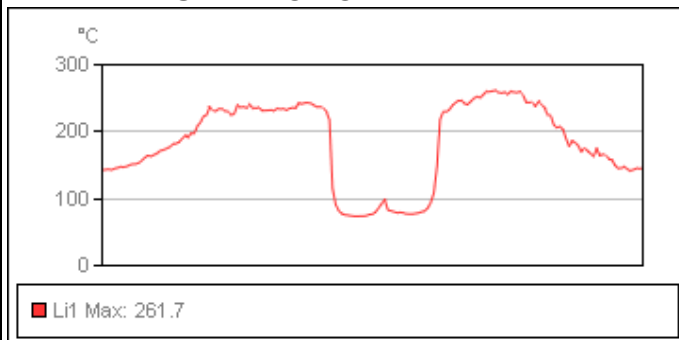
Location	Generator Room
Equipment	STBD Generator
Type	Top Of Generator

Object Parameters	Value
Date	06/08/2010
Image Time	08:57:21
Atmospheric Temperature	44.0 °C
Ar1 Max. Temperature	477.3 °C
Emissivity	0.95
Object Distance	4.0 m
Reflected Apparent Temperature	59.6 °C
Image File name	IR_6833.jpg

Priority 1

Temperatures in excess of the upper limit of 220°C are highlighted in green.

The hot surfaces appear to be caused by visible gaps in the casing.
