Thermographic Water Leak Investigation

SAMPLE REPORT

Pixel Thermographics Ltd

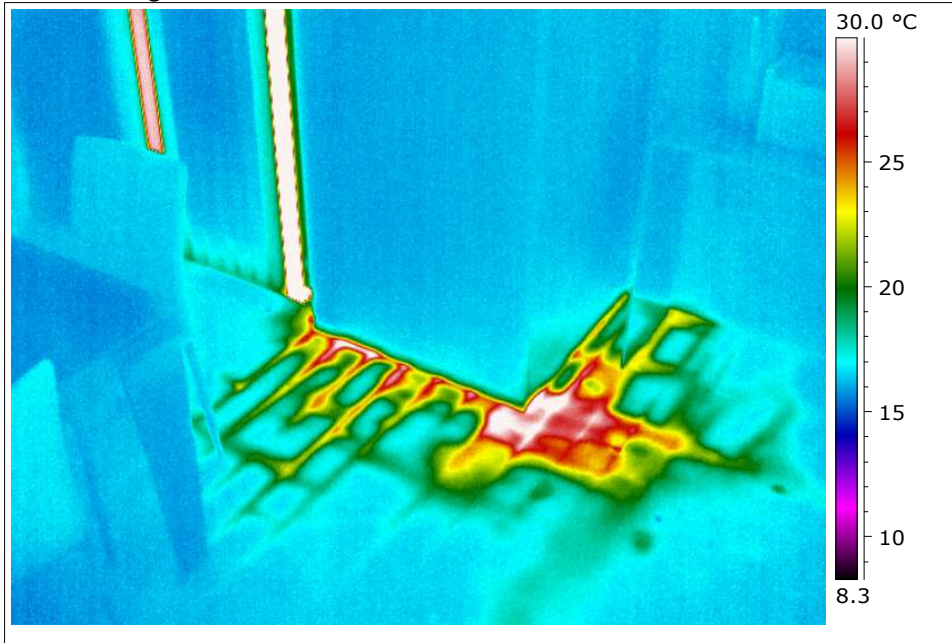
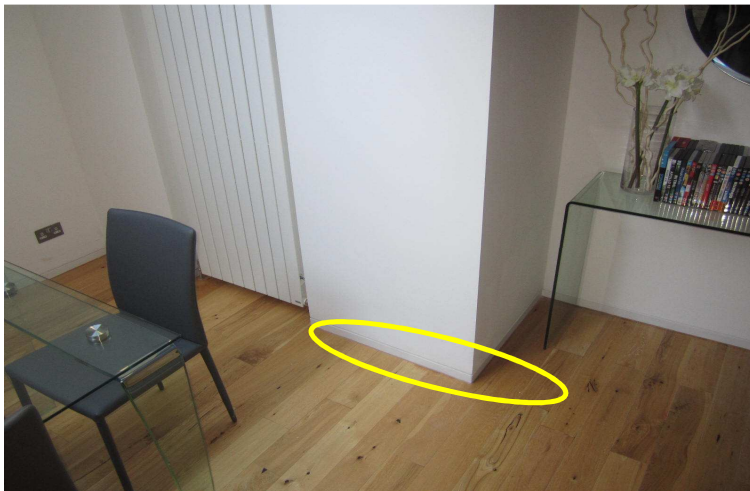
Area: Dining Room Wall - Leak Location

Thermal image clearly shows water leak originating from underside of wall.
The circled area should be exposed to reveal the pipework and suspected leak site.

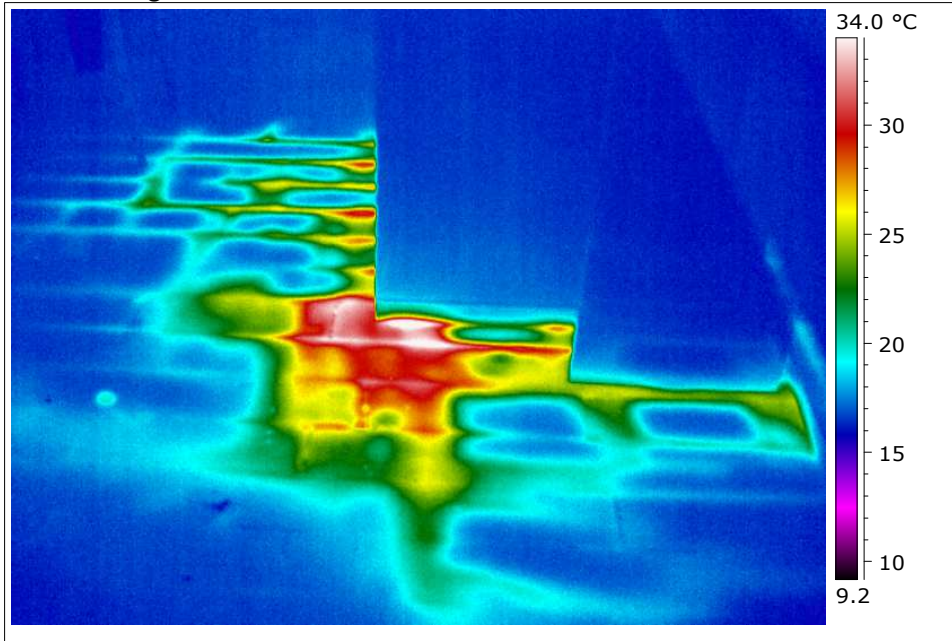
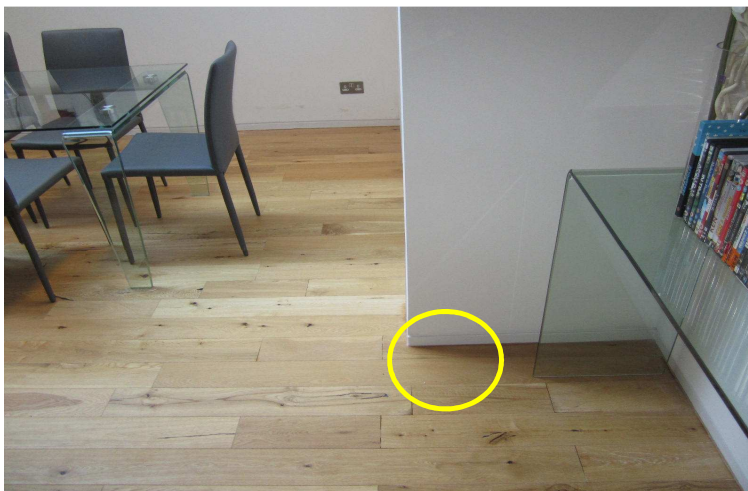
Area: Dining Room Wall - Leak Location

Thermal image clearly shows water leak originating from underside of wall.
The circled area should be exposed to reveal the pipework and suspected leak site.

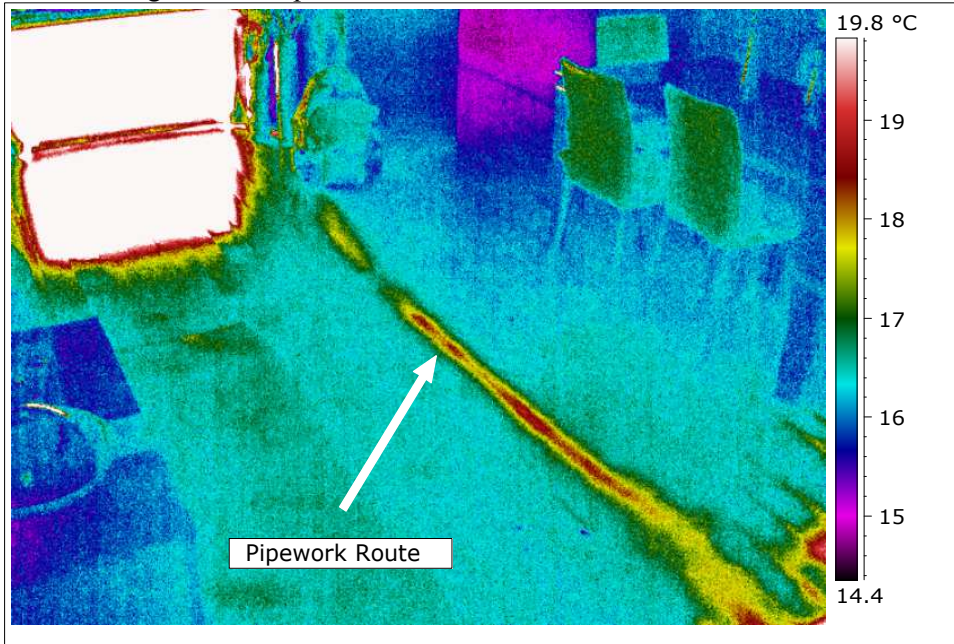
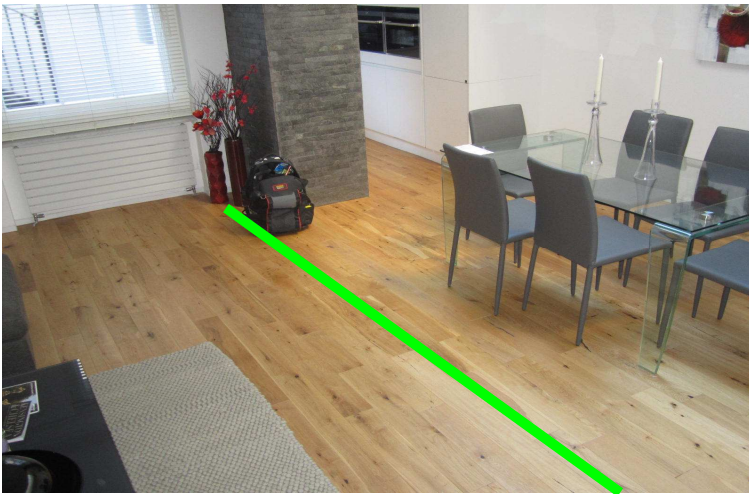
Area: Dining Room - Pipework Location

Image recorded to show the location of central heating pipework within the floor.
For information only.

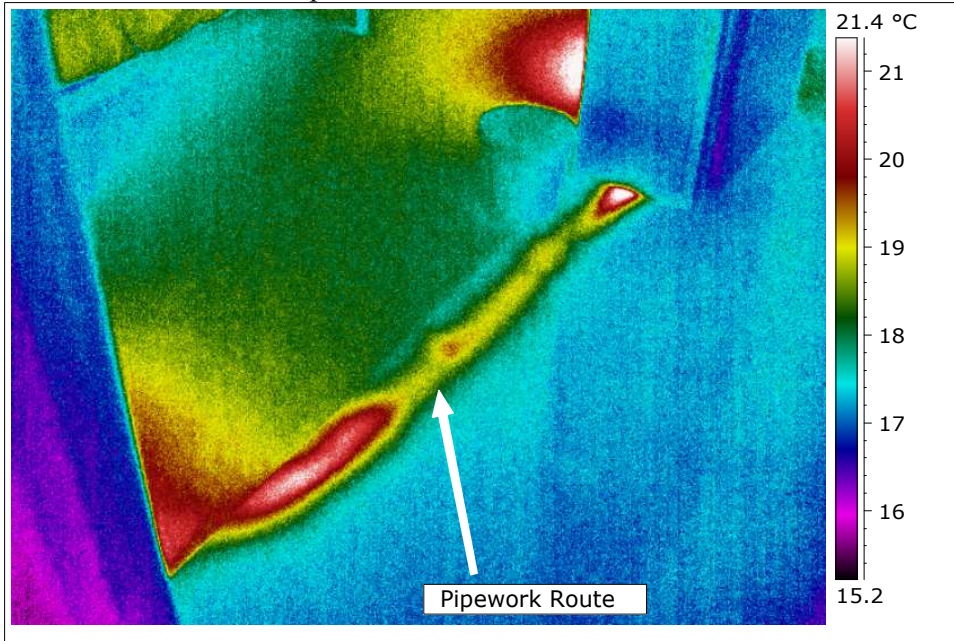
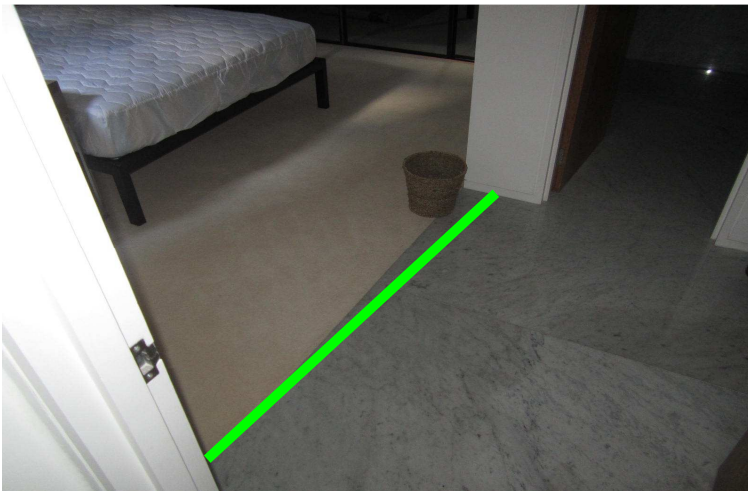
Area: Back Bedroom - Pipework Location

Image recorded to show the location of central heating pipework within the floor.
For information only.
