Thermographic CUI Survey

Sample Report

Pixel Thermographics Ltd

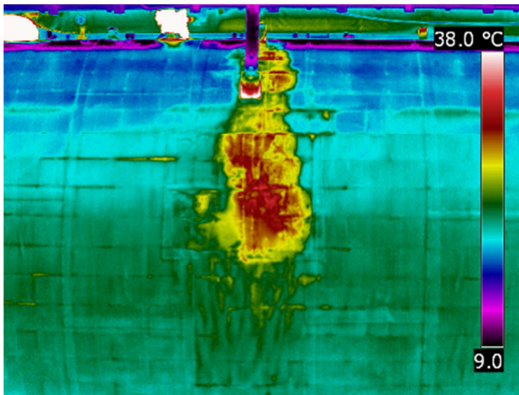
Fig.1 Thermal Image from Previous

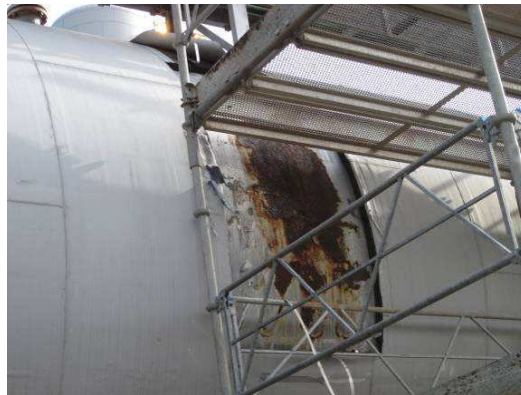
Fig.2 Digital Image Showing Section of Removed Insulation with Clear Corrosion Having Commenced

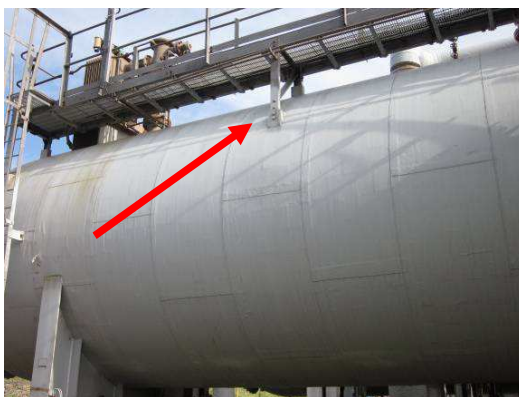
The source of the moisture into the insulation was traced as originating from the walkway support brackets and can be seen in the images below:

Fig.1 Walkway Gantry Support Bracket

The client has carried out remedial work to the rest of these brackets fitted to approximately 12 other vessels and has therefore prevented significant damage to these vessels

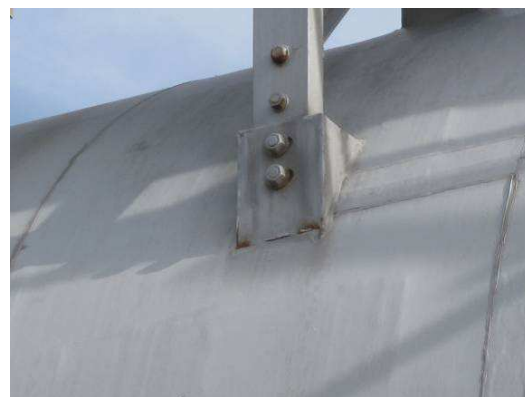
Fig.2 Close up Of Bracket

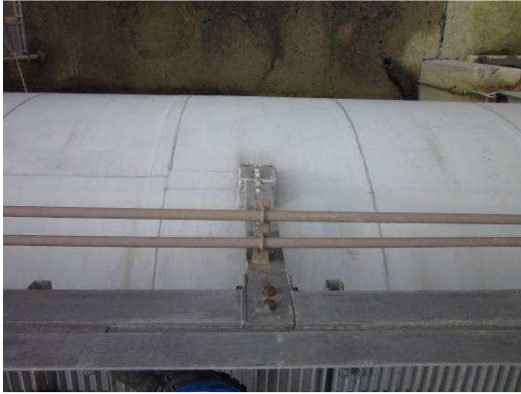
Fig.3 View of Bracket From Above

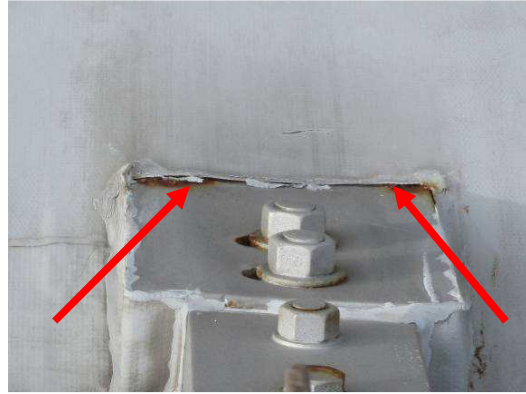
Fig.4 Close up View of Bracket Showing Gap Where Water Enters Insulation

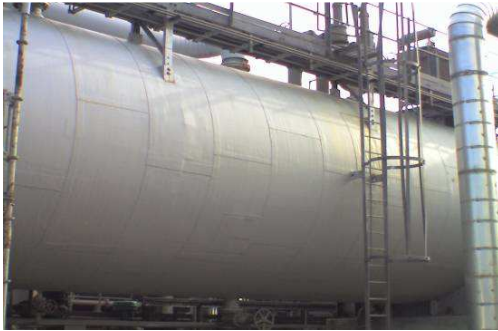
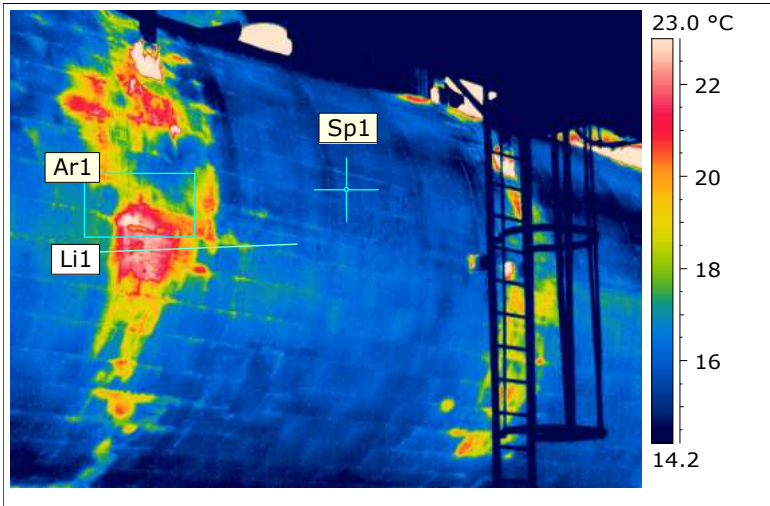
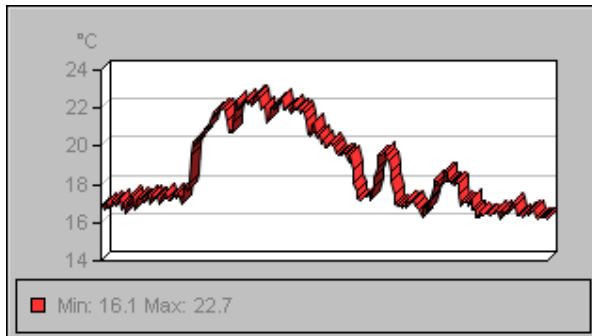
Filename	IR_3233.jpg
Item	T-120A
Description	A Train 2nd Stage Desalter
Elevation	West
Location	Centre Right of Vessel
Drawing Number	FLO-STA-PPI-200101
Image Camera Type	ThermaCAM P640 West
Image Serial Number	309000233
Image Camera Lens	FOL38
Emissivity	0.93

The warm areas of insulation indicate moisture ingress within the insulation. Likely ingress point is via the walkway support leg where it passes through the insulation.

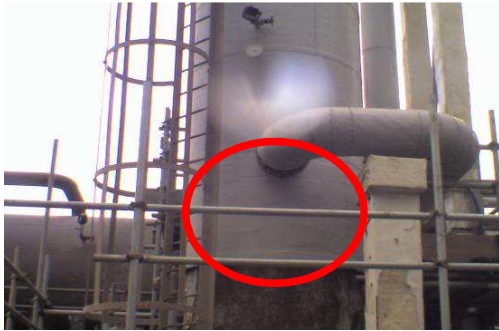
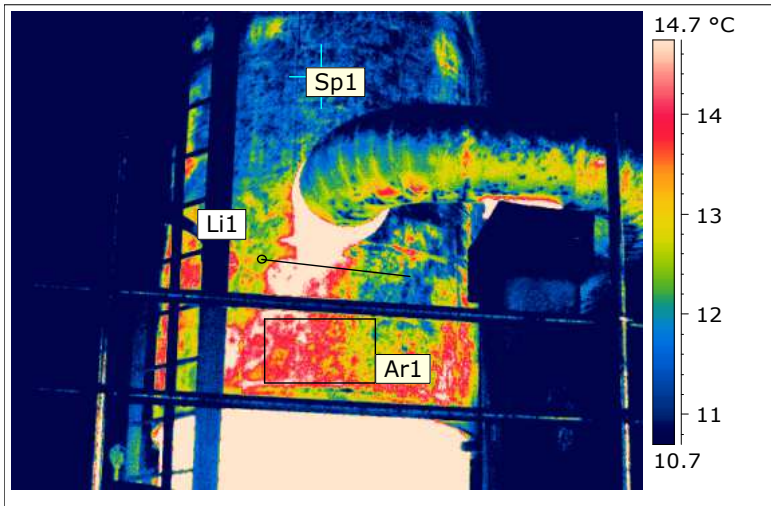
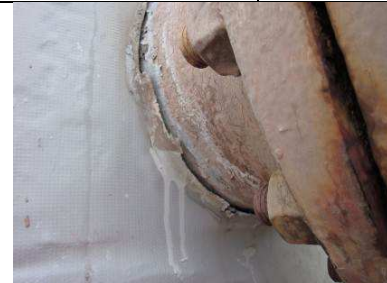
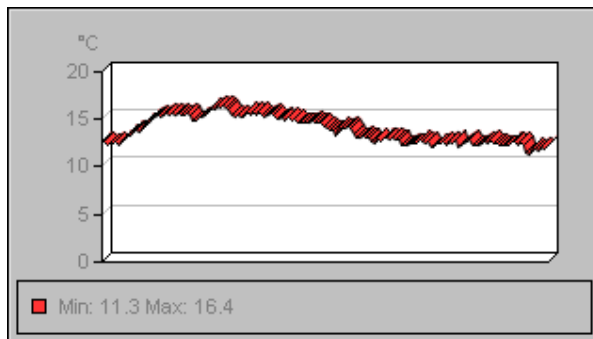
Filename	IR_3298.jpg
Item	V-2102A
Description	A Train Side Draw Scrubber
Elevation	West
Location	Lower Section at 10" Pipe Inlet
Drawing Number	FLO-STA-PPI-20013
Image Camera Type	ThermaCAM P640 West
Image Serial Number	309000233
Image Camera Lens	FOL38
Emissivity	0.93

Warm areas of insulation towards the base of the vessel indicate water ingress. Closer inspection revealed a failed seal around the pipe entry point – see small image.

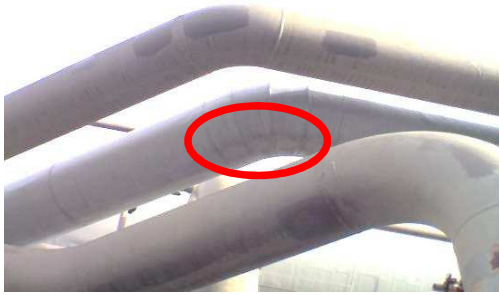
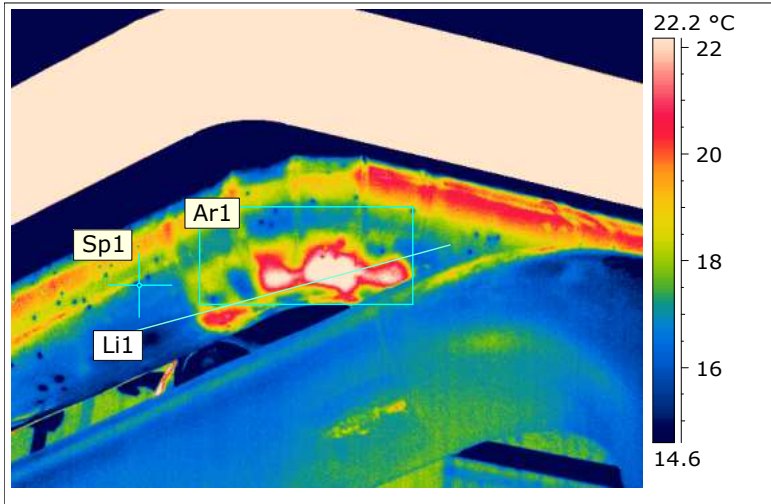
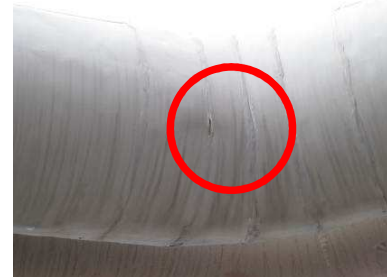
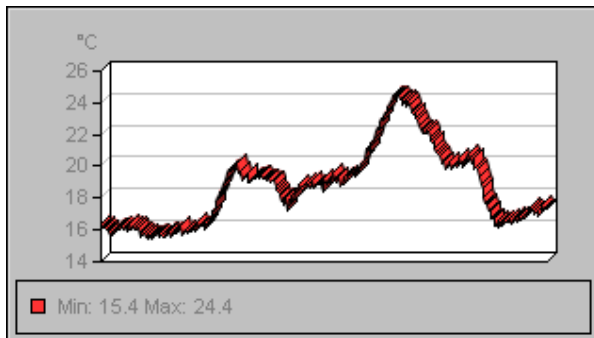
Filename	IR_3251.jpg
Item	12"-PL-5091-L2
Description	A Train
Elevation	
Location	Close to E5001A between T20A and T120A
Drawing Number	
Image Camera Type	ThermaCAM P640 West
Image Serial Number	309000233
Image Camera Lens	FOL38
Emissivity	0.93

Warm area at bottom of pipe indicates water ingress. Closer visual inspection revealed a slit in the Ulva cladding towards the back of the pipe – see small image.

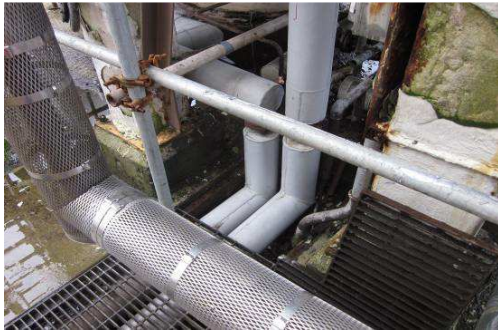
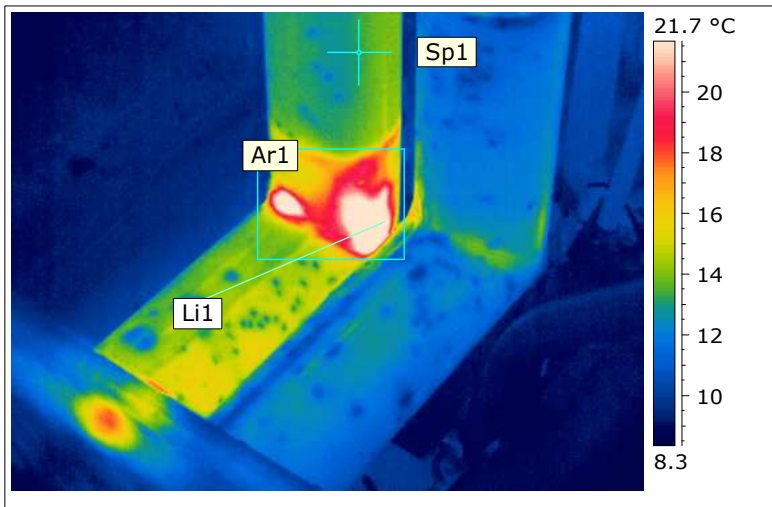
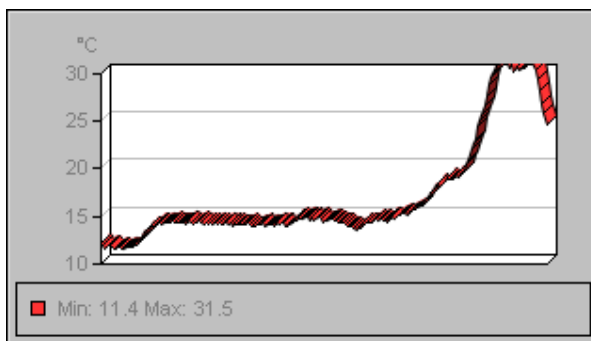
Filename	IR_3296.jpg
Item	2"-HO-2101A1-L2
Description	Hot Oil Supply to V2102A
Elevation	N/A
Location	In Gulley by Vessel V-2102A
Drawing Number	ISO No. OH 007
Image Camera Type	ThermaCAM P640 West
Image Serial Number	309000233
Image Camera Lens	FOL38
Emissivity	0.93

Warm area on insulation indicates water ingress within the insulation at this point. No visible damage found but area above should be inspected and sealed if required.

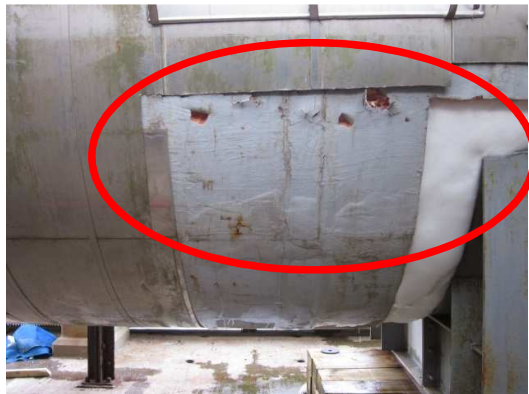
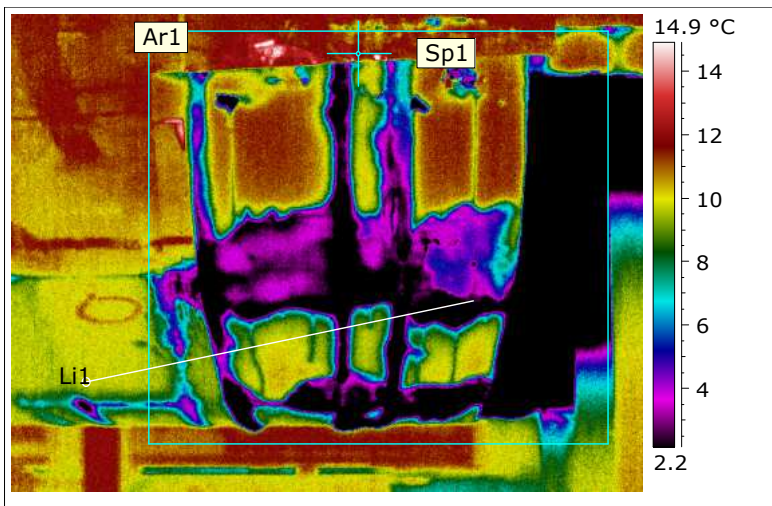
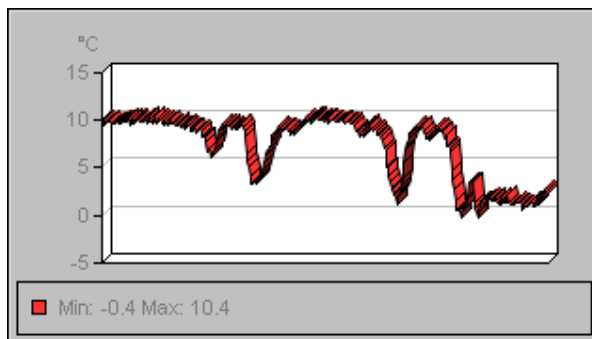
Filename	IR_12579.jpg
Item	V-3501 - Surge Drum
Description	Side of Saddle
Elevation	North
Location	
Drawing Number	
Image Camera Type	ThermaCAM P640 West
Image Serial Number	309000233
Image Camera Lens	FOL19
Emissivity	0.70

OBSERVATIONS Irregular thermal profile indicates water ingress within this section of insulation which is likely to result in corrosion under insulation. Visual damage to insulation noted in this area which allows condensation to form and enter the insulation.

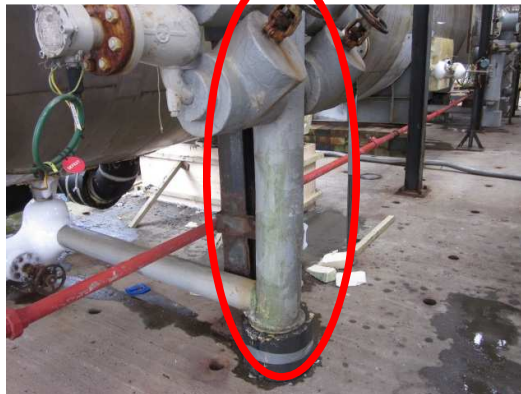
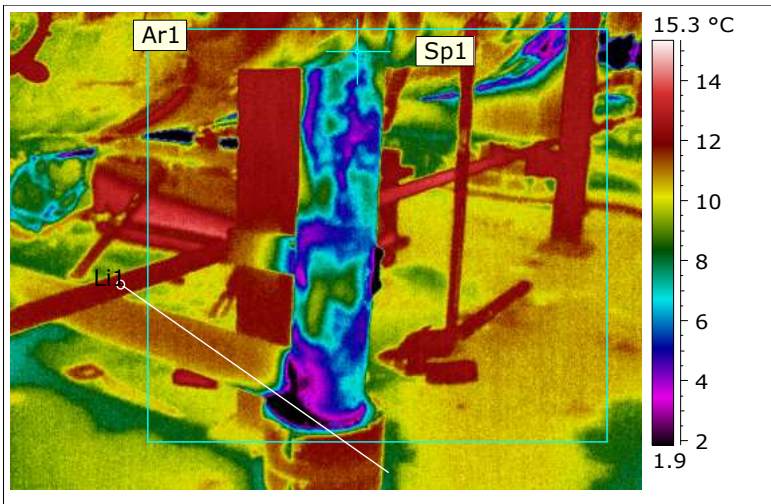
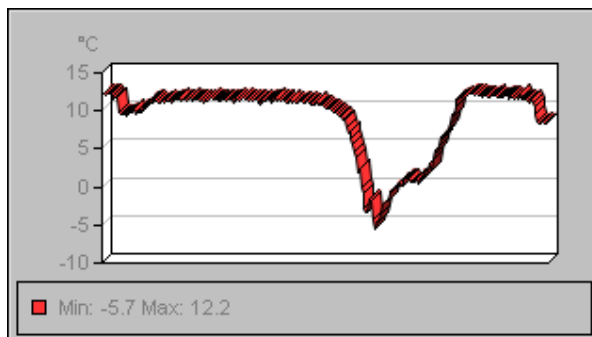
Filename	IR_12581.jpg
Item	
Description	
Elevation	
Location	
Drawing Number	
Image Camera Type	ThermaCAM P640 West
Image Serial Number	309000233
Image Camera Lens	FOL19
Emissivity	0.70

OBSERVATIONS Irregular thermal profile indicates water ingress within this section of insulation which is likely to result in corrosion under insulation. Open seam at valve spindle noted which allows condensation to form and enter the insulation.

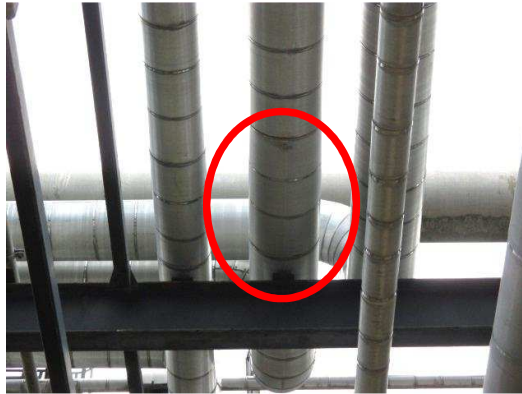
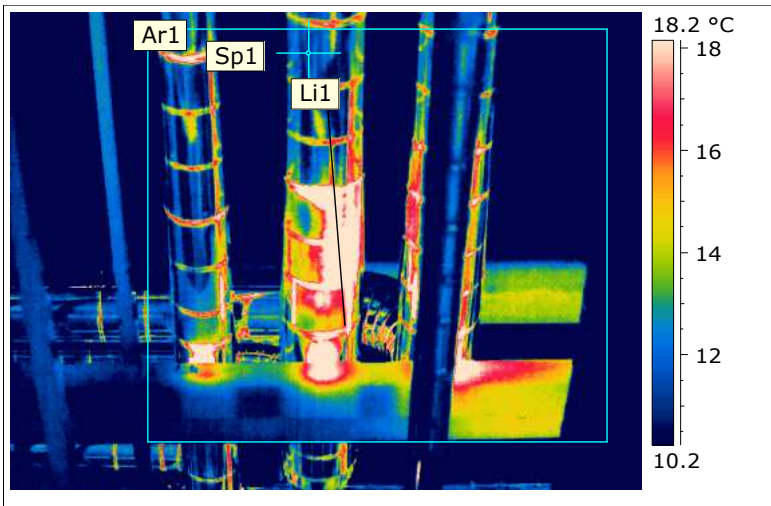
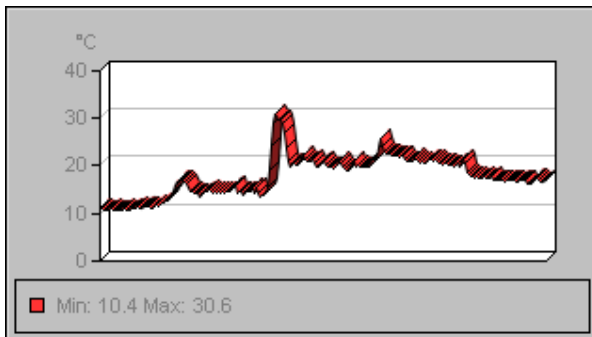
Filename	IR_4803.jpg
Item	
Description	
Elevation	
Location	
Drawing Number	
Image Camera Type	ThermaCAM P640 West
Image Serial Number	309000233
Image Camera Lens	FOL38
Emissivity	0.70

OBSERVATIONS Thermal profile on steel cladded insulation indicates water ingress which is likely to result in corrosion under insulation.
