Compressed Air Leak Survey

SAMPLE REPORT

Bury St Edmunds

Client:	<i>Confidential</i>
Inspection Site:	Bury St Edmunds
Contact Person:	<i>Confidential</i>
Surveyor:	<i>Confidential</i>
Survey Equipment:	UE Systems Ultraprobe 2000 – Ultrasonic Leak Detector
Survey Date(s):	1st December 2022

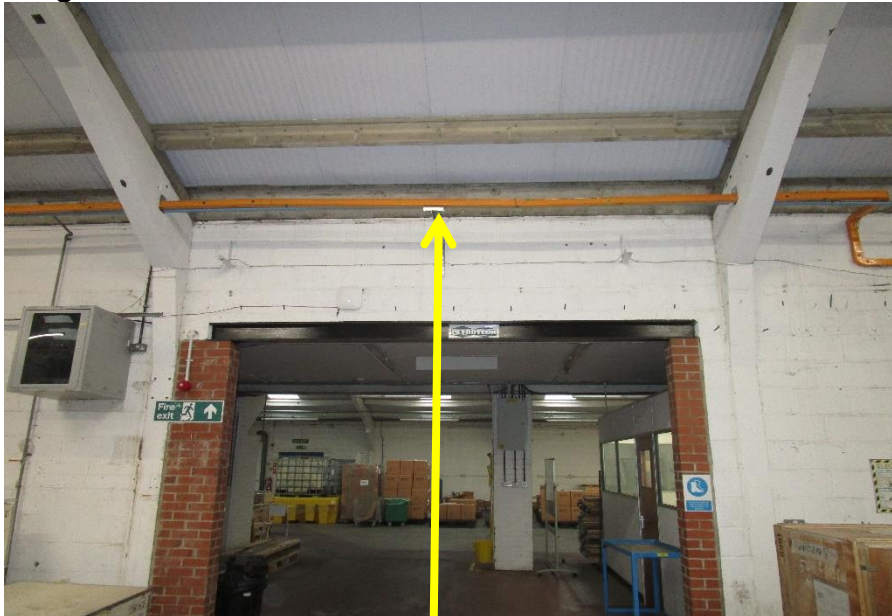
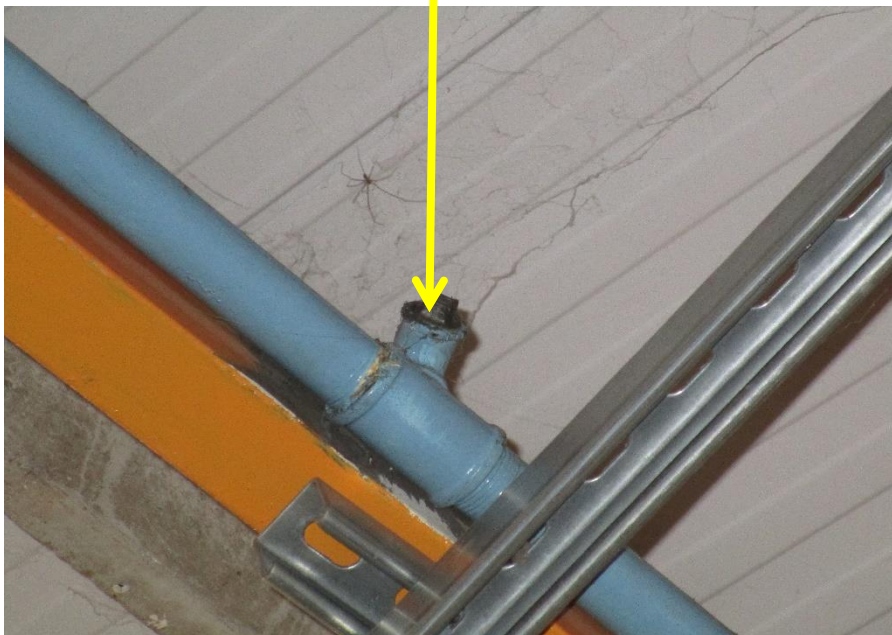
Leak No.	Location	Nature of Leak	Level
2	Stores	Leak From Threaded Pipe Blank Connection High Level (No Label Attached)	1

Annual Cost of Leak:	£86
-----------------------------	------------

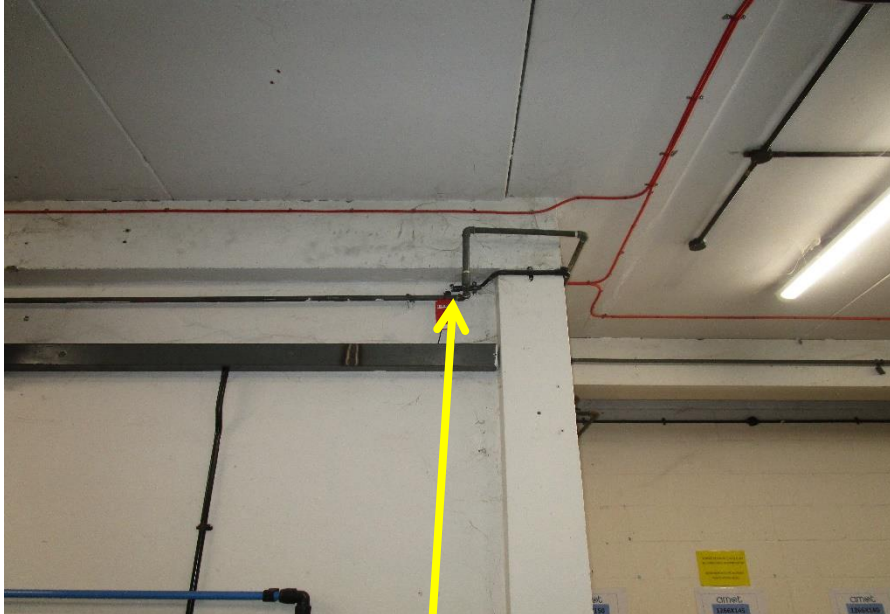
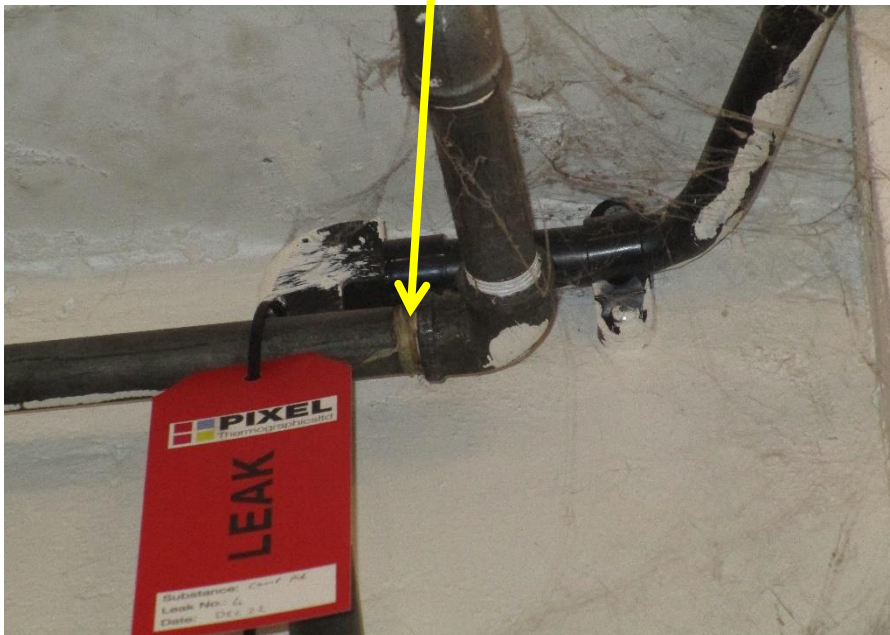
Leak No.	Location	Nature of Leak	Level
4	Stock Room	Leak From Threaded 90 Degree Bend	1

Annual Cost of Leak:	£86
-----------------------------	------------

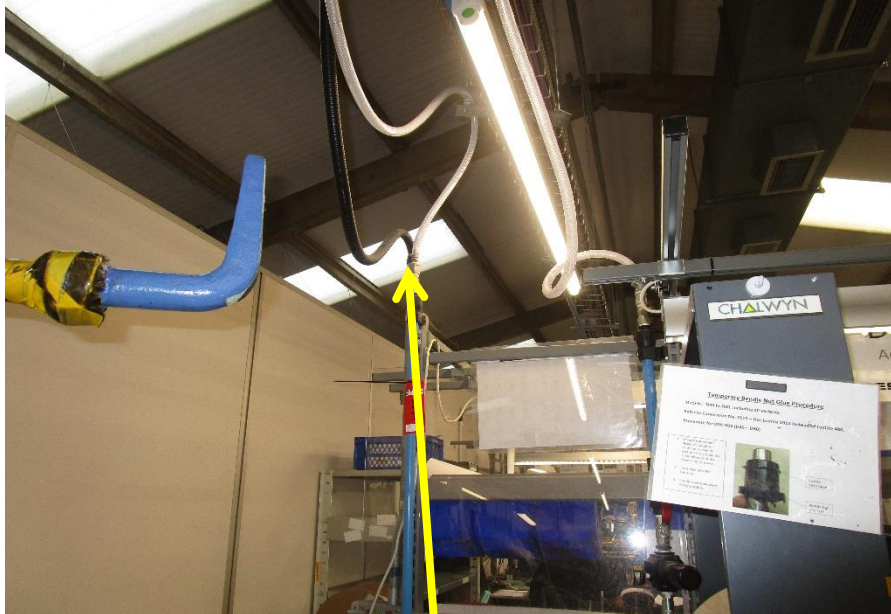
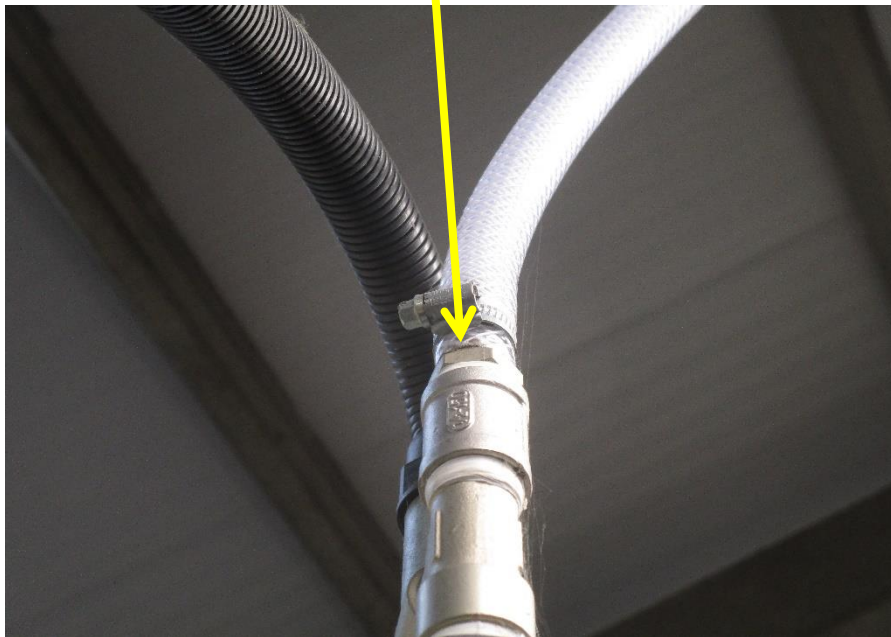
Leak No.	Location	Nature of Leak	Level
5	Dess Chalwyn Dess 9	Leak From Jubilee Hose Connection	2

Annual Cost of Leak:	£336
-----------------------------	-------------

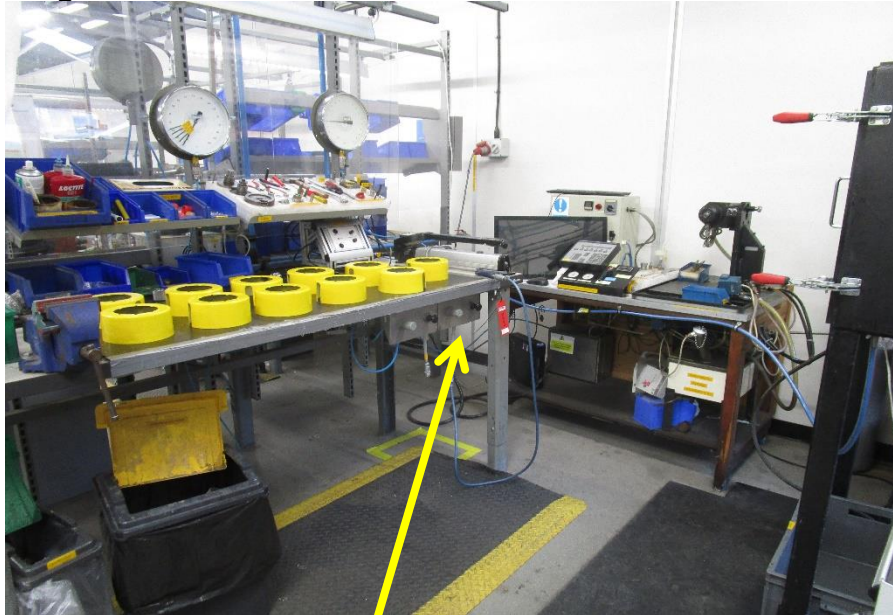
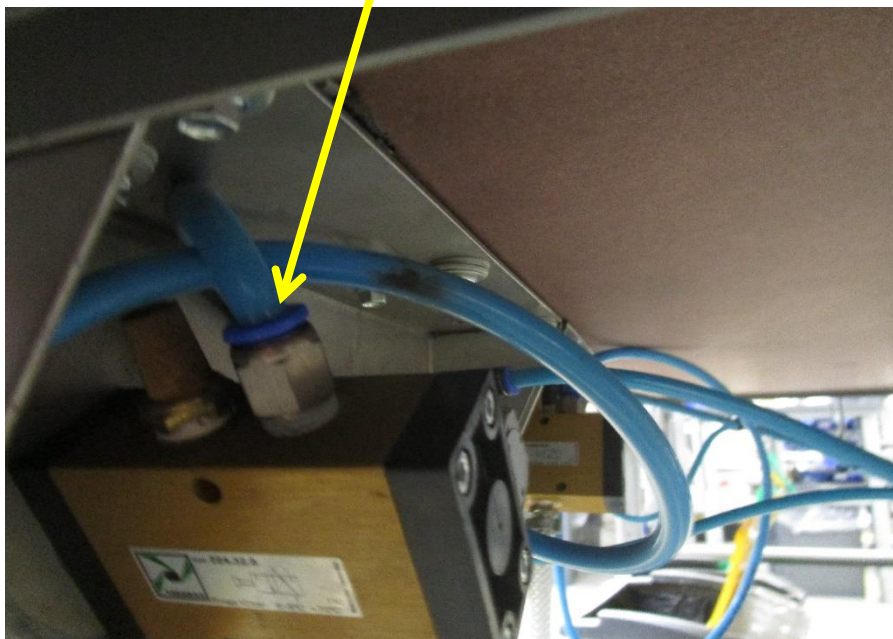
Leak No.	Location	Nature of Leak	Level
6	Dess Chalwyn Dess 0	Leak From Push Fit Hose Connection Under Work Station	2

Annual Cost of Leak:	£336
-----------------------------	-------------

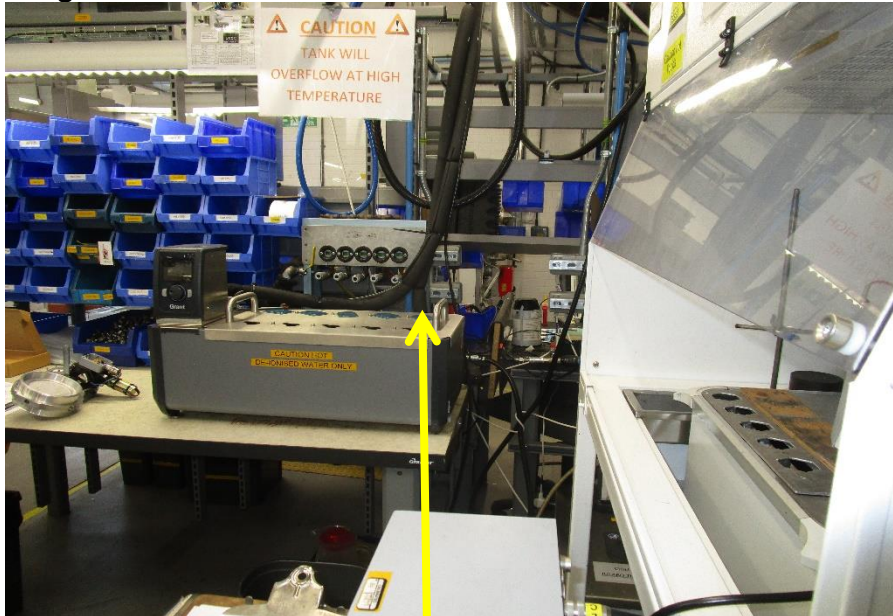
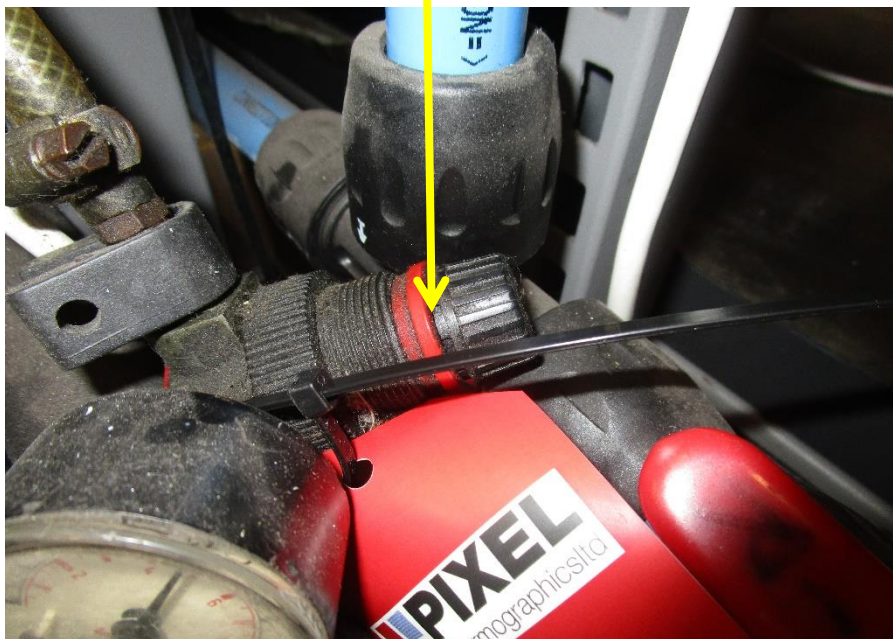
Leak No.	Location	Nature of Leak	Level
8	Dess Chalwyn Scon 2	Leak From Regulator Body	3

Annual Cost of Leak:	£672
-----------------------------	-------------

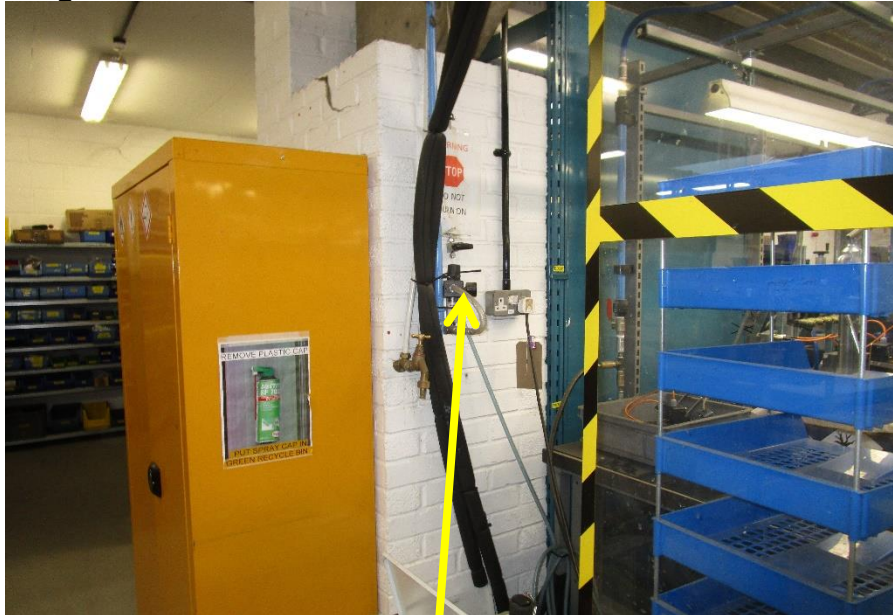
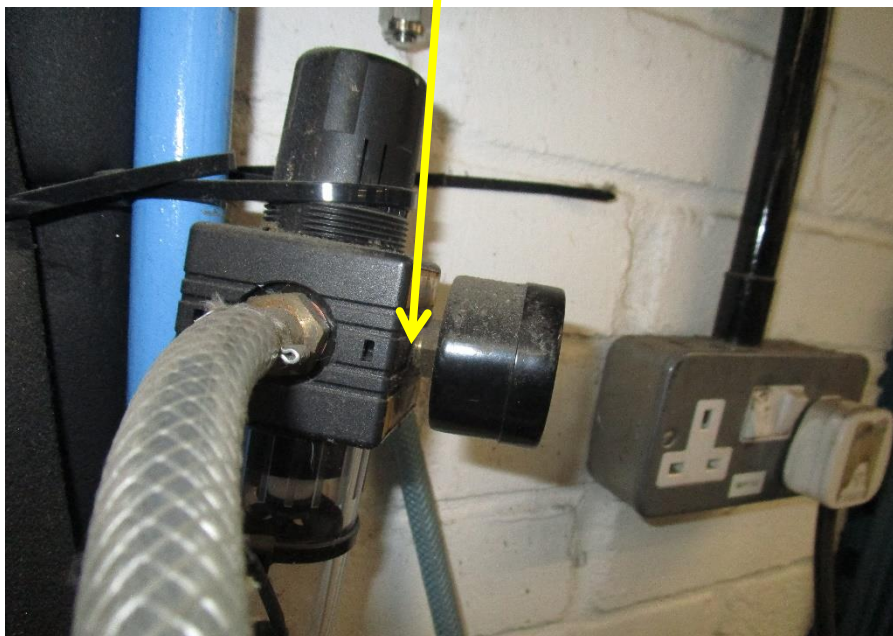
Leak No.	Location	Nature of Leak	Level
9	Dess Chalwyn Scon 1	Leak From Threaded Filter Connection to Gauge	1

Annual Cost of Leak:	£86
-----------------------------	------------

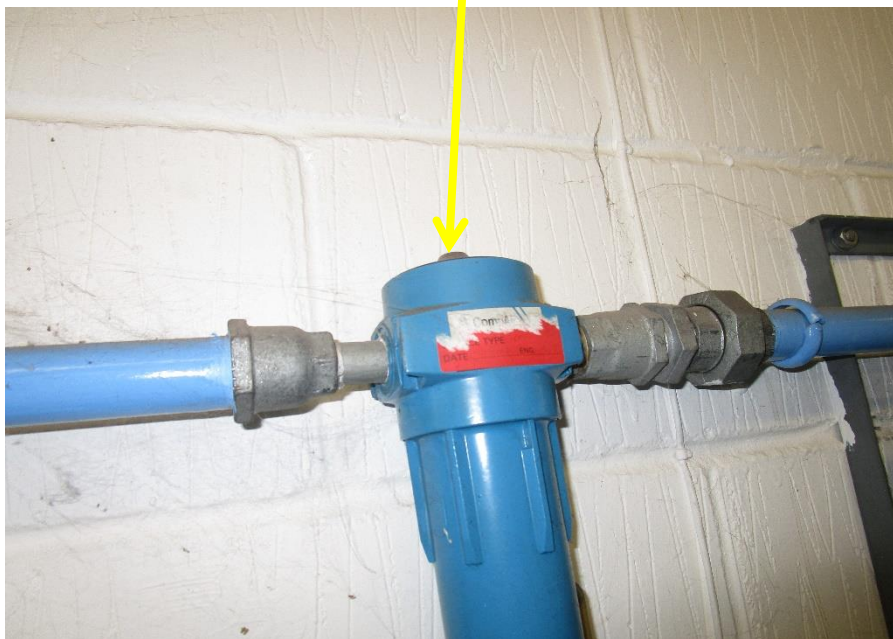
Leak No.	Location	Nature of Leak	Level
10	Dess Chalwyn	Leak From Top of Filter Body	3

Annual Cost of Leak:	£672
-----------------------------	-------------

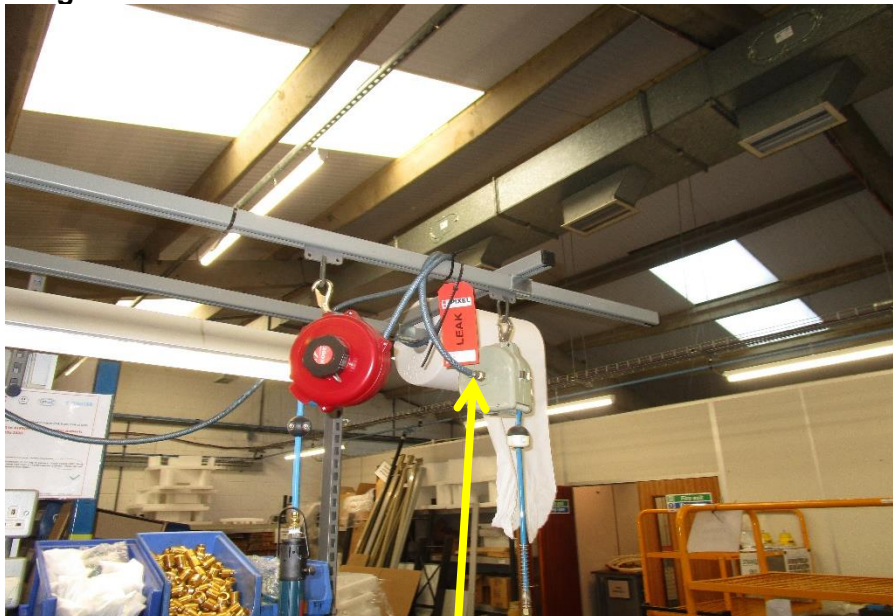
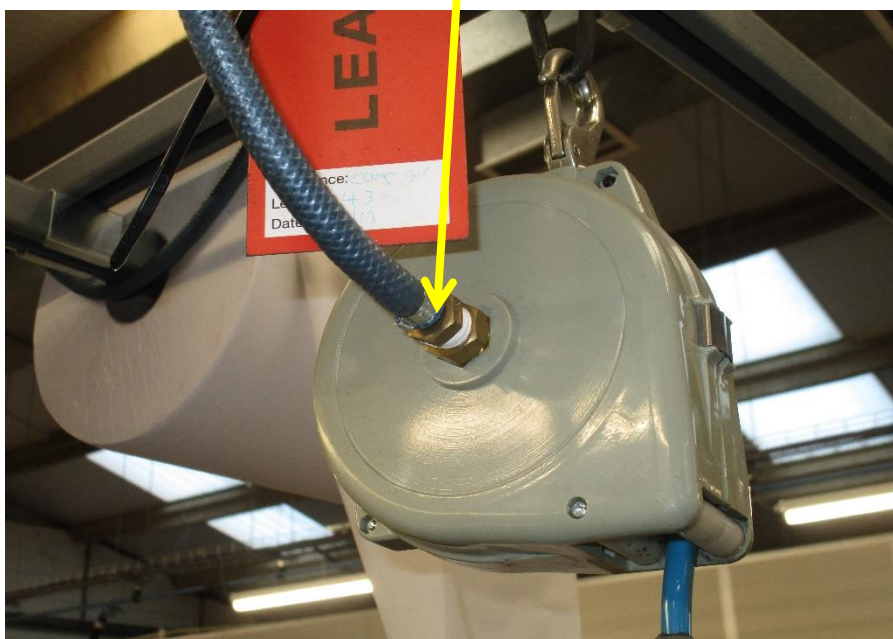
Leak No.	Location	Nature of Leak	Level
12	Dess Chalwyn Scon 1	Leak From Jubilee Hose Connection to Reel	1

Annual Cost of Leak:	£86
-----------------------------	------------

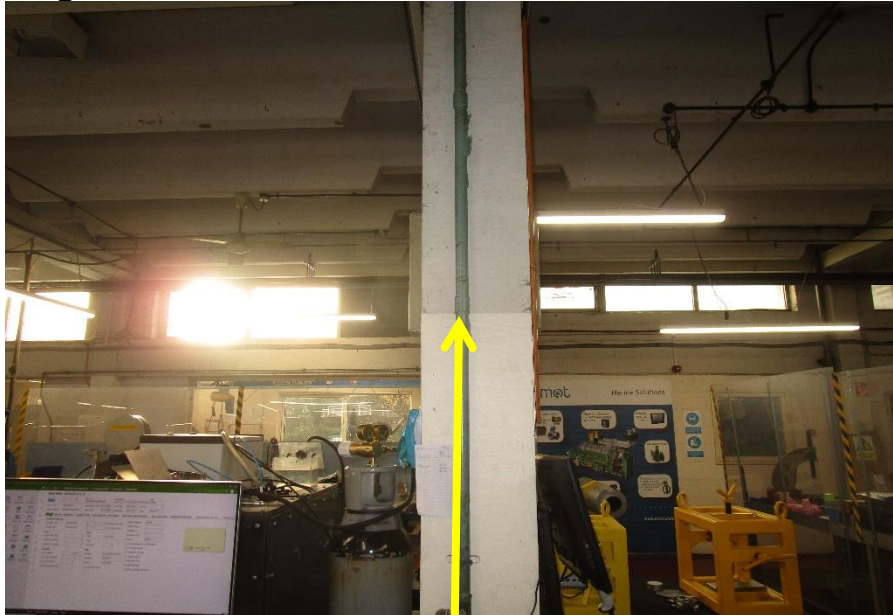
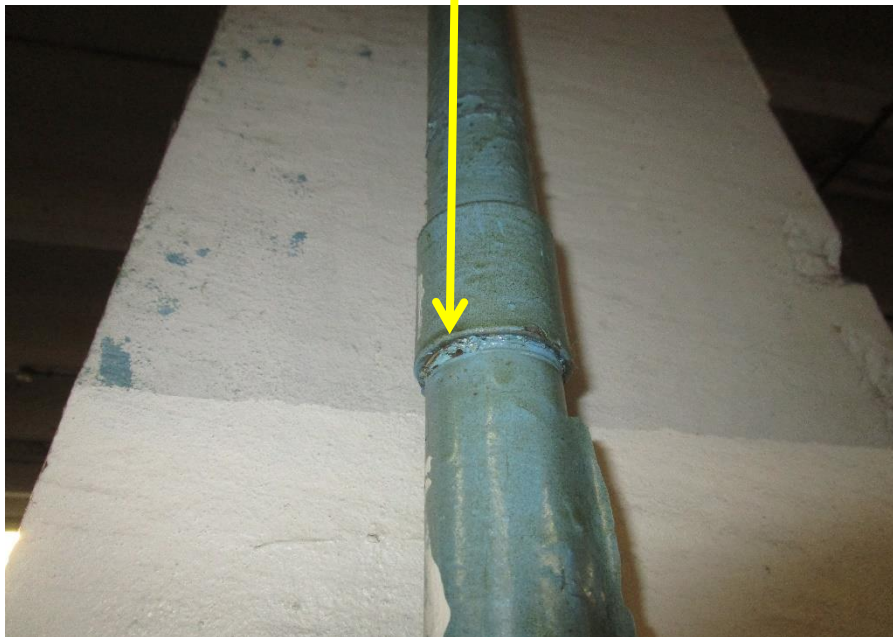
Leak No.	Location	Nature of Leak	Level
14	Air Start Area	Leak From Threaded Pipe Joint Connection	1

Annual Cost of Leak:	£86
-----------------------------	------------

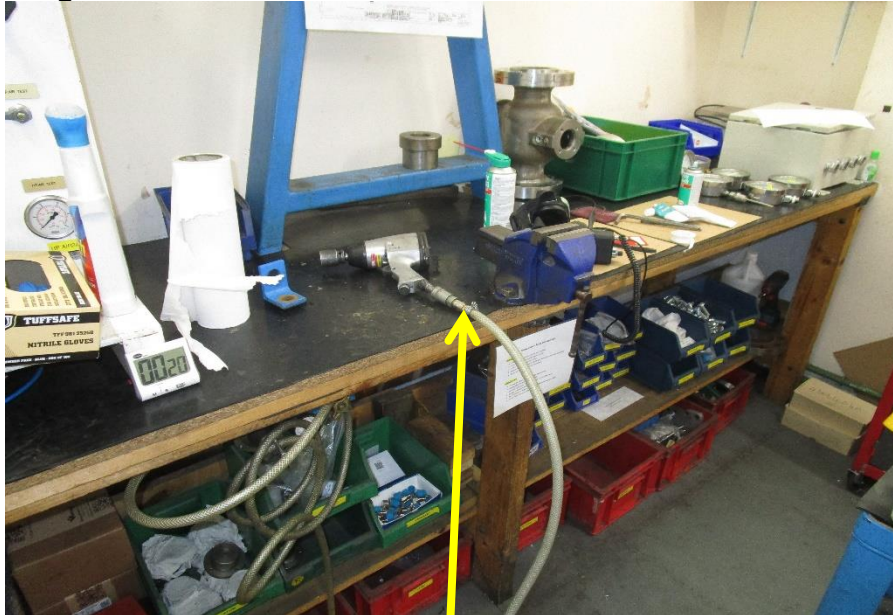
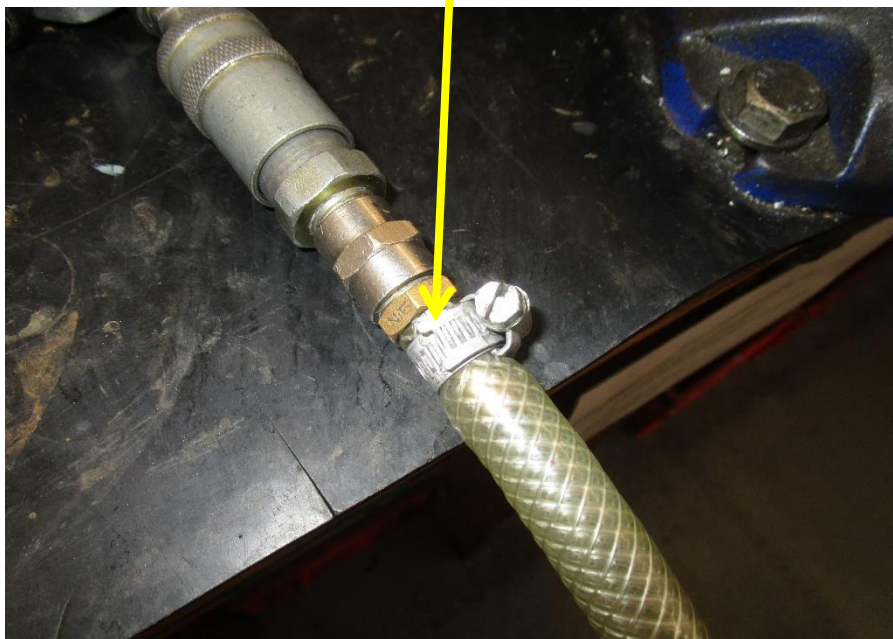
Leak No.	Location	Nature of Leak	Level
15	Centrax Room	Leak From Jubilee Hose Connection to Air Drill	2

Annual Cost of Leak:	£336
-----------------------------	-------------

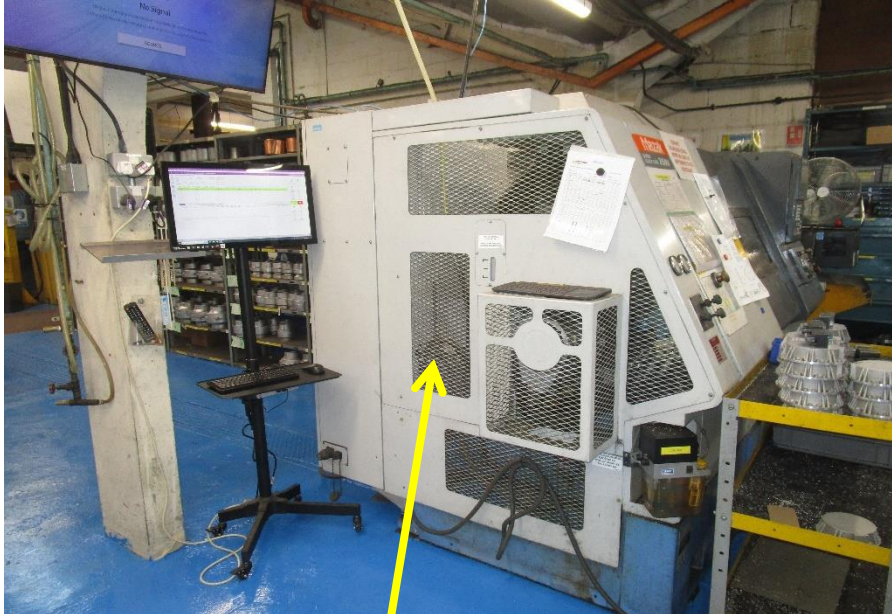
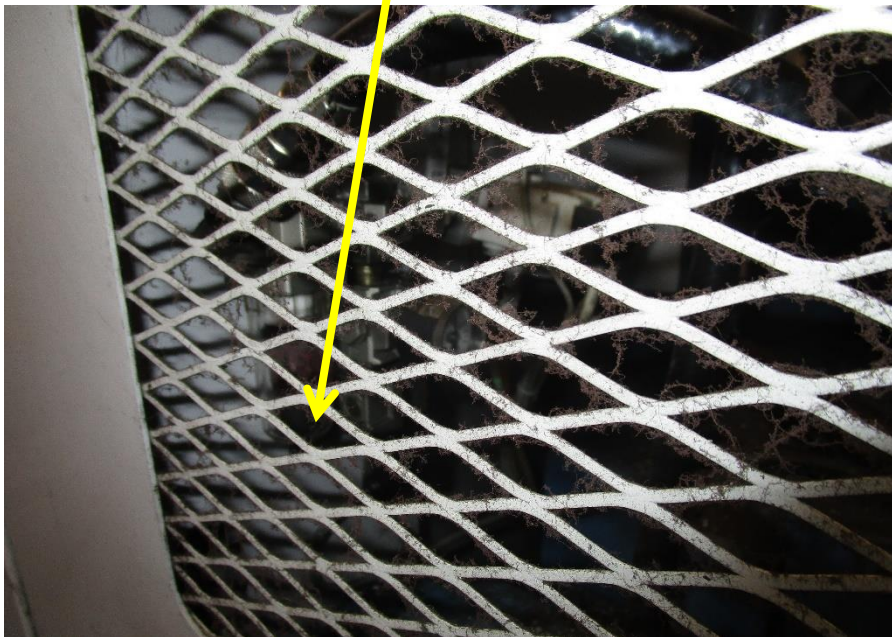
Leak No.	Location	Nature of Leak	Level
20	Shop Floor	Leak From Within Mazak 2	2

Annual Cost of Leak:	£336
-----------------------------	-------------

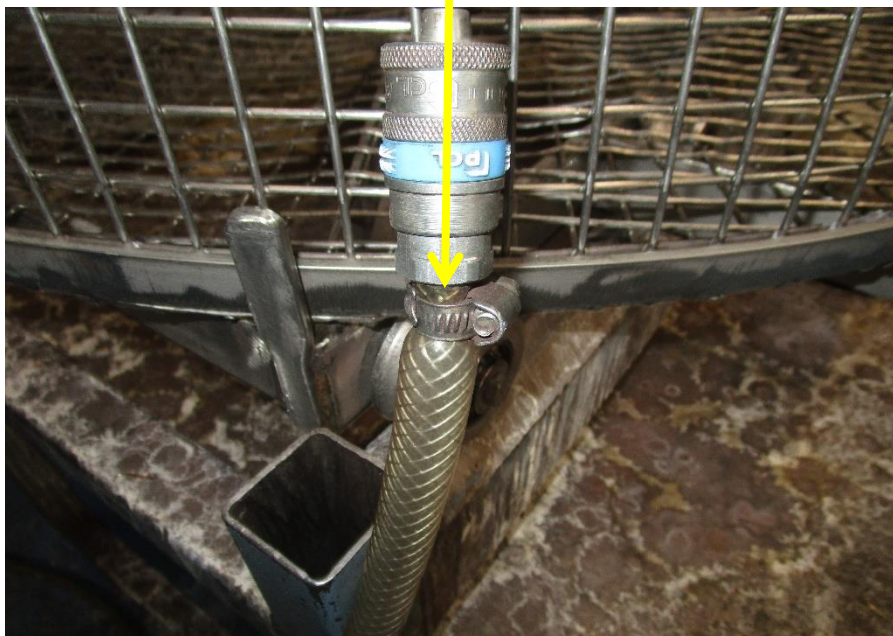
Leak No.	Location	Nature of Leak	Level
22	Shop Floor	Leak From Jubilee Hose Connection to Air Gun	2

Annual Cost of Leak:	£336
-----------------------------	-------------

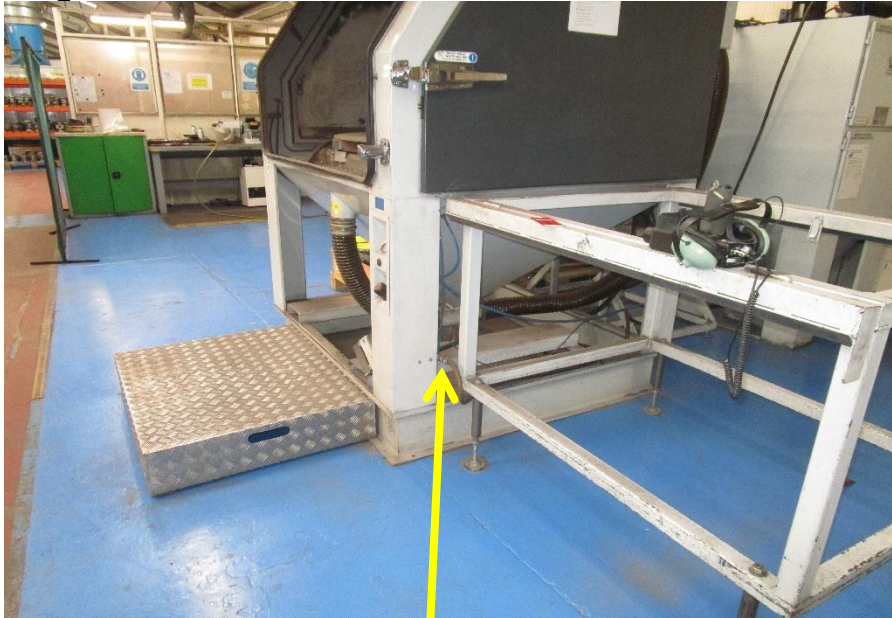
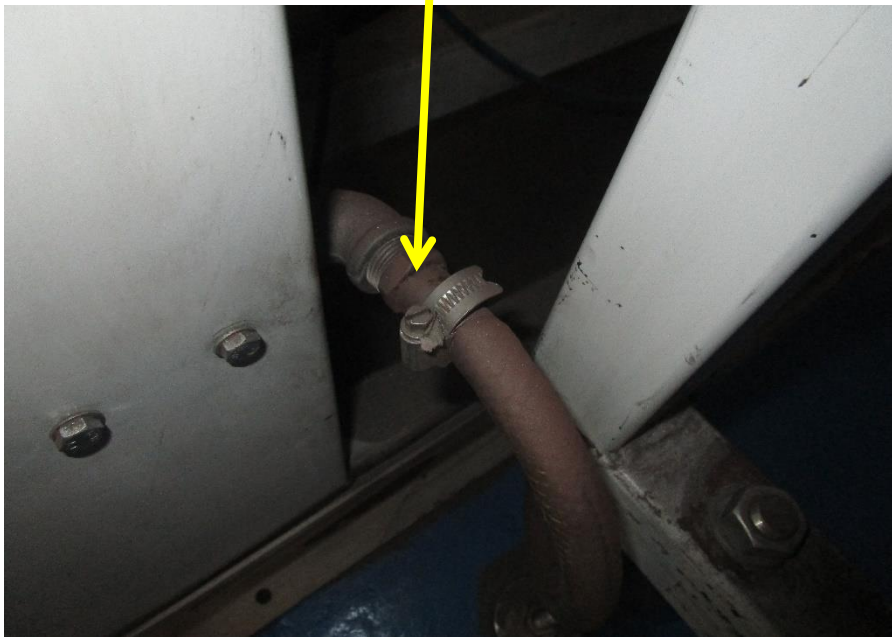
Leak No.	Location	Nature of Leak	Level
23	Shop Floor	Leak From Jubilee Hose Connection to 90 Degree Angle	3

Annual Cost of Leak:	£672
-----------------------------	-------------

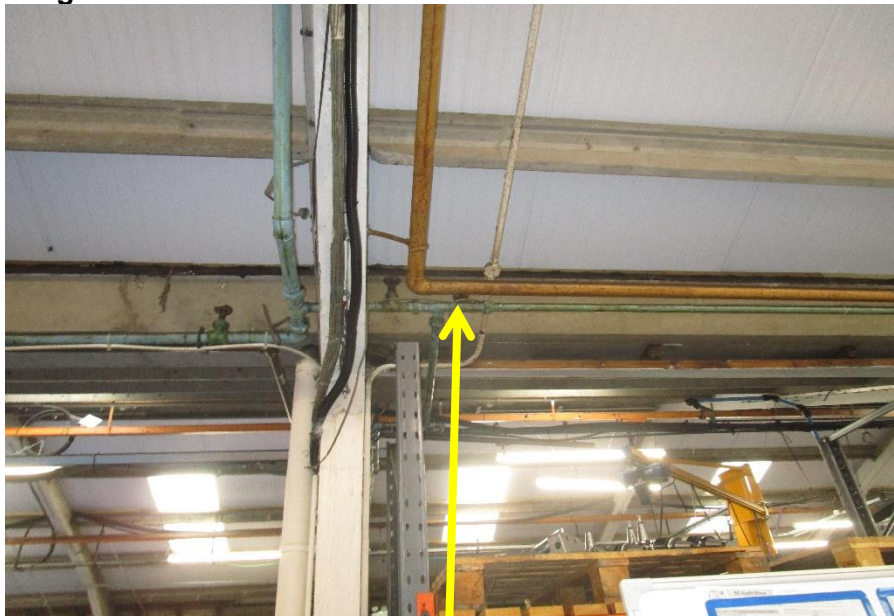
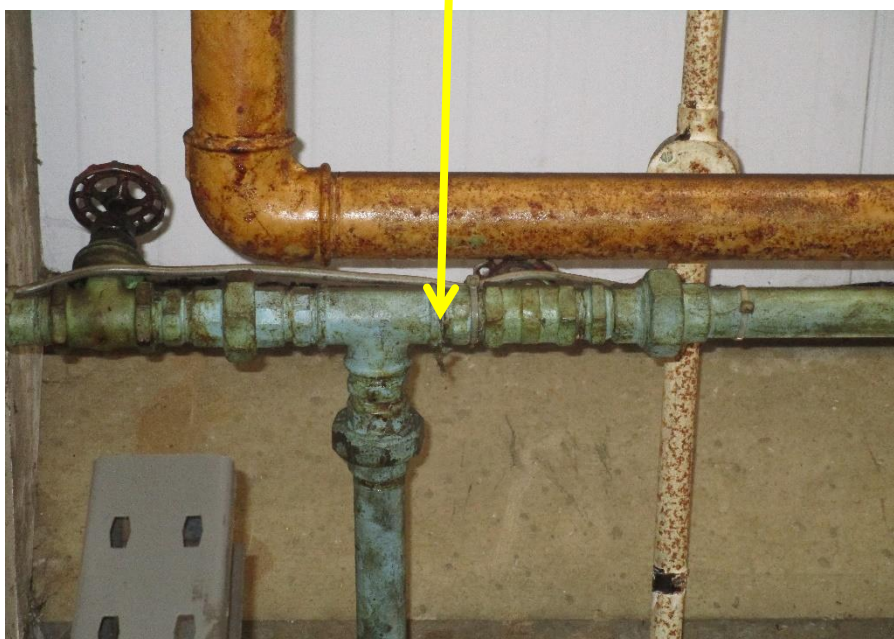
Leak No.	Location	Nature of Leak	Level
25	Shop Floor	Leak From Pipe Work High Level By Machine 2 (No Label Attached)	2

Annual Cost of Leak:	£336
-----------------------------	-------------

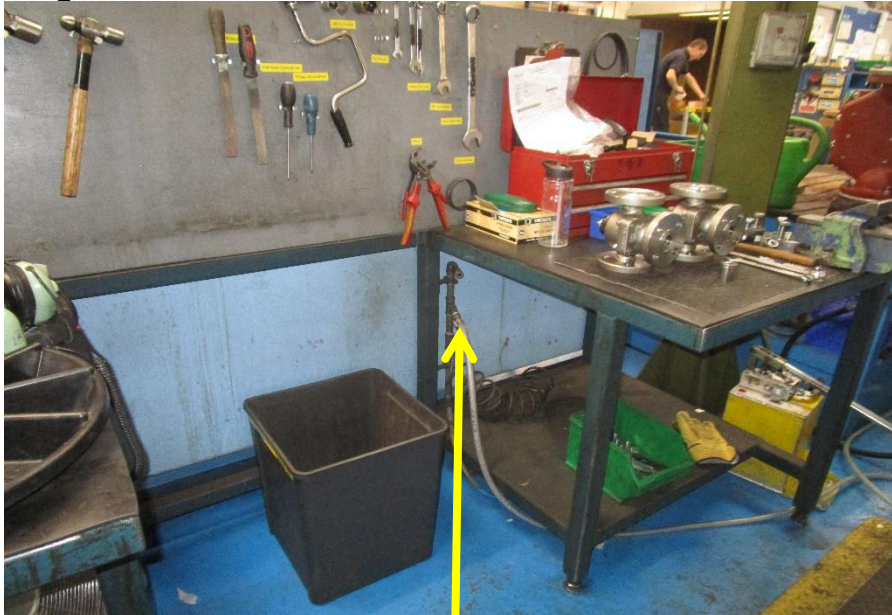
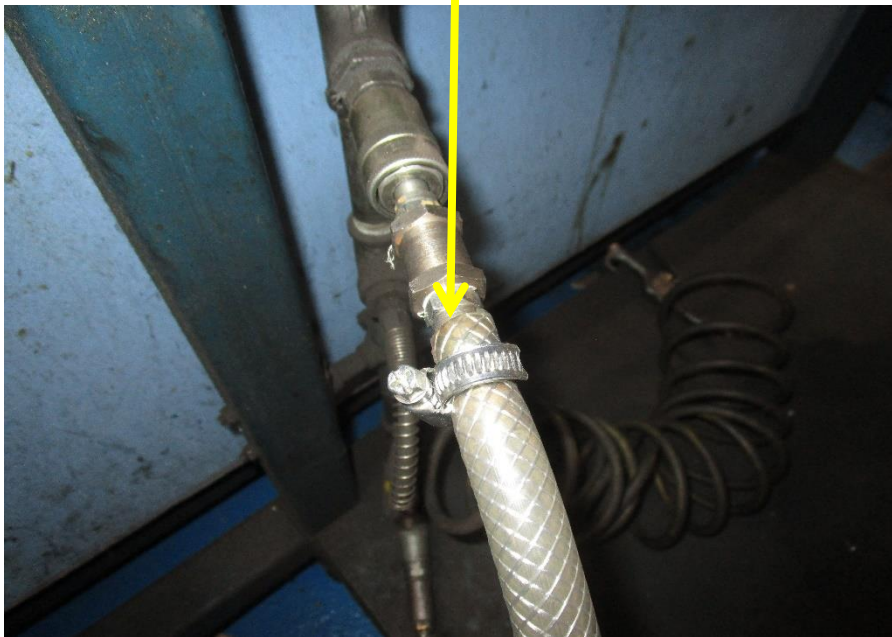
Leak No.	Location	Nature of Leak	Level
28	Shop Floor	Leak From Jubilee Hose Connection to Quick Release	2

Annual Cost of Leak:	£336
-----------------------------	-------------

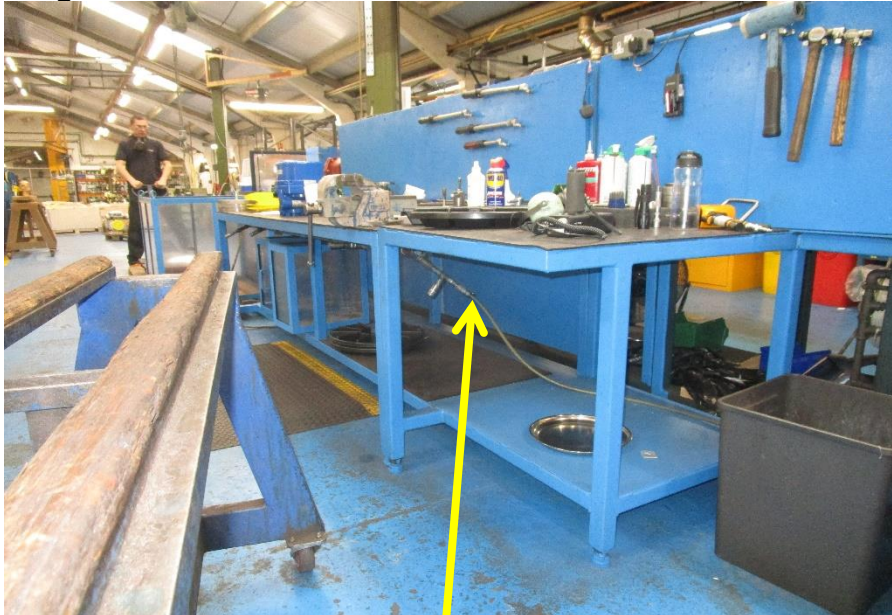
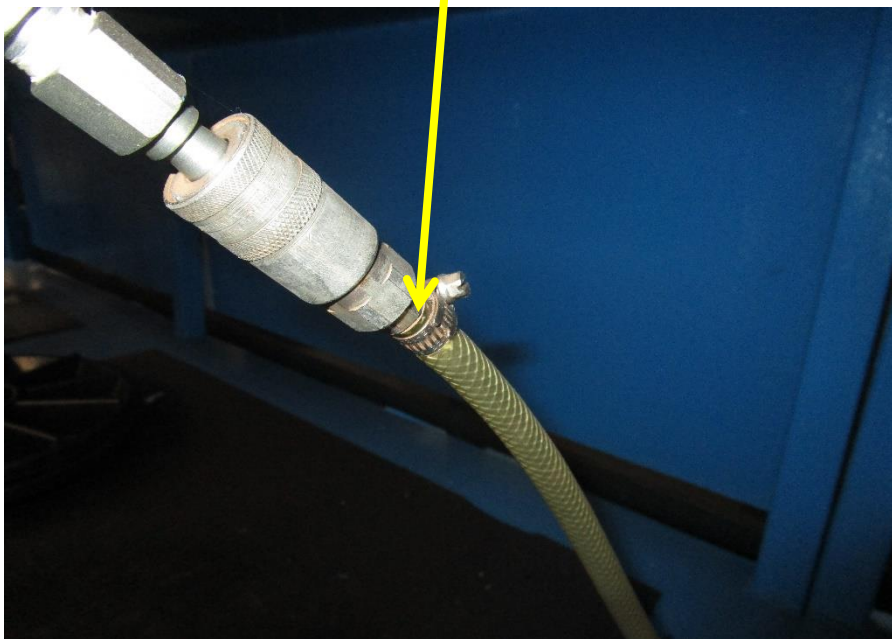
Leak No.	Location	Nature of Leak	Level
31	Shop Floor	Leak From Jubilee Hose Connection to Quick Release	2

Annual Cost of Leak:	£336
-----------------------------	-------------

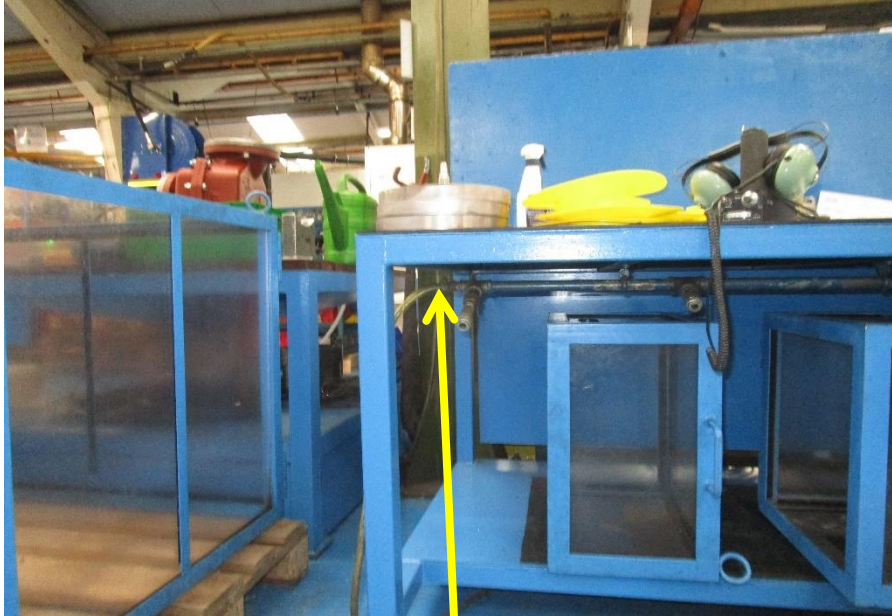
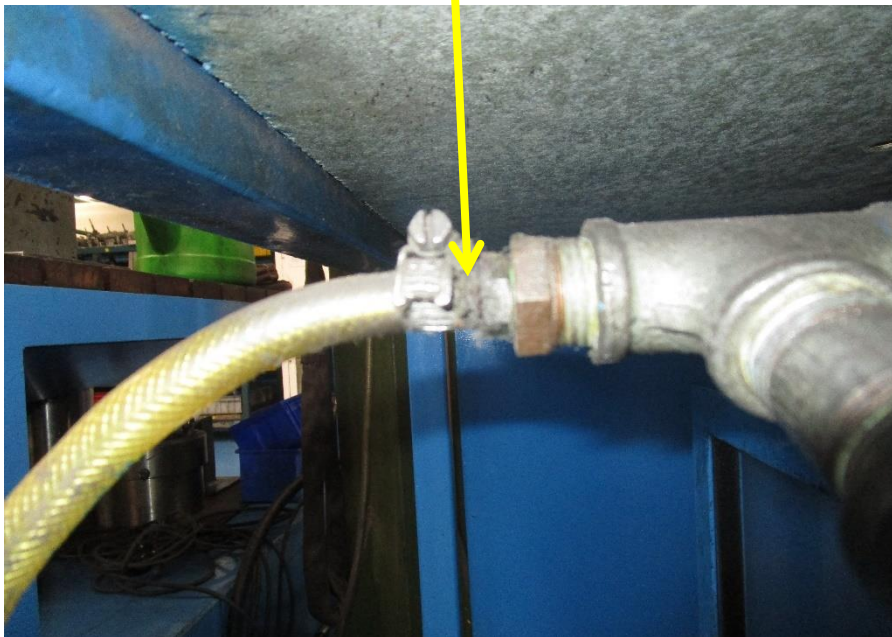
Leak No.	Location	Nature of Leak	Level
32	Shop Floor	Leak From Jubilee Hose Connection to Tee	2

Annual Cost of Leak:	£336
-----------------------------	-------------
