Electrical Thermographic Survey

Sample Report

Pixel Thermographics Ltd

Thermographic Electrical Inspection Sample Report	Inspection Date:
---	--	-------------------------

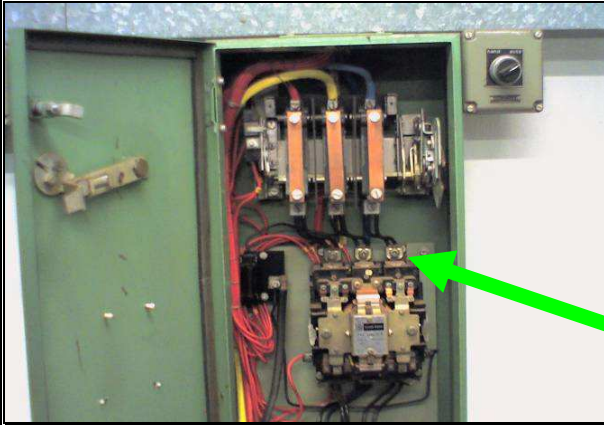
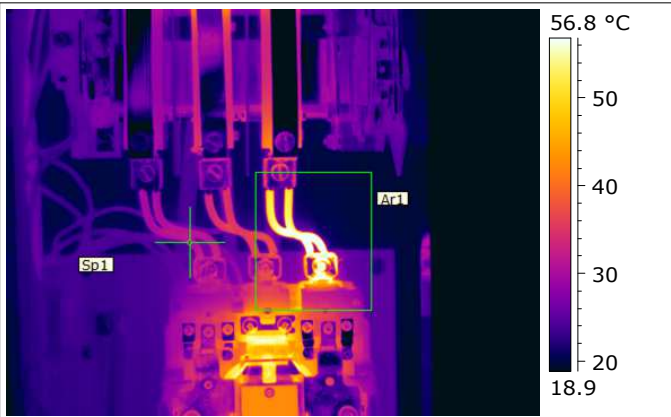
Location	Block 157 Pump House
Equipment	157 Pump Set 3
Type	Contactors

Object Parameters	Value
Atmospheric Temperature	11.7 °C
Sp1 Temperature	31.0 °C
Ar1 Max. Temperature	67.0 °C
Emissivity	0.94
Object Distance	1.5 m
Reflected Apparent Temperature	12.9 °C
Image File name	Contactors.jpg

Difference Ar1 - Sp1	36.0 °C
Fault Rating	Priority 1

Elevated temperature noted on incoming feed to contactor from isolator.

Current measurements were taken and 43 Amps was measured across each phase indicating that load is not the cause of the temperature rise.

Likely cause of the rise is a poor or high resistance connection.

Recommendation is to inspect, clean and remake off this connection

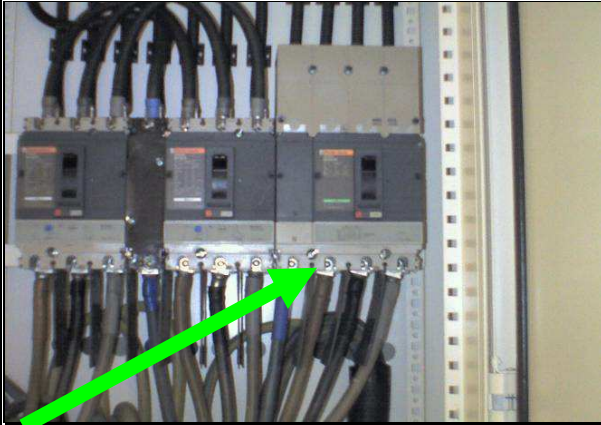
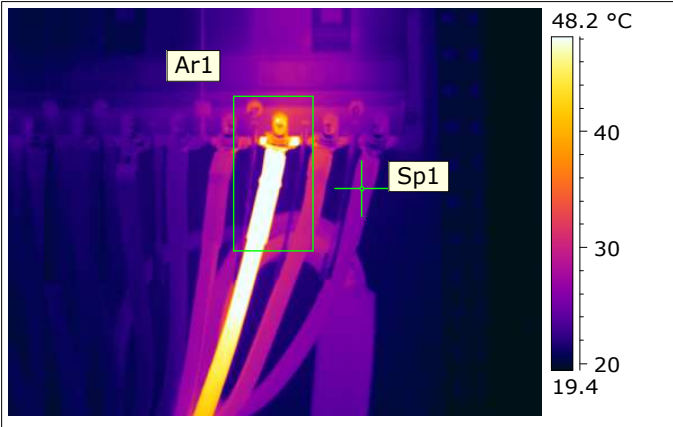
Location	Old Wing - Main UPS Room
Equipment	UPS Input / Output Panel
Type	Connection From Breaker

Object Parameters	Value
Atmospheric Temperature	21.0 °C
Sp1 Temperature	25.8 °C
Ar1 Max. Temperature	58.4 °C
Emissivity	0.95
Object Distance	1.5 m
Reflected Apparent Temperature	21.0 °C
Image File name	IR_10238.jpg
Difference Ar1 - Sp1	32.6 °C
Fault Rating	Priority 2

Elevated temperature noted on phase 1 (brown) outgoing connection from the breaker.

The temperature varied considerably during the course of the survey and the Thermographer witnessed temperatures up to 70°C shortly before this image was recorded.

The likely cause of this rise in temperature is a poor or loose connection to the breaker.

Recommendation is to isolate, disconnect, clean and remake off this connection.

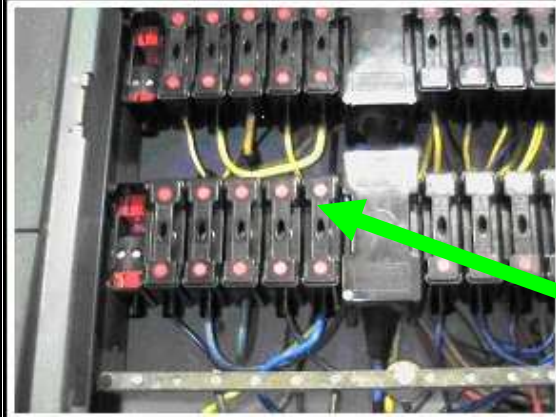
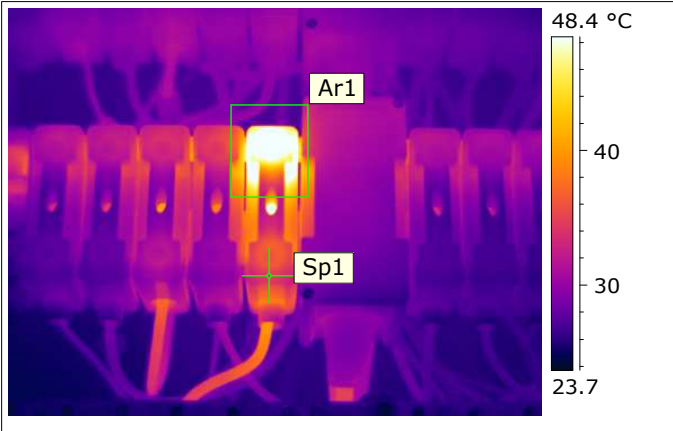
Location	Main Switchroom 2
Equipment	Fuseboard A-1-4-6
Type	Fuse Blue 6

Object Parameters	Value
Atmospheric Temperature	23.2 °C
Sp1 Temperature	34.7 °C
Ar1 Max. Temperature	56.7 °C
Emissivity	0.95
Object Distance	1.5 m
Reflected Apparent Temperature	25.0 °C
Image File name	IR_0033.jpg
Difference Ar1 - Sp1	22.0 °C
Fault Rating	Priority 2

Raised temperature noted on in-feed side of fuse carrier.

Temperature imbalance such as this would not be expected across a fuse and indicates an internal problem.

Possible source of temperature rise includes poor connection, loose fuse fixing, or high resistance blade connections.

Recommendation is to inspect, check fuse carrier blades for signs of pitting or heat damage, replace the fuse, re-tighten the fuse fixings and re-tighten all connections.

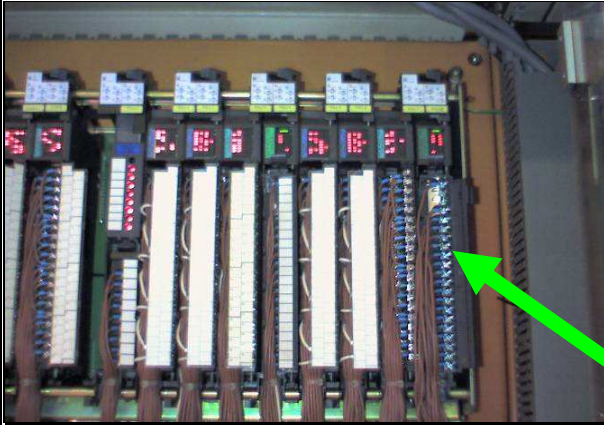
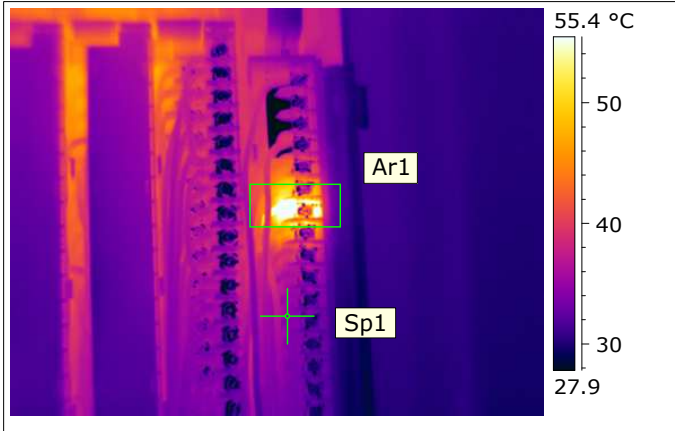
Location	Line 7 PLC Section
Equipment	AB PLC Digital Output Rack
Type	Terminal No. 7

Object Parameters	Value
Atmospheric Temperature	21.5 °C
Sp1 Temperature	34.3 °C
Ar1 Max. Temperature	71.8 °C
Emissivity	0.95
Object Distance	1.5 m
Reflected Apparent Temperature	21.5 °C
Image File name	IR_2007-08-07_0026.jpg

Difference Ar1 - Sp1	37.5 °C
Fault Rating	Priority 1

Temperature increase on terminal No.7.

Likely cause of heat rise is a loose connection to the PLC module.

Recommendation is to tighten up the terminal screw on the device.

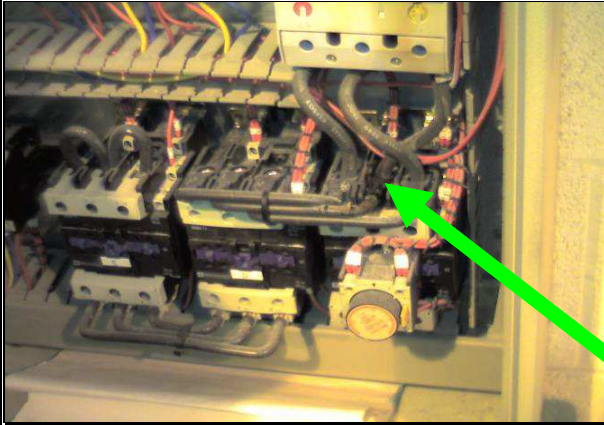
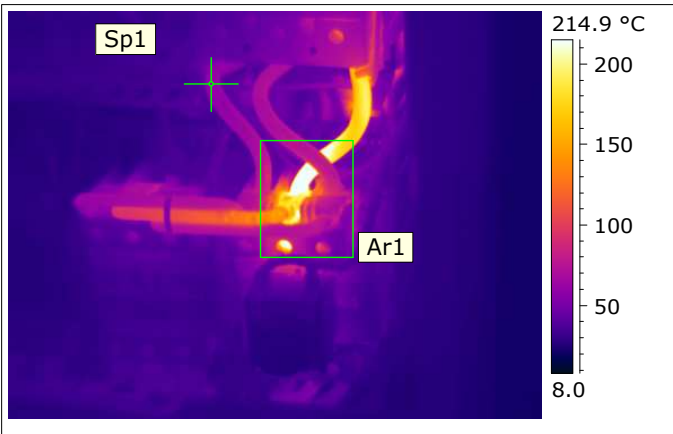
Location	Sanitex Roller Machine
Equipment	Main Control Panel
Type	Overload Incoming Phase 3

Object Parameters	Value
Atmospheric Temperature	21.0 °C
Sp1 Temperature	60.9 °C
Ar1 Max. Temperature	273.6 °C
Emissivity	0.95
Object Distance	1.5 m
Reflected Apparent Temperature	21.0 °C
Image File name	IR_2630.jpg
Difference Ar1 - Sp1	212.7 °C
Fault Rating	Priority 1

Dangerously high temperatures noted on incoming phase 2 connection to main overload unit.

Visible heat damage also noted at the time of the survey.

The unit manager and operator were both made aware of this fault immediately and the decision was made to isolate this equipment until a repair could be carried out.

Recommendation is to replace the overload, the contactor and the 3 feed cables which have all suffered heat damage as a result of this fault.

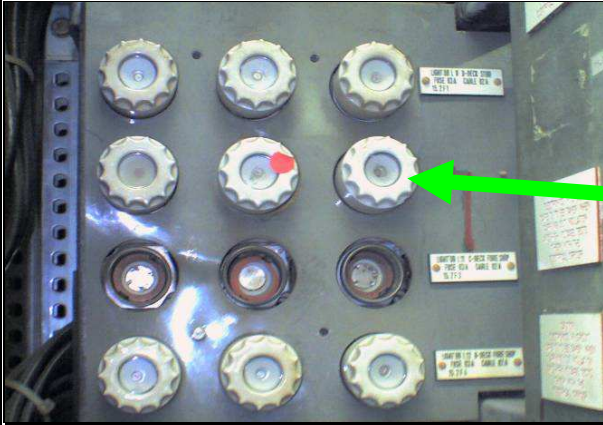
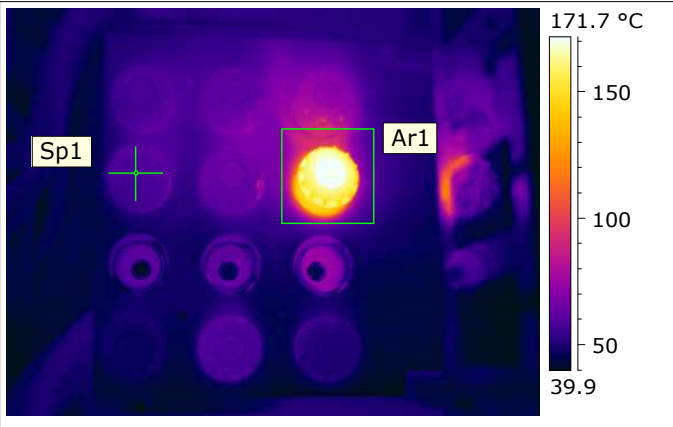
Location	Main Control Room
Equipment	Main Switchboard (Aft)
Type	Panel 15 - Bottle Fuse - Lighting Board L11 Phase 3

Object Parameters	Value
Atmospheric Temperature	25.0 °C
Sp1 Temperature	58.9 °C
Ar1 Max. Temperature	193.8 °C
Emissivity	0.95
Object Distance	1.5 m
Reflected Apparent Temperature	25.0 °C
Image File name	IR_6727.jpg
Difference Ar1 - Sp1	134.9 °C
Fault Rating	Priority 1

Significantly elevated surface temperatures noted on bottle fuse carrier.

Likely causes of heat rise include dirty or pitted conductive surface, loose or poorly fitted fuse carrier or poor outgoing connection at rear.

Recommendation is to remove the carrier, replace the fuse, check all surfaces are clean and re-install the carrier ensuring it is tight and secure.

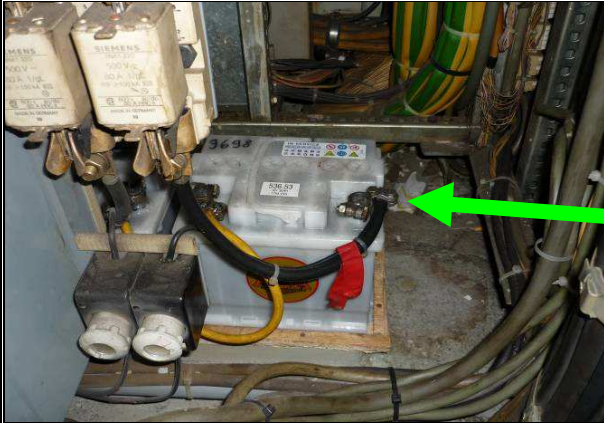
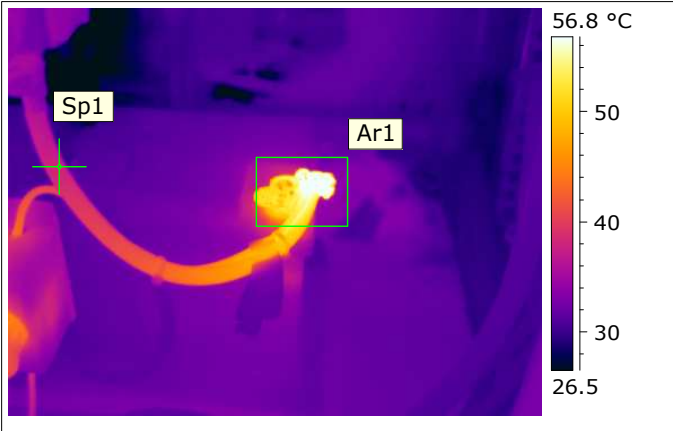
Location	Main Control Room
Equipment	Main Switchboard (Central)
Type	24V Simos Alarms Negative Battery Connection

Object Parameters	Value
Atmospheric Temperature	25.0 °C
Sp1 Temperature	37.9 °C
Ar1 Max. Temperature	61.3 °C
Emissivity	0.95
Object Distance	1.5 m
Reflected Apparent Temperature	25.0 °C
Image File name	IR_6733.jpg
Difference Ar1 - Sp1	23.5 °C
Fault Rating	Priority 2

Elevated temperature noted on battery negative connection.
Likely cause of heat rise is a poor or loose connection.
Recommendation is to inspect, clean and re-tighten this connection.

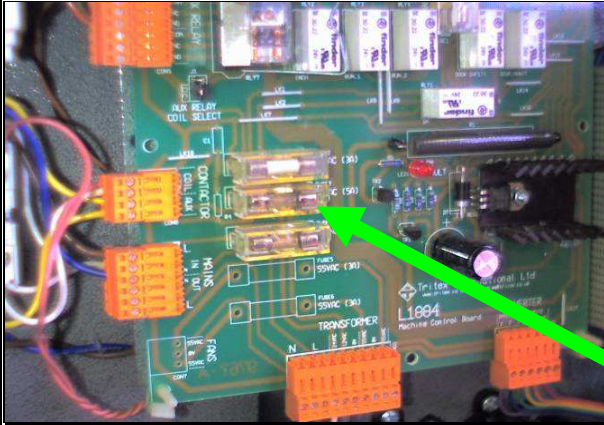
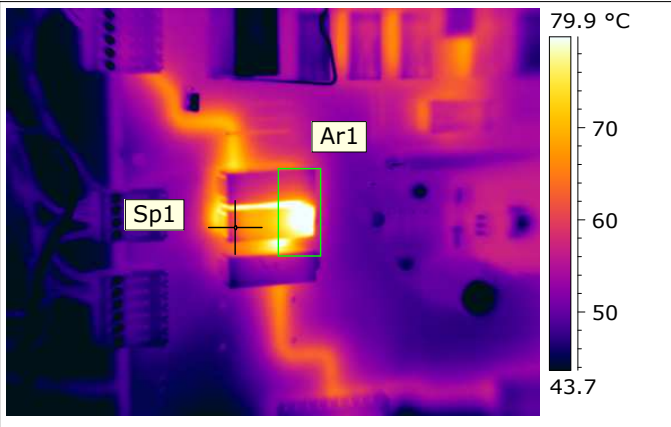
Location	Machine Room
Equipment	Sewing Machine F6 Control Panel
Type	PCB Mounted Fuse Carrier

Object Parameters	Value
Atmospheric Temperature	21.0 °C
Sp1 Temperature	61.9 °C
Ar1 Max. Temperature	94.3 °C
Emissivity	0.95
Object Distance	1.5 m
Reflected Apparent Temperature	21.0 °C
Image File name	IR_1400.jpg
Difference Ar1 - Sp1	32.4 °C
Fault Rating	Priority 2

Elevated temperature noted on end of fuse carrier on machine PCB unit.

Temperature differential across a fuse carrier would not be expected and indicates an internal issue.

Discussion with machine operator highlighted that the machine stops intermittently and this fault could well be the cause of this.

Recommendation is to replace the fuse carrier and fuse.

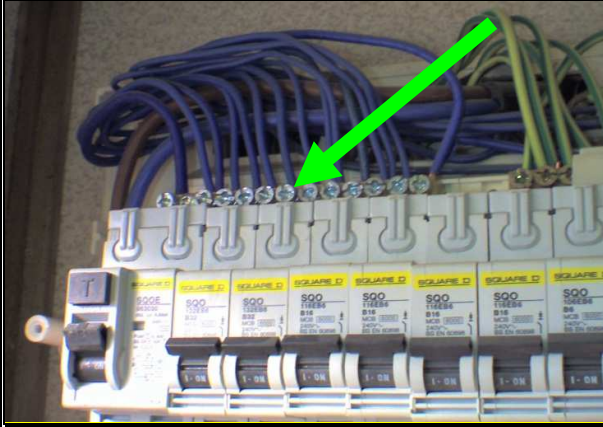
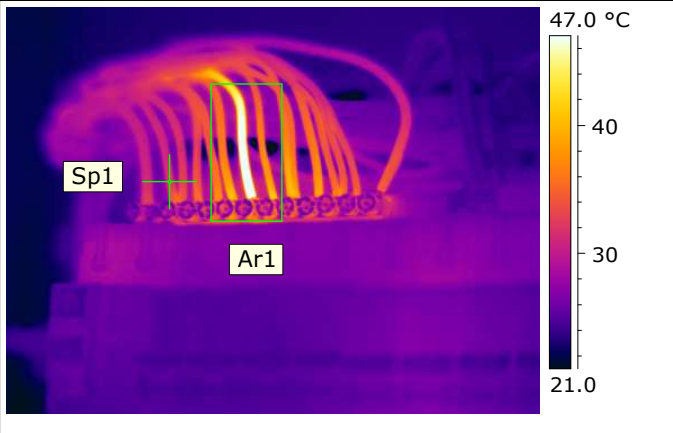
Location	Main Office
Equipment	Distribution Board
Type	Neutral Connection

Object Parameters	Value
Atmospheric Temperature	20.0 °C
Sp1 Temperature	32.7 °C
Ar1 Max. Temperature	55.9 °C
Emissivity	0.95
Object Distance	1.5 m
Reflected Apparent Temperature	20.0 °C
Image File name	IR_4062.jpg
Difference Ar1 - Sp1	23.3 °C
Fault Rating	Priority 2

Elevated temperature noted on neutral connection on distribution board.

Likely cause of heat rise is a poor or loose connection.

Recommendation is to inspect, clean and remake off this connection.

Note: Repair work was carried out at the time of the survey. See next page for analysis following completion of the repair.

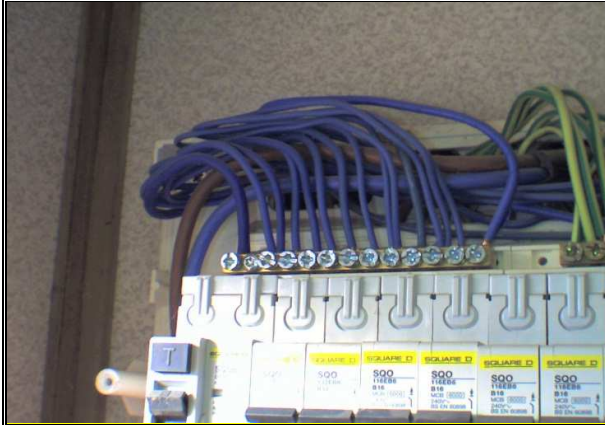
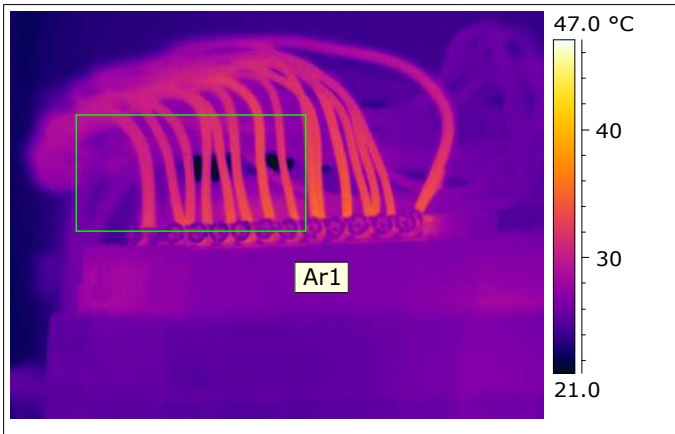
Location	Main Office
Equipment	Distribution Board
Type	Neutral Connection - RESOLVED

Object Parameters	Value
Atmospheric Temperature	20.0 °C
Ar1 Max. Temperature	34.6 °C
Emissivity	0.95
Object Distance	1.5 m
Reflected Apparent Temperature	20.0 °C
Image File name	IR_4064.jpg

Difference Ar1 - Sp1	0.0 °C
Fault Rating	Priority 0.0

The thermal image shows that following the repair, the temperatures have returned to normal and the fault has disappeared.

No further work required.
