Electrical Thermographic Survey

Sample Report

January 2011

Pixel Thermographics Ltd

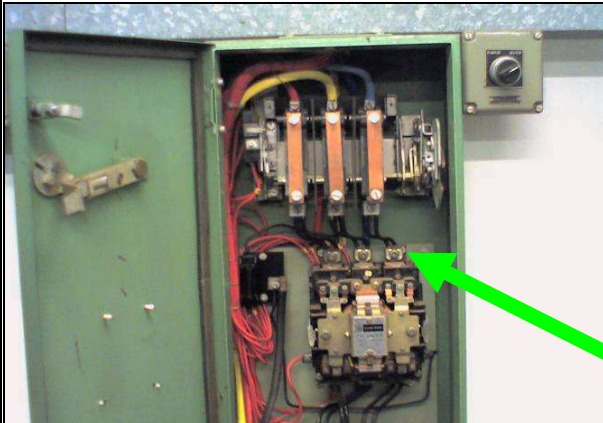
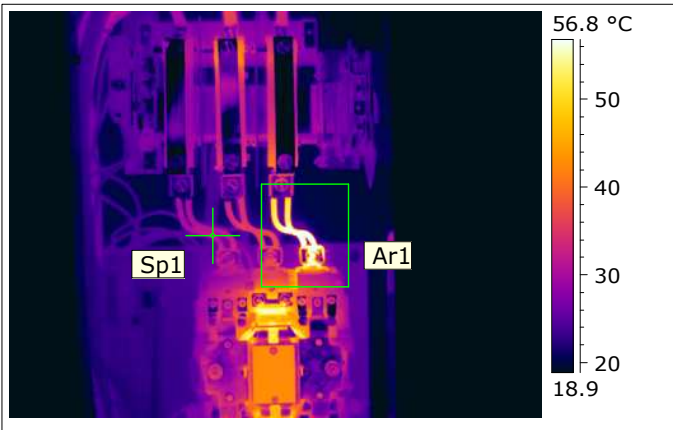
Location	Block 157 Pump House
Equipment	157 Pump Set 3
Type	Contactator

Object Parameters	Value
Atmospheric Temperature	11.7 °C
Emissivity	0.94
Object Distance	1.5 m
Reflected Apparent Temperature	12.9 °C
Image File name	Contactator.jpg
Sp1 Temperature	31.0 °C
Ar1 Max. Temperature	67.0 °C
Difference Ar1 - Sp1	36.0 °C
Fault Rating	Priority 1

Elevated temperature noted on incoming feed to contactor from isolator.

Current measurements were taken and 43 Amps was measured across each phase indicating that load is not the cause of the temperature rise.

Likely cause of the rise is a poor or high resistance connection.

Recommendation is to inspect, clean and remake off this connection

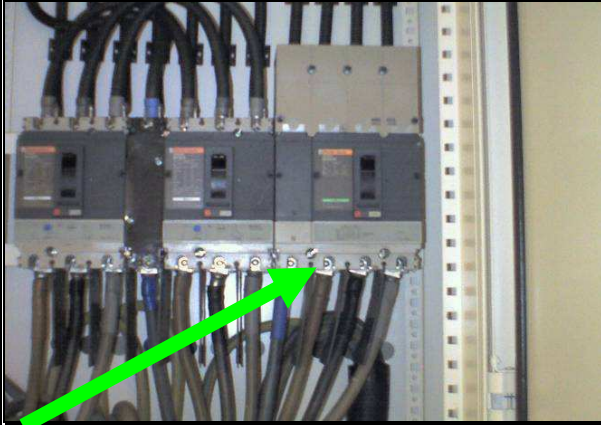
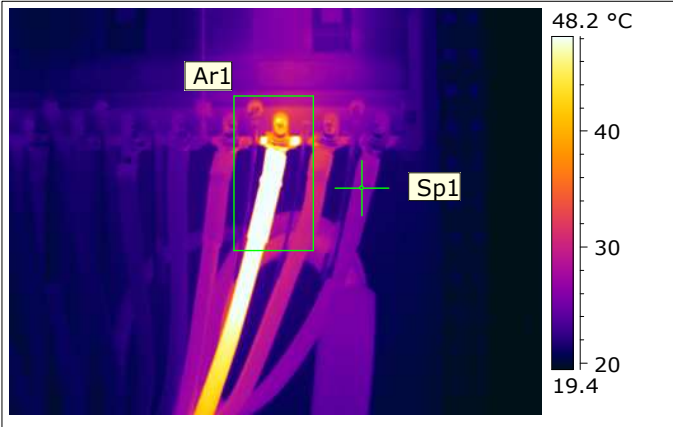
Location	Old Wing - Main UPS Room
Equipment	UPS Input / Output Panel
Type	Connection From Breaker

Object Parameters	Value
Atmospheric Temperature	21.0 °C
Emissivity	0.95
Object Distance	1.5 m
Reflected Apparent Temperature	21.0 °C
Image File name	IR_10238.jpg
Sp1 Temperature	25.8 °C
Ar1 Max. Temperature	58.4 °C
Difference Ar1 - Sp1	32.6 °C
Fault Rating	Priority 2

Elevated temperature noted on phase 1 (brown) outgoing connection from the breaker. The temperature varied considerably during the course of the survey and the Thermographer witnessed temperatures up to 70°C shortly before this image was recorded.

The likely cause of this rise in temperature is a poor or loose connection to the breaker.

It is recommended that the lug is cut off and replaced with new. Also replace the breaker as internal temperatures may well have exceeded the manufacturers recommendations.

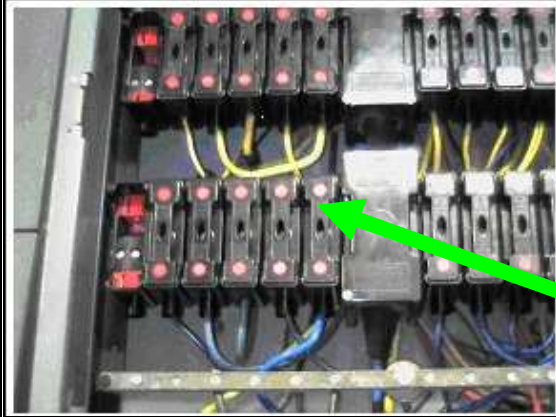
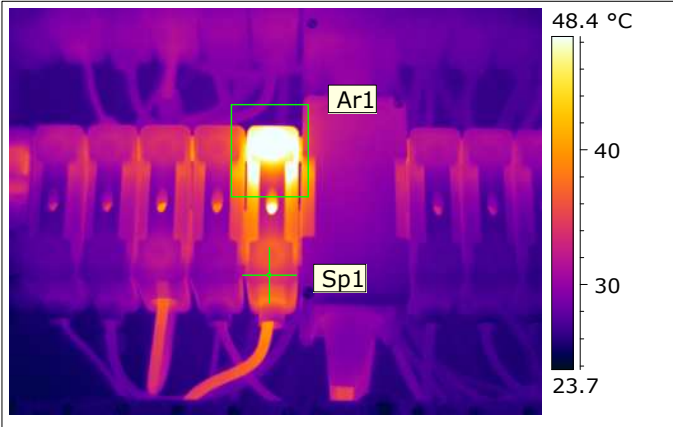
Location	Main Switchroom 2
Equipment	Fuseboard A-1-4-6
Type	Fuse Blue 6

Object Parameters	Value
Atmospheric Temperature	23.2 °C
Emissivity	0.95
Object Distance	1.5 m
Reflected Apparent Temperature	25.0 °C
Image File name	IR_0033.jpg
Sp1 Temperature	34.7 °C
Ar1 Max. Temperature	56.7 °C
Difference Ar1 - Sp1	22.0 °C
Fault Rating	Priority 2

Raised temperature noted on in-feed side of fuse carrier.

Temperature imbalance such as this would not be expected across a fuse and indicates an internal problem.

Possible source of temperature rise includes poor connection, loose fuse fixing, or high resistance blade connections.

Recommendation is to inspect, check fuse carrier blades for signs of pitting or heat damage, re-tighten the fuse fixings and re-tighten all connections.

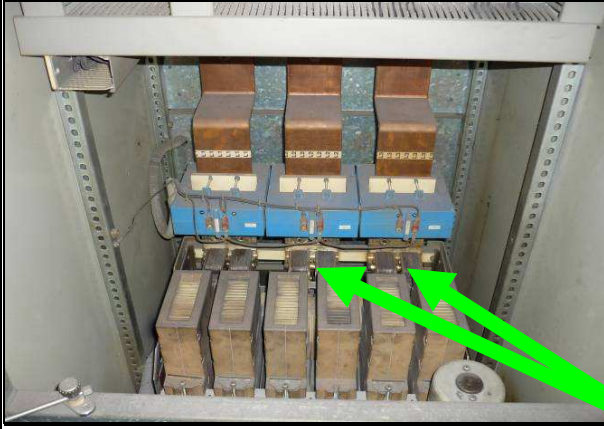
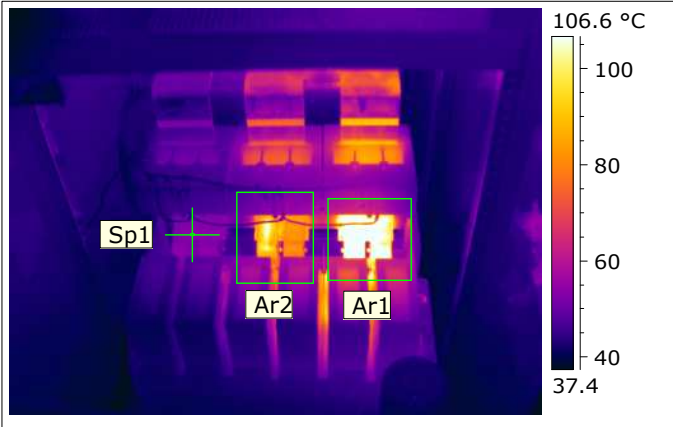
Location	Main Control Room
Equipment	Main Switchboard (Central)
Type	Panel 5 - Main Breaker - Phase 2 & 3

Object Parameters	Value
Atmospheric Temperature	25.0 °C
Emissivity	0.95
Object Distance	1.5 m
Reflected Apparent Temperature	25.0 °C
Image File name	IR_6731.jpg
Sp1 Temperature	53.4 °C
Ar1 Max. Temperature	163.9 °C
Ar2 Max. Temperature	111.6 °C
Difference Ar1 - Sp1	110.5 °C
Fault Rating	Priority 1

Significantly elevated temperatures noted on the contacts of Phases 3 and 2 of the circuit breaker.

Likely cause of this heat rise is poor or dirty connections between the breaker and the contact.

Recommendation is to remove the breaker and completely clean the connections and contacts of phases 2 and 3.

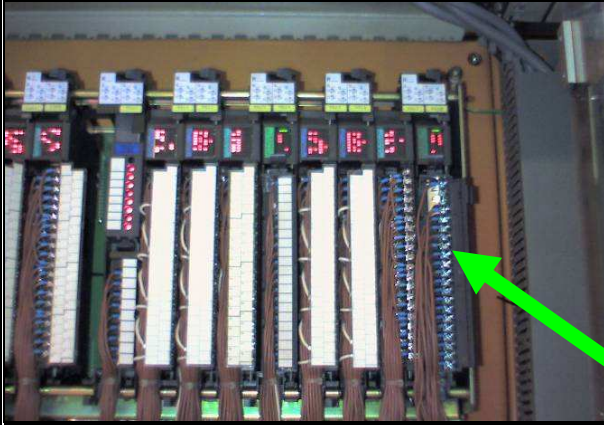
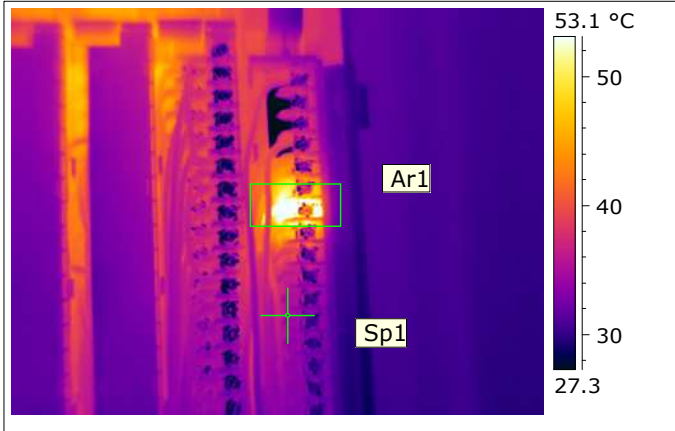
Location	Line 7 PLC Section
Equipment	AB PLC Digital Output Rack
Type	Terminal No. 7

Object Parameters	Value
Atmospheric Temperature	21.5 °C
Emissivity	0.95
Object Distance	1.5 m
Reflected Apparent Temperature	21.5 °C
Image File name	IR_2007-08-07_0026.jpg
Sp1 Temperature	34.3 °C
Ar1 Max. Temperature	71.8 °C

Difference Ar1 - Sp1	37.5 °C
Fault Rating	Priority 1

Temperature increase on terminal No.7.

No information was available at the time of survey to indicate the downstream device but significant temperature rise indicates an issue worth investigating.

Recommendation is to inspect and identify downstream connected device. Check expected operating currents.

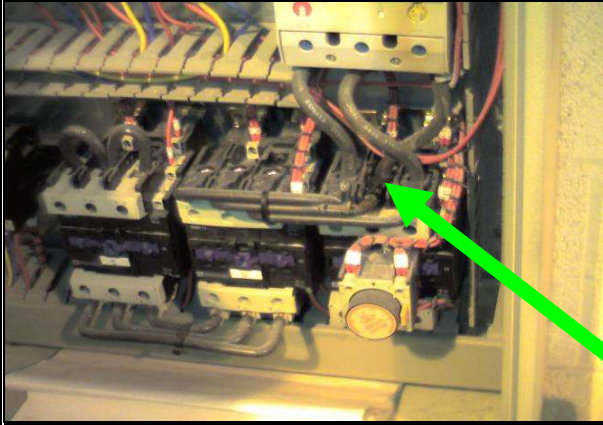
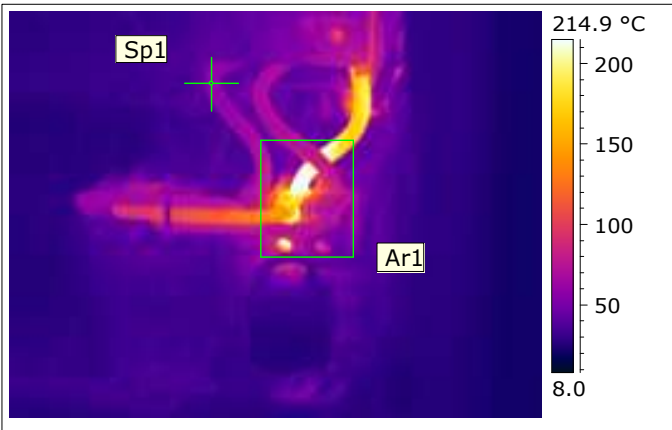
Location	Sanitex Roller Machine
Equipment	Main Control Panel
Type	Overload Incoming Phase 3

Object Parameters	Value
Atmospheric Temperature	21.0 °C
Emissivity	0.95
Object Distance	1.5 m
Reflected Apparent Temperature	21.0 °C
Image File name	IR_2630.jpg
Sp1 Temperature	60.9 °C
Ar1 Max. Temperature	273.6 °C
Difference Ar1 - Sp1	212.7 °C
Fault Rating	Priority 1

Dangerously high temperatures noted on incoming phase 2 connection to main overload unit.

Visible heat damage also noted at the time of the survey.

The unit manager and operator were both made aware of this fault immediately and the decision was made to isolate this equipment until a repair could be carried out.

Recommendation is to replace the overload, the contactor and the 3 feed cables which have all suffered heat damage as a result of this fault.

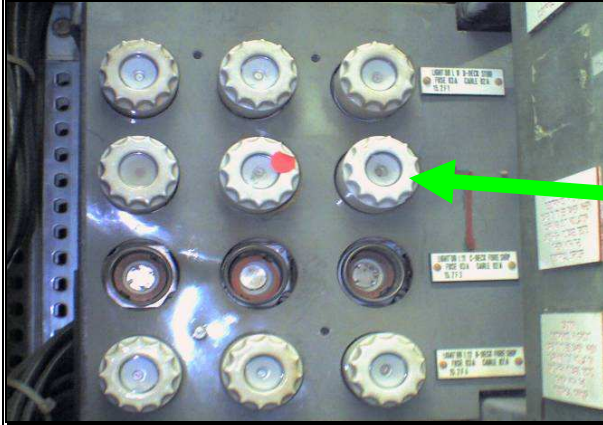
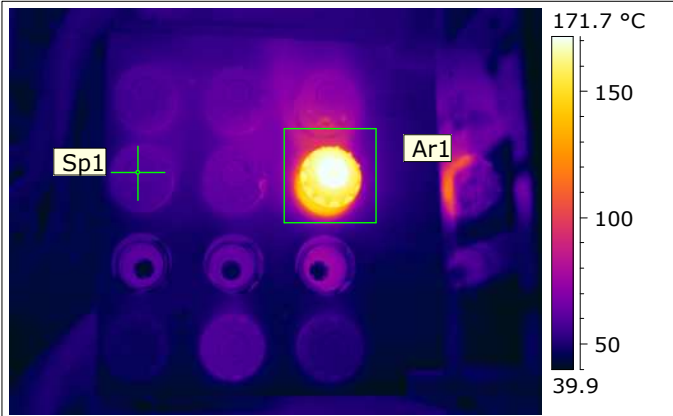
Location	Main Control Room
Equipment	Main Switchboard (Aft)
Type	Panel 15 - Bottle Fuse - Lighting Board L11 Phase 3

Object Parameters	Value
Atmospheric Temperature	25.0 °C
Emissivity	0.95
Object Distance	1.5 m
Reflected Apparent Temperature	25.0 °C
Image File name	IR_6727.jpg
Sp1 Temperature	58.9 °C
Ar1 Max. Temperature	193.8 °C
Difference Ar1 - Sp1	134.9 °C
Fault Rating	Priority 1

Significantly elevated surface temperatures noted on bottle fuse carrier.

Likely causes of heat rise include dirty or pitted conductive surface, loose or poorly fitted fuse carrier or poor outgoing connection at rear.

Recommendation is to remove the carrier, replace the fuse, check all surfaces are clean and re-install the carrier ensuring it is tight.

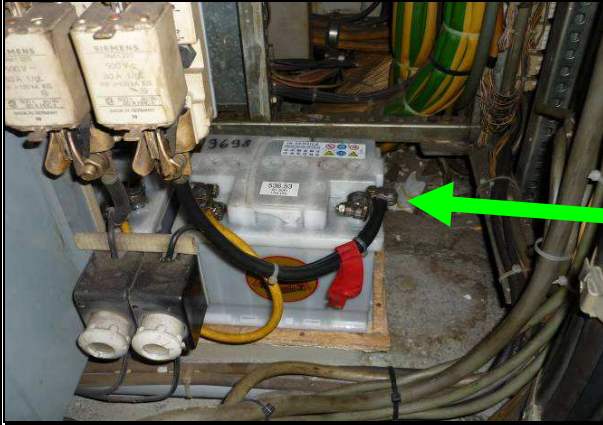
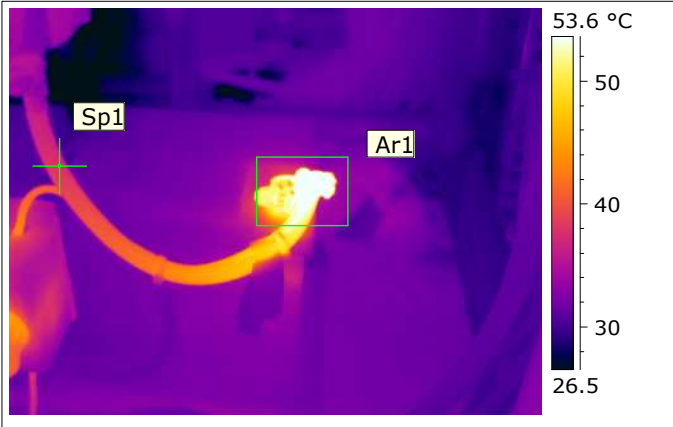
Location	Main Control Room
Equipment	Main Switchboard (Central)
Type	24V Simos Alarms Negative Battery Connection

Object Parameters	Value
Atmospheric Temperature	25.0 °C
Emissivity	0.95
Object Distance	1.5 m
Reflected Apparent Temperature	25.0 °C
Image File name	IR_6733.jpg
Sp1 Temperature	37.9 °C
Ar1 Max. Temperature	61.3 °C
Difference Ar1 - Sp1	23.5 °C
Fault Rating	Priority 2

Elevated temperature noted on battery negative connection.
Likely cause of heat rise is a poor or loose connection.
Recommendation is to inspect, clean and re-tighten this connection.

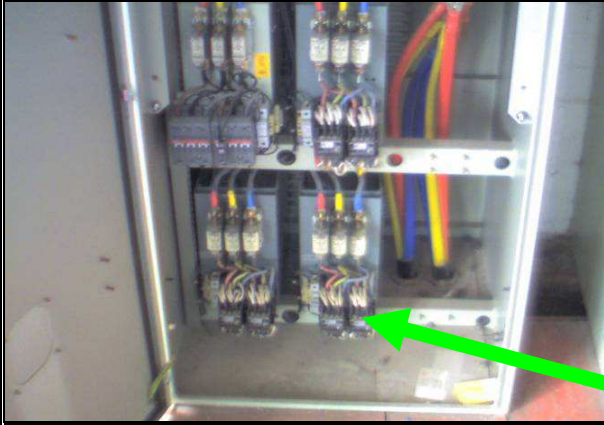
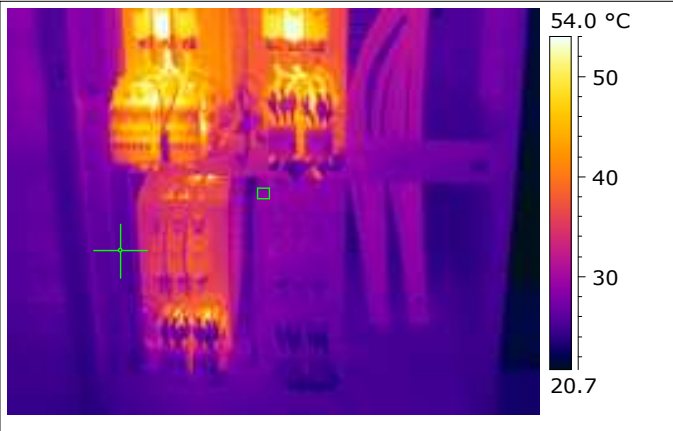
Location	Main Switchroom
Equipment	Power Factor Control Cubicle 1
Type	Capacitor Bank No. 6

Object Parameters	Value
Atmospheric Temperature	20.0 °C
Emissivity	0.95
Object Distance	1.5 m
Reflected Apparent Temperature	20.0 °C
Image File name	IR_8067.jpg
Sp1 Temperature	25.7 °C
Ar1 Max. Temperature	30.2 °C
Difference Ar1 - Sp1	4.4 °C
Fault Rating	Priority 3

Capacitor bank 6 noted as not being under load at time of survey.

Inspection of PFC controls indicated that the bank should be energized and therefore highlights a possible control issue.

Recommendation is to test, inspect, and re-instate this capacitor bank.

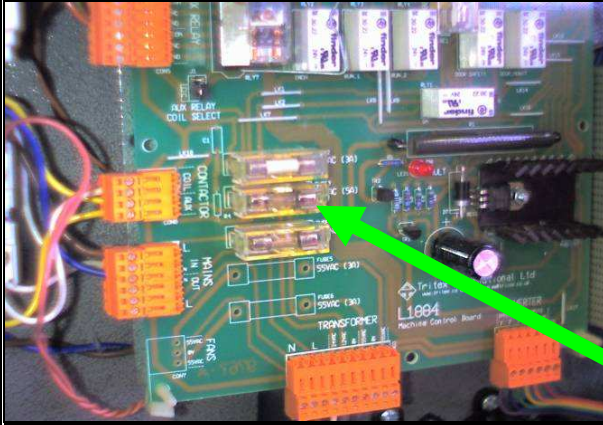
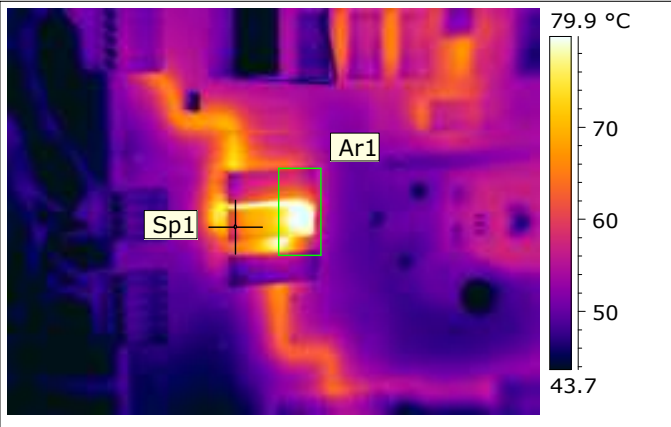
Location	Machine Room
Equipment	Sewing Machine F6 Control Panel
Type	PCB Mounted Fuse Carrier

Object Parameters	Value
Atmospheric Temperature	21.0 °C
Emissivity	0.95
Object Distance	1.5 m
Reflected Apparent Temperature	21.0 °C
Image File name	IR_1400.jpg
Sp1 Temperature	61.9 °C
Ar1 Max. Temperature	94.3 °C
Difference Ar1 - Sp1	32.4 °C
Fault Rating	Priority 2

Elevated temperature noted on end of fuse carrier on machine PCB unit.

Temperature differential across a fuse carrier would not be expected and indicates an internal issue.

Discussion with machine operator highlighted that the machine stops intermittently and this fault could well be the cause of this.

Recommendation is to replace the fuse carrier and fuse.

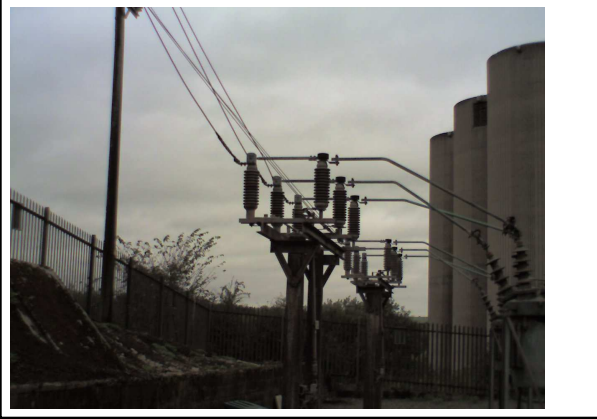
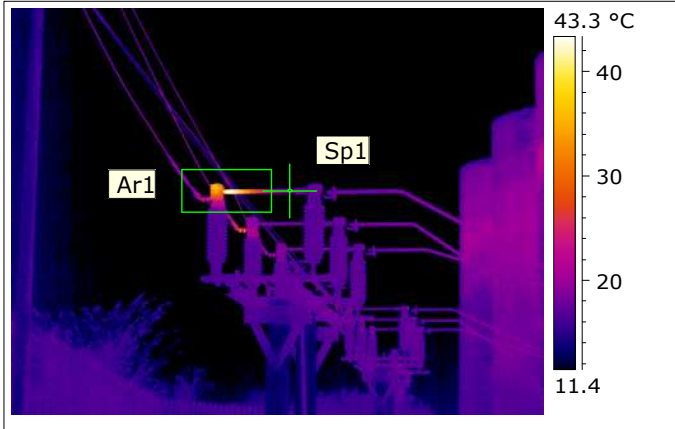
Location	Main 33kV Switchyard
Equipment	Incoming 33kV Supply Line 2
Type	Phase 1 Connection

Object Parameters	Value
Atmospheric Temperature	16.0 °C
Emissivity	0.40
Object Distance	7.0 m
Reflected Apparent Temperature	16.0 °C
Image File name	Pole 1L1 Substation 1.jpg
Sp1 Temperature	19.9 °C
Ar1 Max. Temperature	57.2 °C

Difference Ar1 - Sp1	37.3 °C
Fault Rating	Priority 2

Elevated temperature noted on 33kV feed line within the switchyard compound.

No current data was available at the time of this survey.

Further investigation and monitoring required of this connection. If degradation is observed then the supply authority should be informed.
