Marine Electrical Thermographic Survey

SAMPLE REPORT

Pixel Thermographics Ltd

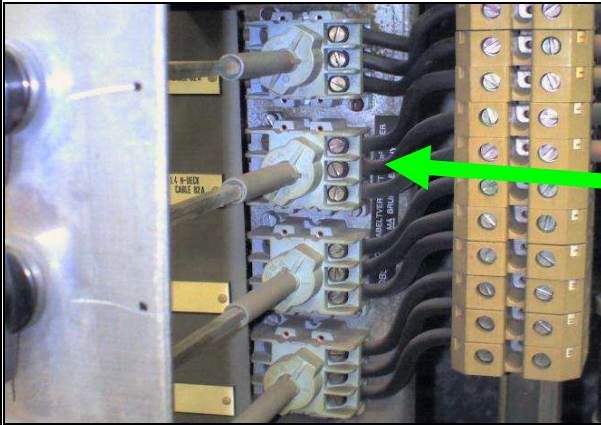
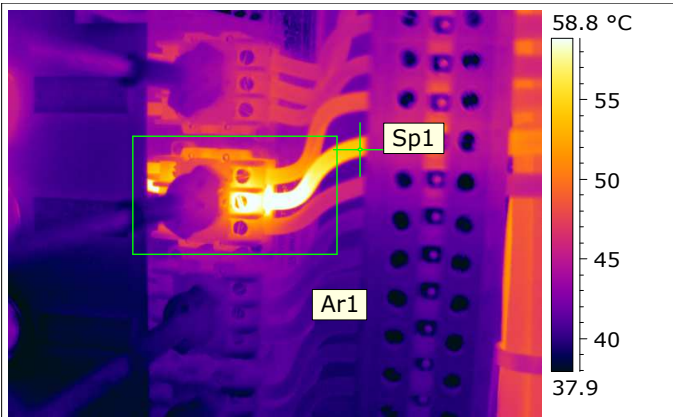
Location	Main Control Room
Equipment	Main Switchboard (Aft)
Type	Panel 14 - Isolator Phase 2 Connection

Object Parameters	Value
Atmospheric Temperature	25.0 °C
Sp1 Temperature	53.9 °C
Ar1 Max. Temperature	71.4 °C
Emissivity	0.95
Object Distance	1.5 m
Reflected Apparent Temperature	25.0 °C
Image File name	IR_6723.jpg
Difference Ar1 - Sp1	17.5 °C
Fault Rating	Priority 2

Elevated temperature noted on isolator outgoing phase 2 connection.

Current measurements indicate that imbalanced load is not the cause of this anomaly.

Likely cause of heat rise is a poor or loose connection.

Recommendation is to inspect, clean and remake off this connection.

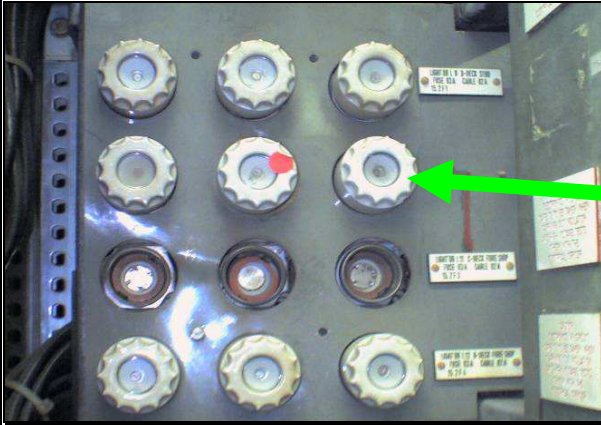
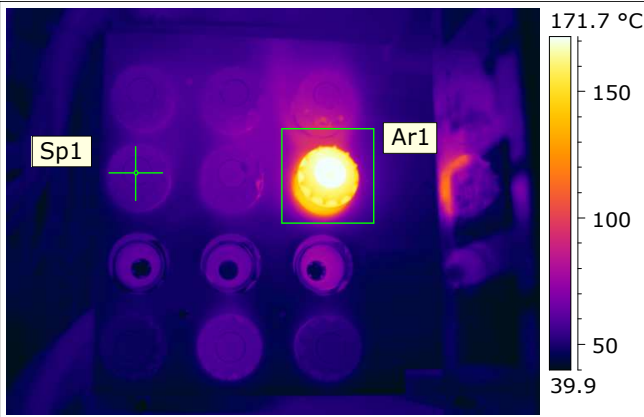
Location	Main Control Room
Equipment	Main Switchboard (Aft)
Type	Panel 15 - Bottle Fuse - Lighting Board L11 Phase 3

Object Parameters	Value
Atmospheric Temperature	25.0 °C
Sp1 Temperature	58.9 °C
Ar1 Max. Temperature	193.8 °C
Emissivity	0.95
Object Distance	1.5 m
Reflected Apparent Temperature	25.0 °C
Image File name	IR_6727.jpg
Difference Ar1 - Sp1	134.9 °C
Fault Rating	Priority 1

Significantly elevated surface temperatures noted on bottle fuse carrier.

Likely causes of heat rise include dirty or pitted conductive surface, loose or poorly fitted fuse carrier or poor outgoing connection at rear.

Recommendation is to remove the carrier, replace the fuse, check all surfaces are clean and re-install the carrier ensuring it is tight.

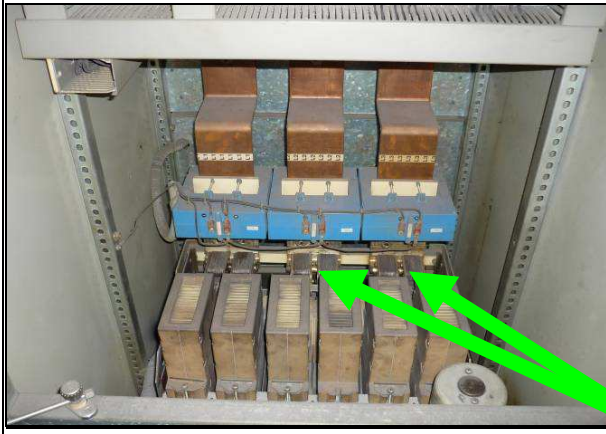
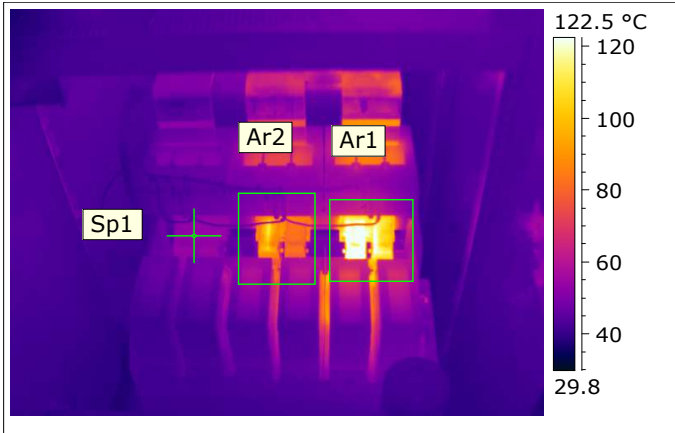
Location	Main Control Room
Equipment	Main Switchboard (Central)
Type	Panel 5 - Main Breaker - Phase 2 & 3

Object Parameters	Value
Atmospheric Temperature	25.0 °C
Sp1 Temperature	53.4 °C
Ar1 Max. Temperature	163.9 °C
Ar2 Max. Temperature	111.6 °C
Emissivity	0.95
Object Distance	1.5 m
Reflected Apparent Temperature	25.0 °C
Image File name	IR_6731.jpg
Difference Ar1 - Sp1	110.5 °C
Fault Rating	Priority 1

Significantly elevated temperatures noted on the contacts of Phases 3 and 2 of the circuit breaker.
Likely cause of this heat rise is poor or dirty connections between the breaker and the contact.
Recommendation is to remove and completely clean the connections and contacts of phases 2 and 3.

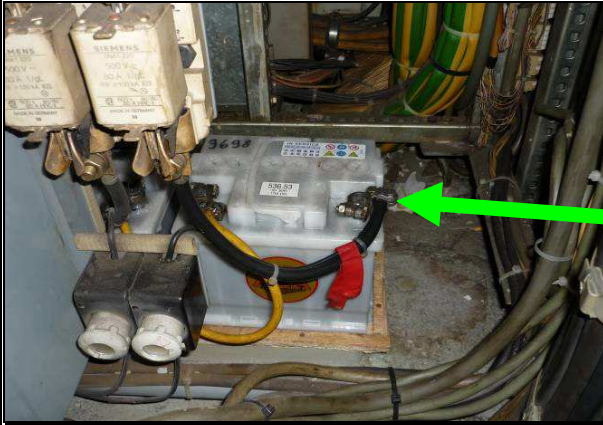
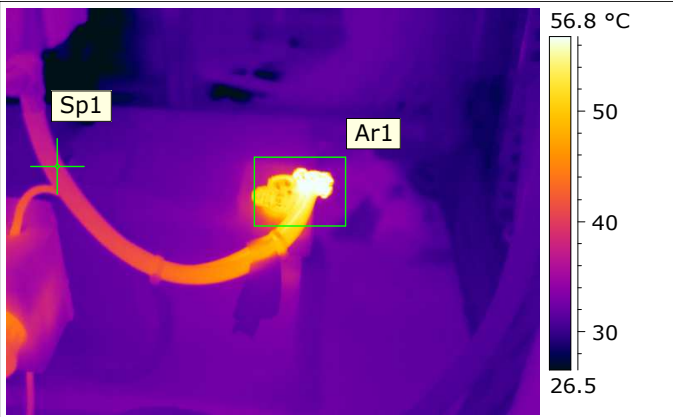
Location	Main Control Room
Equipment	Main Switchboard (Central)
Type	24V Simos Alarms Negative Battery Connection

Object Parameters	Value
Atmospheric Temperature	25.0 °C
Sp1 Temperature	37.9 °C
Ar1 Max. Temperature	61.3 °C
Emissivity	0.95
Object Distance	1.5 m
Reflected Apparent Temperature	25.0 °C
Image File name	IR_6733.jpg
Difference Ar1 - Sp1	23.5 °C
Fault Rating	Priority 2

Elevated temperature noted on battery negative connection.
Likely cause of heat rise is a poor or loose connection.
Recommendation is to inspect, clean and re-tighten this connection.

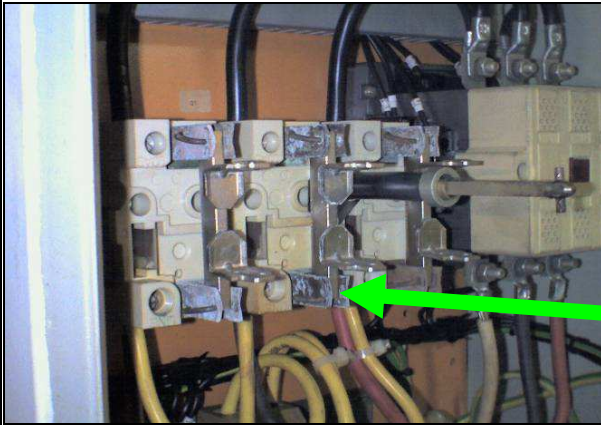
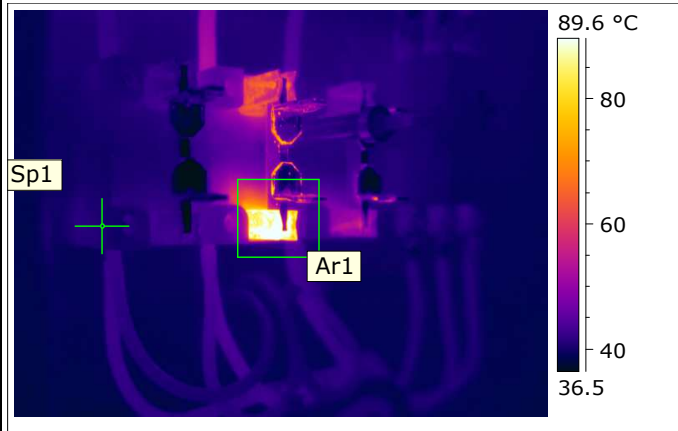
Location	VPP Room
Equipment	VPP Oil Pump (Centre)
Type	Isolator Incoming Phase 2 Contact

Object Parameters	Value
Atmospheric Temperature	33.1 °C
Sp1 Temperature	40.7 °C
Ar1 Max. Temperature	105.0 °C
Emissivity	0.95
Object Distance	1.5 m
Reflected Apparent Temperature	33.1 °C
Image File name	IR_6739.jpg
Difference Ar1 - Sp1	64.3 °C
Fault Rating	Priority 1

Significantly elevated temperature noted on phase 2 of the isolator mechanism.
Likely cause of this heat rise is a loose or dirty contact connection.
Recommendation is to inspect and thoroughly clean this contact.

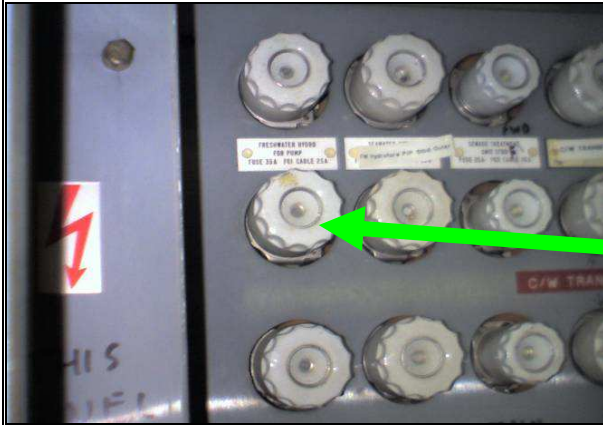
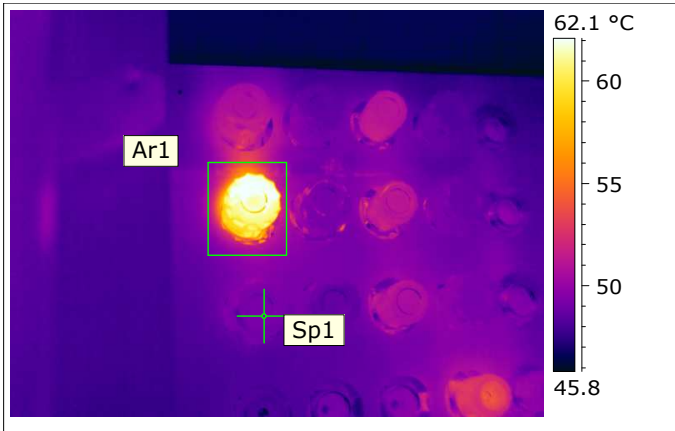
Location	Generator Room
Equipment	DB Engine Panel 2
Type	Bottle Fuse - Fresh Water Hydro FGR Pump - Phase 2

Object Parameters	Value
Atmospheric Temperature	36.5 °C
Sp1 Temperature	49.3 °C
Ar1 Max. Temperature	64.5 °C
Emissivity	0.95
Object Distance	1.5 m
Reflected Apparent Temperature	36.5 °C
Image File name	IR_6754.jpg
Difference Ar1 - Sp1	15.2 °C
Fault Rating	Priority 2

Elevated surface temperatures noted on bottle fuse carrier.

Likely causes of heat rise include dirty or pitted conductive surface, loose or poorly fitted fuse carrier or poor outgoing connection at rear.

Recommendation is to remove the carrier, replace the fuse, check all surfaces are clean and re-install the carrier ensuring it is tight.

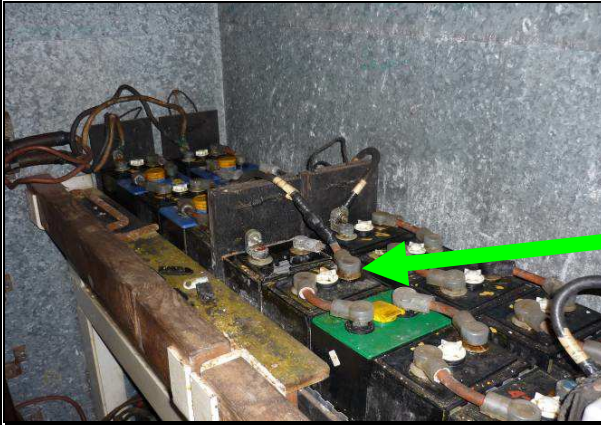
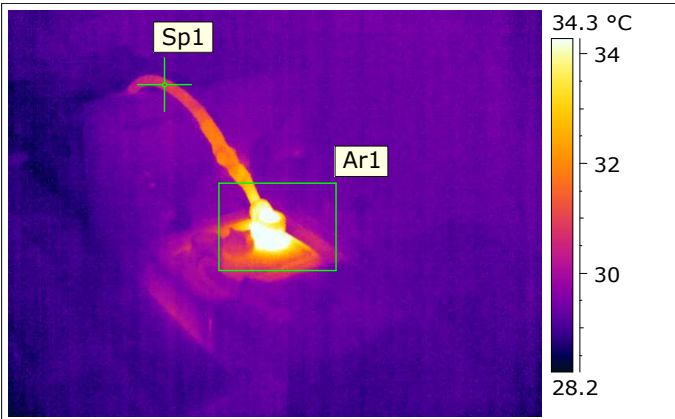
Location	Level 5 Battery Room
Equipment	220v Batteries
Type	Battery Connection

Object Parameters	Value
Atmospheric Temperature	32.3 °C
Sp1 Temperature	30.9 °C
Ar1 Max. Temperature	36.6 °C
Emissivity	0.95
Object Distance	1.5 m
Reflected Apparent Temperature	32.3 °C
Image File name	IR_6772.jpg

Difference Ar1 - Sp1	5.7 °C
Fault Rating	Priority 3

Elevated temperature noted on battery connection.

The thermal profile indicates that the likely cause of this heat rise is a faulty battery cell.

Recommendation is to replace the battery cell.

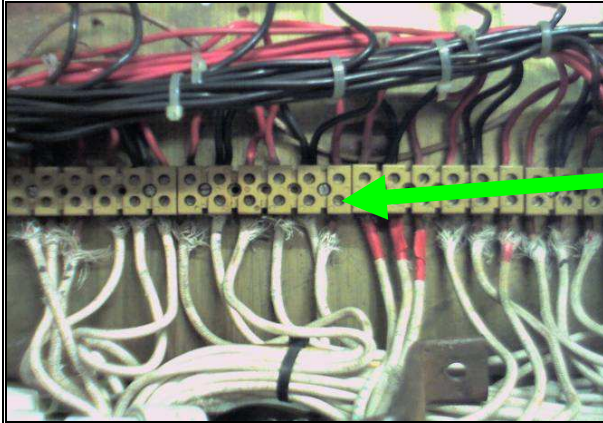
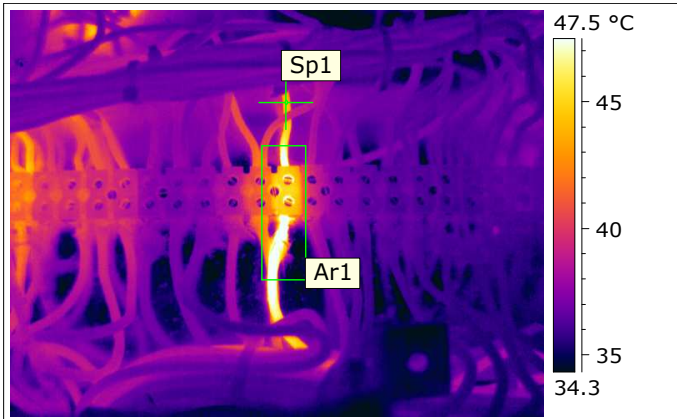
Location	Level 7 - Galley
Equipment	Hot Plate Control Panel
Type	Termination in Base of Panel

Object Parameters	Value
Atmospheric Temperature	32.3 °C
Sp1 Temperature	44.4 °C
Ar1 Max. Temperature	54.9 °C
Emissivity	0.95
Object Distance	1.5 m
Reflected Apparent Temperature	32.3 °C
Image File name	IR_6774.jpg

Difference Ar1 - Sp1	10.6 °C
Fault Rating	Priority 2

Elevated temperature noted on terminal connection.
Likely cause of heat rise is a poor or loose connection.
Recommendation is to inspect, clean and remake off this connection.
