**Electrical Thermographic Survey**

**Sample Report**

**Pixel Thermographics Ltd**

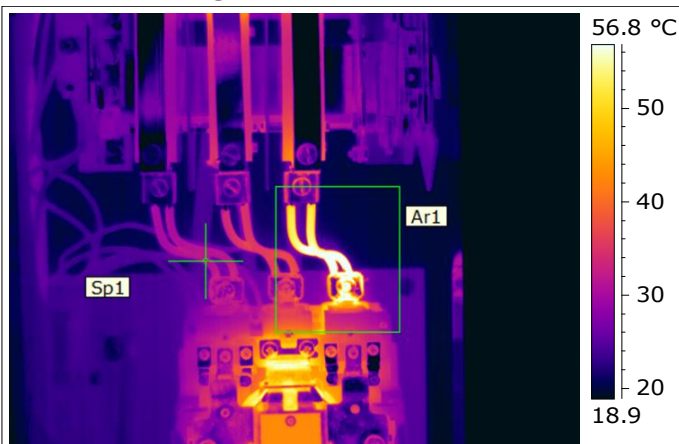
| Equipment | 157 Pump Set 3 |

| Fault Rating | Priority 1 |

Elevated temperature noted on incoming feed to contactor from isolator.

Current measurements were taken and 43 Amps was measured across each phase indicating that load is not the cause of the temperature rise.

Likely cause of the rise is a poor or high resistance connection.

Recommendation is to inspect, clean and remake off this connection

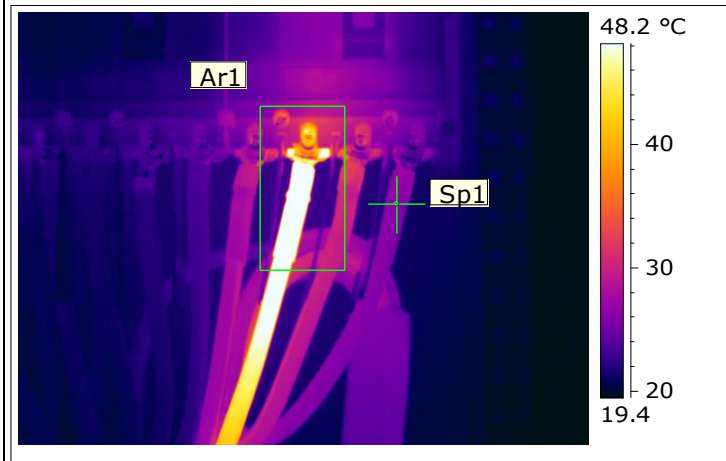
| Equipment | UPS Input / Output Panel |

| <b>Fault Rating</b> | <b>Priority 2</b> |

Elevated temperature noted on phase 1 (brown) outgoing connection from the breaker.

The temperature varied considerably during the course of the survey and the Thermographer witnessed temperatures up to 70°C shortly before this image was recorded.

The likely cause of this rise in temperature is a poor or loose connection to the breaker.

Recommendation is to isolate, disconnect, clean and remake off this connection.

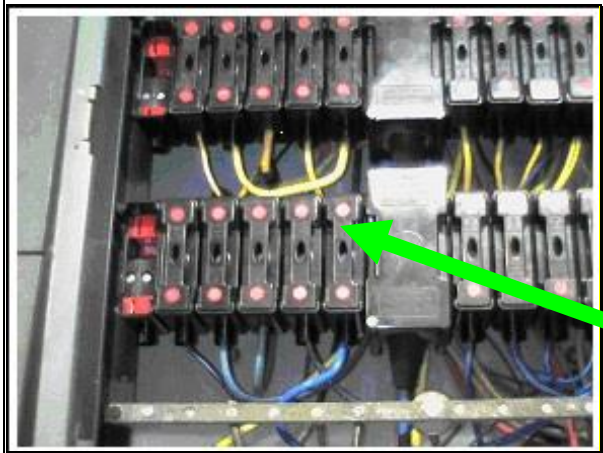
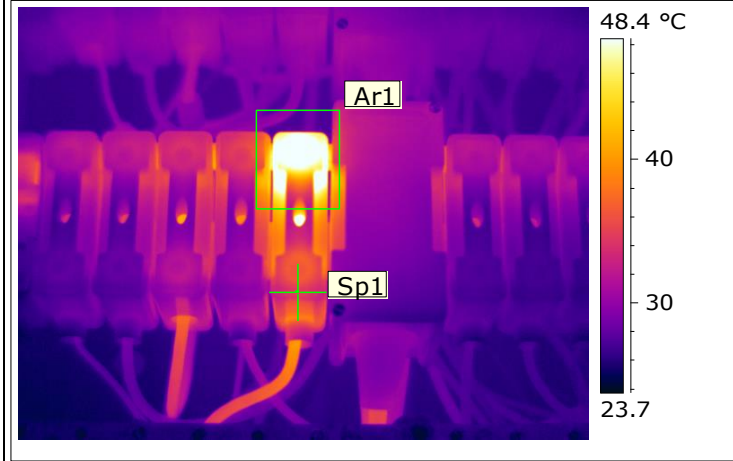
| Equipment | Fuseboard A-1-4-6 |

| Fault Rating | Priority 2 |

Raised temperature noted on in-feed side of fuse carrier.

Temperature imbalance such as this would not be expected across a fuse and indicates an internal problem.

Possible source of temperature rise includes poor connection, loose fuse fixing, or high resistance blade connections.

Recommendation is to inspect, check fuse carrier blades for signs of pitting or heat damage, replace the fuse, re-tighten the fuse fixings and re-tighten all connections.

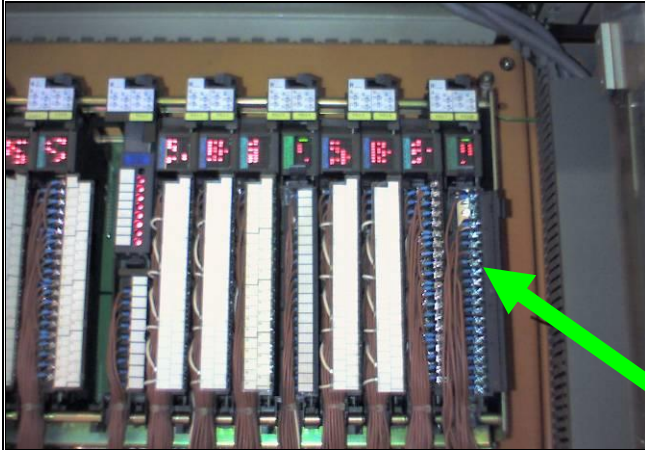
| Equipment | AB PLC Digital Output Rack |

| <b>Fault Rating</b> | <b>Priority 1</b> |

Temperature increase on terminal No.7.

Likely cause of heat rise is a loose connection to the PLC module.

Recommendation is to tighten up the terminal screw on the device.

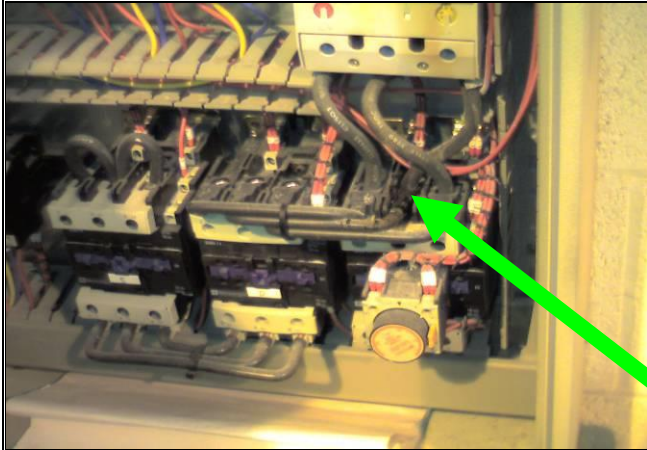
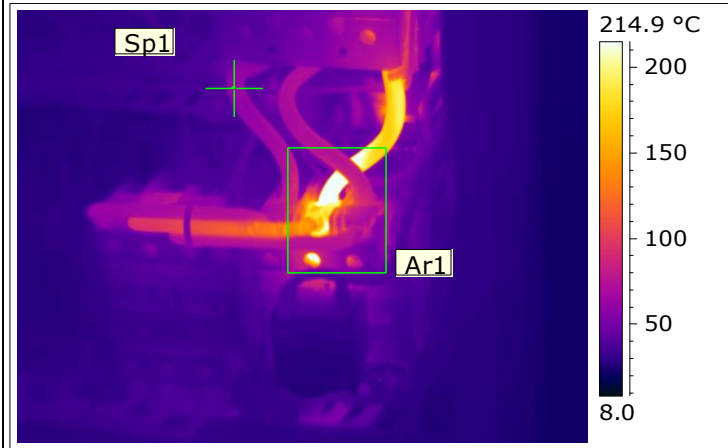
| Equipment | Main Control Panel |

| Object Parameters | Value |
|---|---|
| <b>Fault Rating</b> | <b>Priority 1</b> |

Dangerously high temperatures noted on incoming phase 2 connection to main overload unit.

Visible heat damage also noted at the time of the survey.

The unit manager and operator were both made aware of this fault immediately and the decision was made to isolate this equipment until a repair could be carried out.

Recommendation is to replace the overload, the contactor and the 3 feed cables which have all suffered heat damage as a result of this fault.

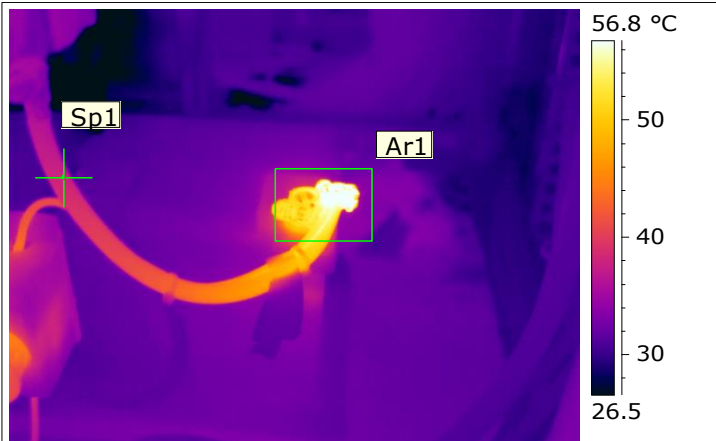
| Equipment | Main Switchboard (Central) |

| <b>Fault Rating</b> | <b>Priority 2</b> |

Elevated temperature noted on battery negative connection.

Likely cause of heat rise is a poor or loose connection.

Recommendation is to inspect, clean and re-tighten this connection.

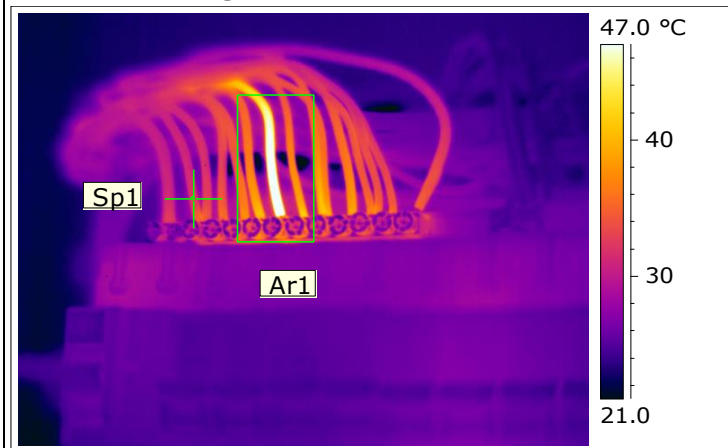
| Equipment | Distribution Board |

| <b>Fault Rating</b> | <b>Priority 2</b> |

Elevated temperature noted on neutral connection on distribution board.

Likely cause of heat rise is a poor or loose connection.

Recommendation is to inspect, clean and remake off this connection.

**Note: Repair work was carried out at the time of the survey. See next page for analysis following completion of the repair.**

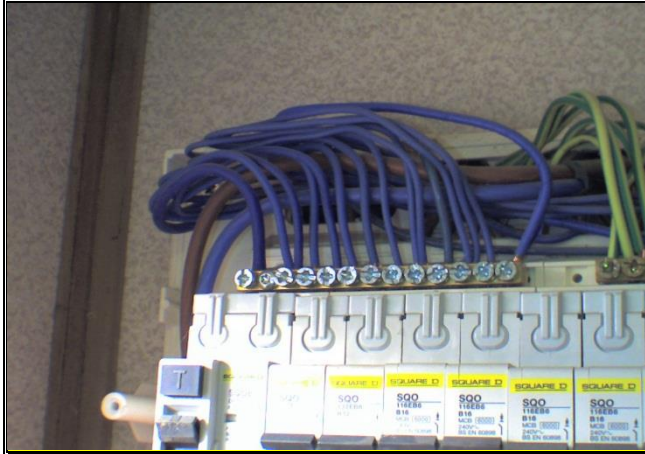
| Equipment | Distribution Board |

The thermal image shows that following the repair, the temperatures have returned to normal and the fault has disappeared.

No further work required.
