SOLAS Compliance Thermographic Survey

Sample Report

August 2010

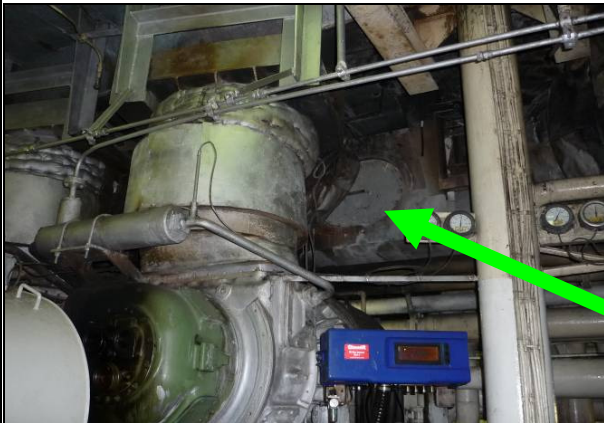
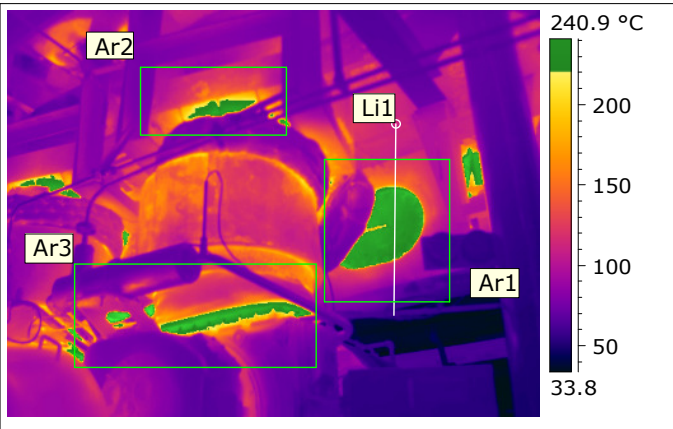
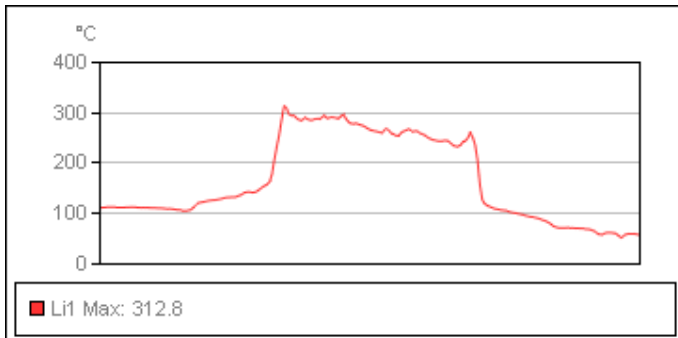
Location	Main Engine Room
Equipment	Port Engine
Type	Turbo Charger (STBD Side) & Exhaust Duct

Object Parameters	Value
Date	06/08/2010
Image Time	08:27:14
Atmospheric Temperature	44.0 °C
Emissivity	0.95
Object Distance	4.0 m
Reflected Apparent Temperature	59.6 °C
Image File name	IR_6806.jpg
Ar1 Max. Temperature	342.9 °C
Ar2 Max. Temperature	294.1 °C
Ar3 Max. Temperature	429.3 °C

Priority 1

Temperatures in excess of the upper limit of 220°C are highlighted in green.

The inspection panel (arrowed) appears to have missing insulation

The inlet and outlet flanges on the turbocharger appear to be uninsulated.

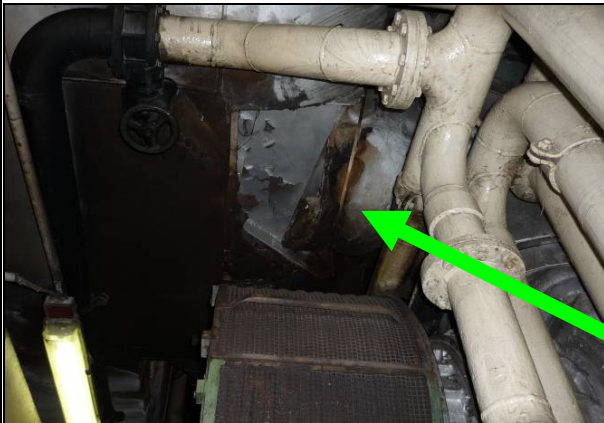
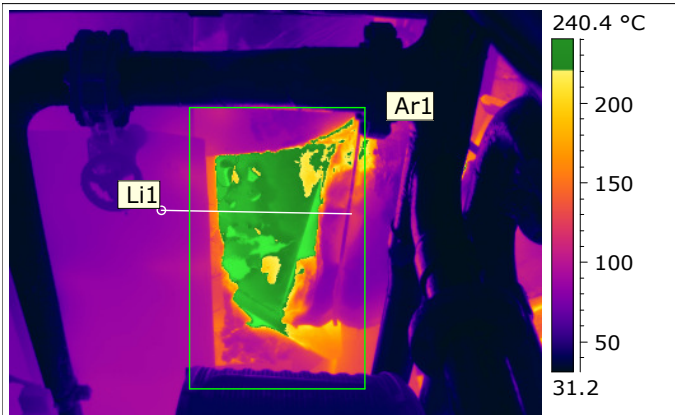
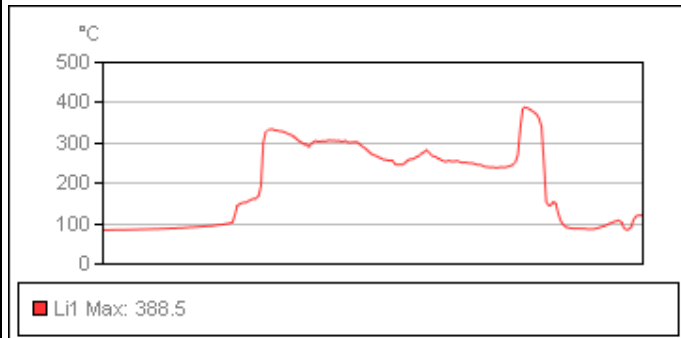
Location	Main Engine Room
Equipment	Port Engine
Type	Exhaust Duct After Turbo Charger

Object Parameters	Value
Date	06/08/2010
Image Time	08:33:07
Atmospheric Temperature	44.0 °C
Emissivity	0.95
Object Distance	4.0 m
Reflected Apparent Temperature	59.6 °C
Image File name	IR_6812.jpg
Ar1 Max. Temperature	413.9 °C

Priority 1

Temperatures in excess of the upper limit of 220°C are highlighted in green.
 Damaged / defective insulation appears to be the cause of the high surface temperatures.

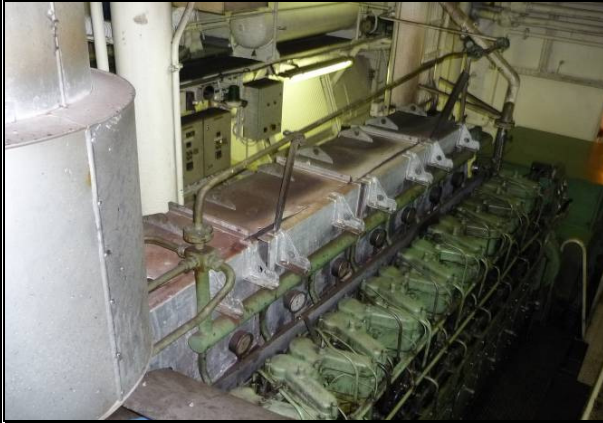
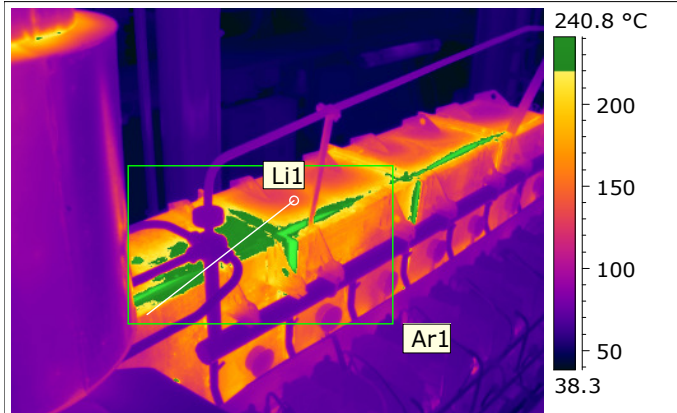
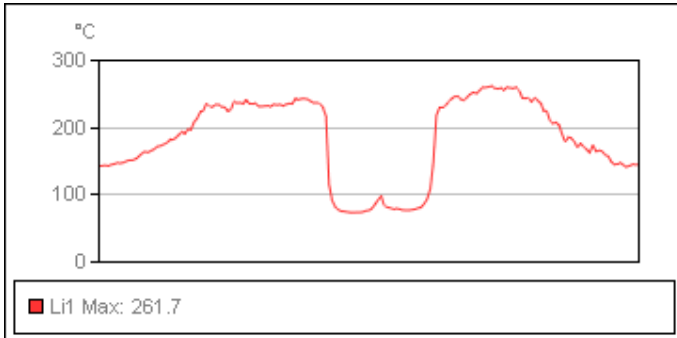
Location	Generator Room
Equipment	STBD Generator
Type	Top Of Generator

Object Parameters	Value
Date	06/08/2010
Image Time	08:57:21
Atmospheric Temperature	44.0 °C
Emissivity	0.95
Object Distance	4.0 m
Reflected Apparent Temperature	59.6 °C
Image File name	IR_6833.jpg
Ar1 Max. Temperature	477.3 °C

Priority 1

Temperatures in excess of the upper limit of 220°C are highlighted in green.

The hot surfaces appear to be caused by visible gaps in the casing.
