Thermographic Water Leak Investigation at

Residential Property

January 2011

Pixel Thermographics Surveyor

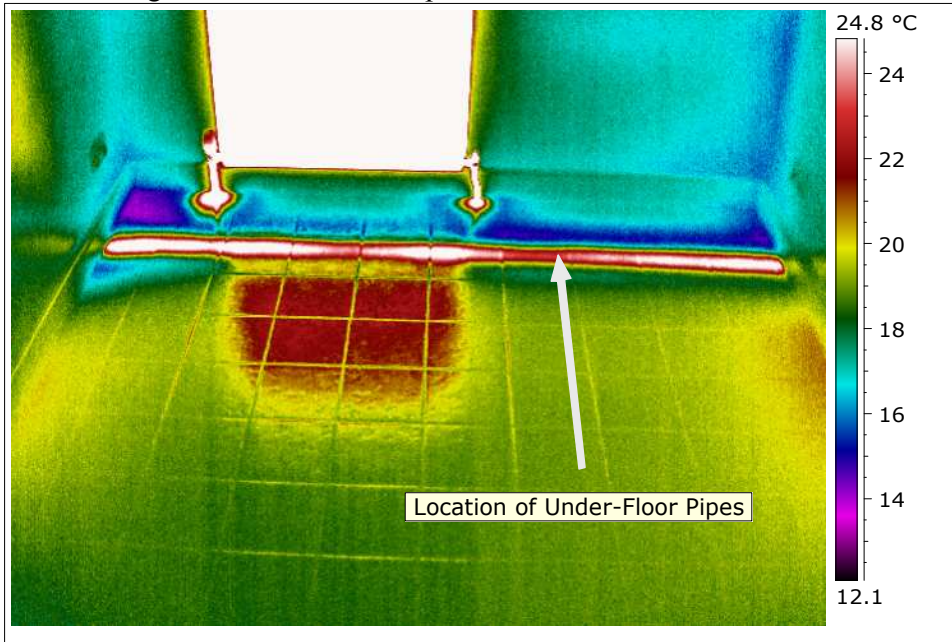
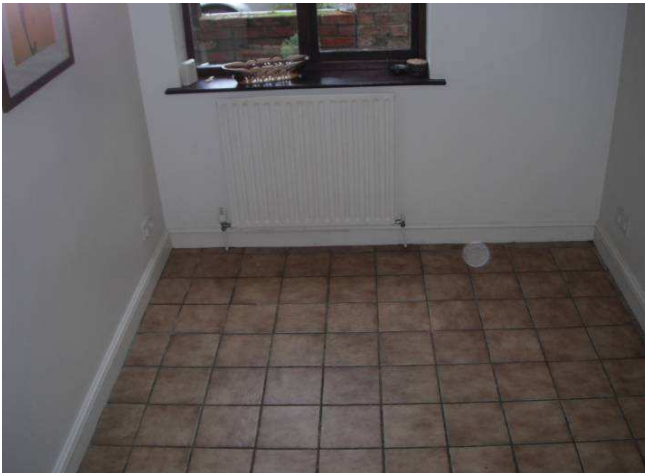
Area: Dining Area - Location of Pipes

Thermal image provided for information to show the location of the under-floor heating pipes which can be seen as the warm (white) line.

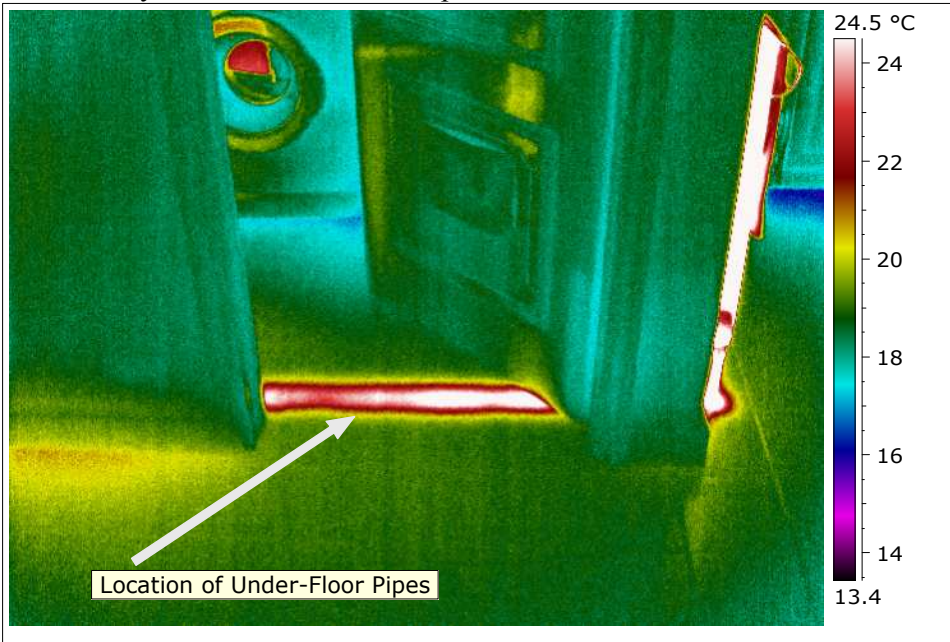
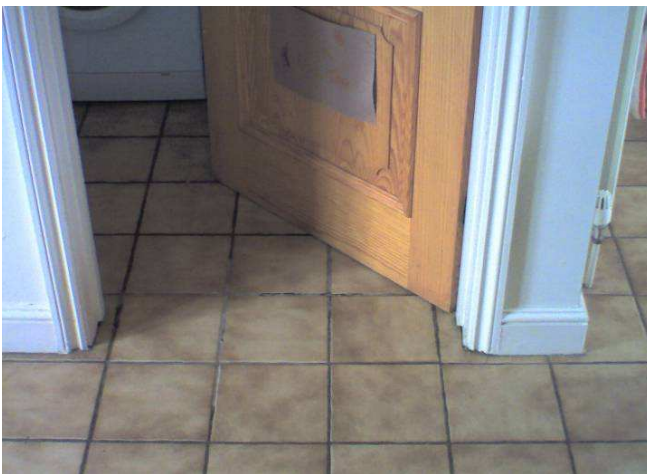
Area: Utility Room - Location of Pipes

Thermal image provided for information to show the location of the under-floor heating pipes which can be seen as the warm (white) line.

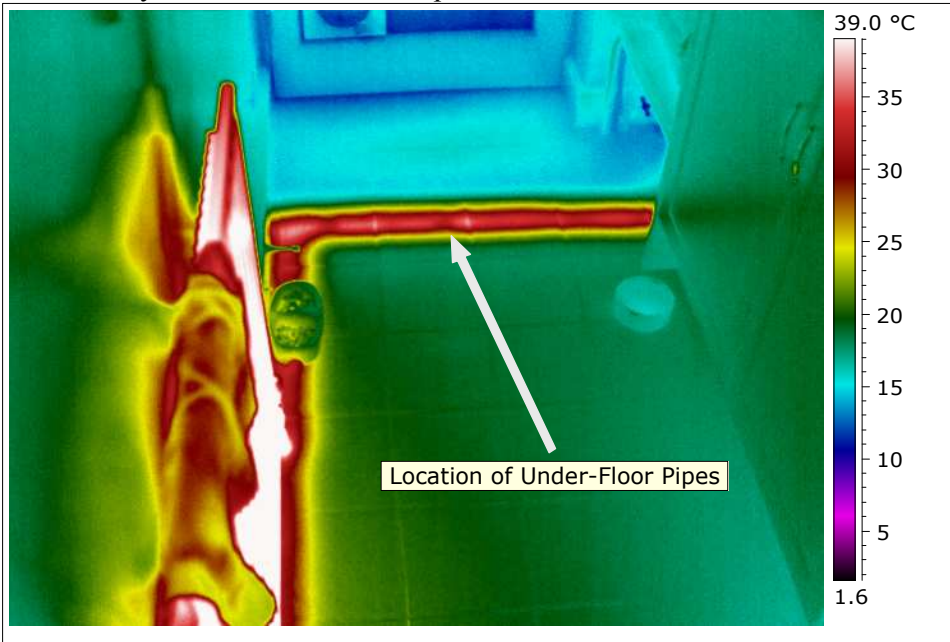
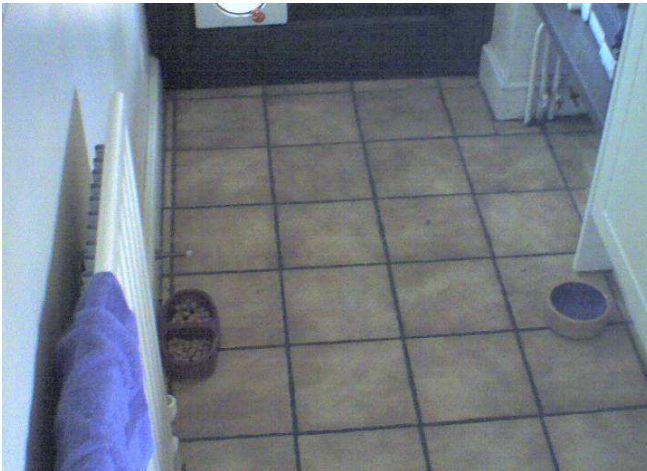
Area: Utility Room - Location of Pipes

Thermal image provided for information to show the location of the under-floor heating pipes which can be seen as the warm (white) line.
