Thermographic Commercial Building Survey

SAMPLE REPORT

Pixel Thermographics Ltd

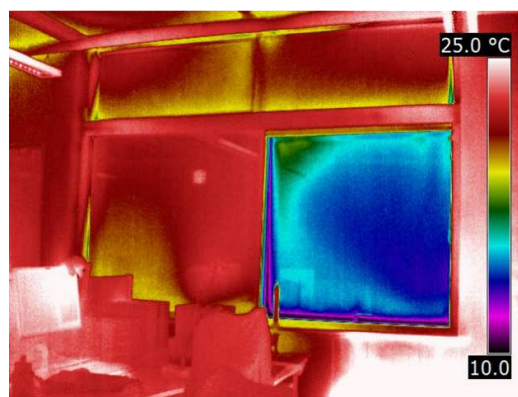
Open Secondary Glazed Window

It was noted that where secondary glazing has been installed on the motorway side of the building that it makes a significant improvement in reducing cold air ingress from relatively poor window seals. Extending the use of secondary glazing or replacing windows would bring about further improvements in air ingress within the facility.

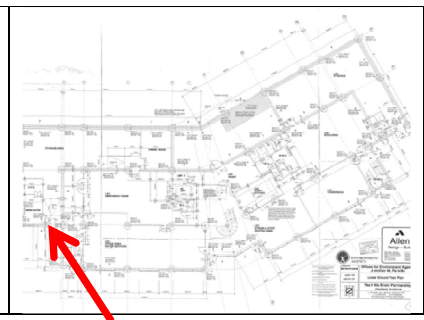
Comment:

Door is poorly sealed – better draught exclusion would reduce cold air ingress into the area.

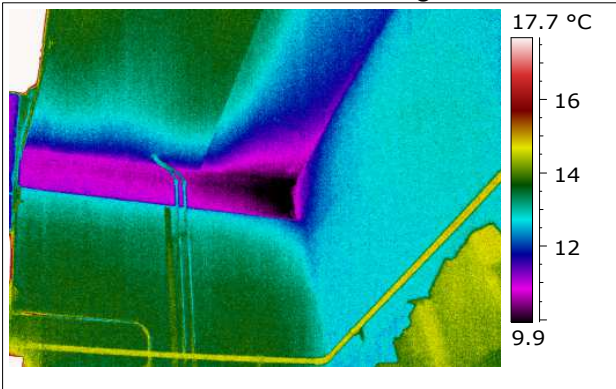
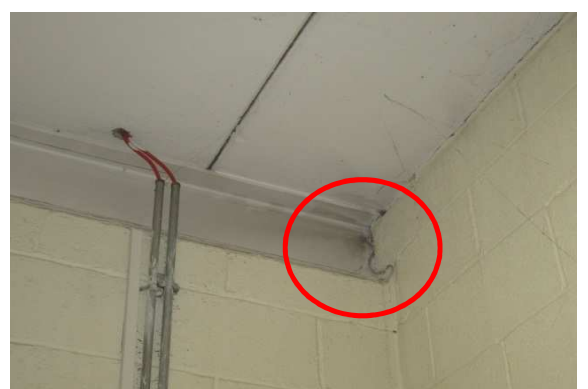
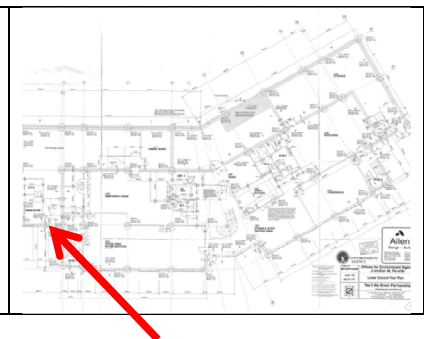
Area: Lower Ground Floor - Storage Room - Wall Above Door

Cold air ingress into area from visible gap at support beam. Sealing the gap would prevent this cold air ingress.

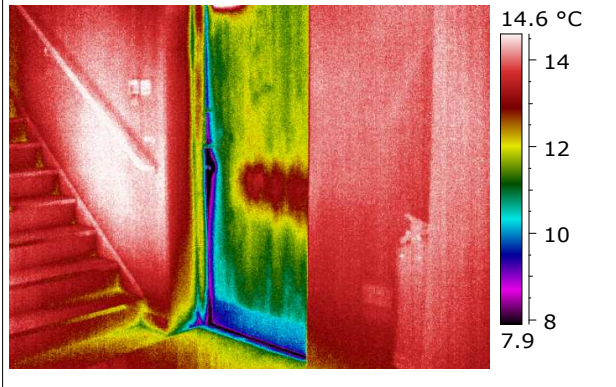
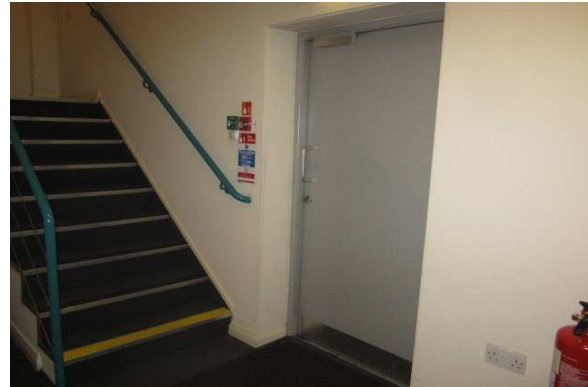
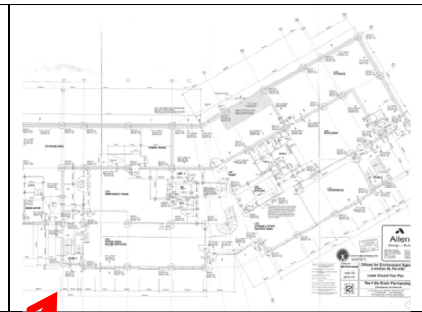
Area: Lower Ground Floor - West Stairwell - Door

Door is poorly sealed – better draught exclusion would reduce cold air ingress into the area.

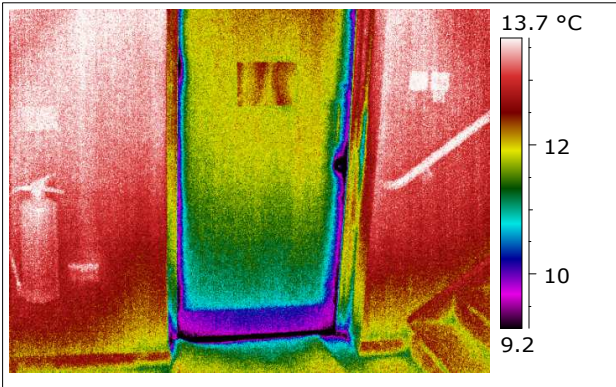
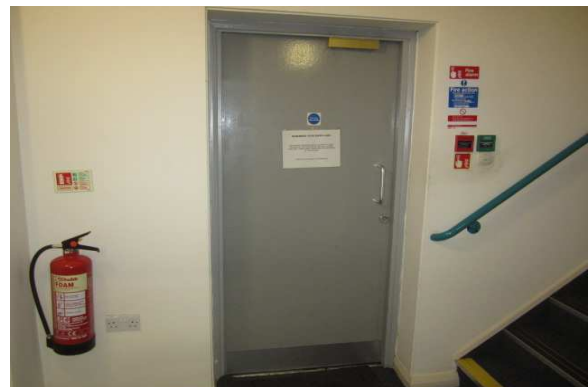
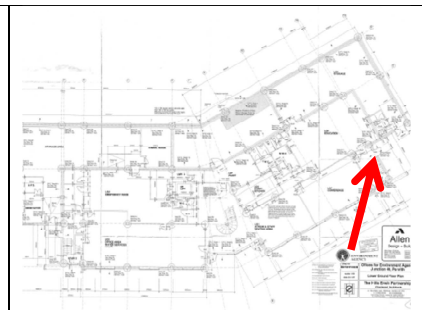
Area: Lower Ground Floor - East Stairwell - Door

Door is poorly sealed – better draught exclusion would reduce cold air ingress into the area.

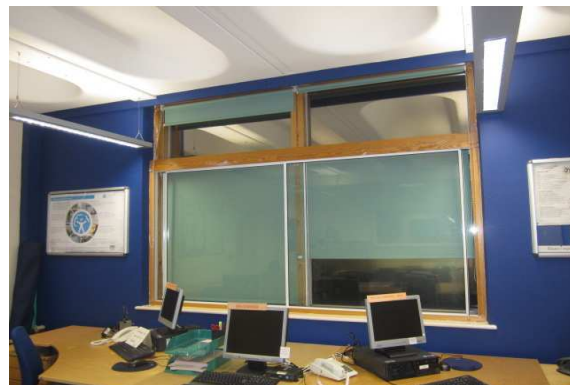
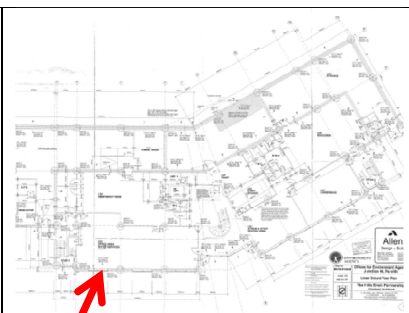
Area: Lower Ground Floor - Cornwell Breakout Room - Window

Secondary glazing installed on the motorway side of the building (lower windows only) greatly reduces air ingress into the rooms (as well as reduces noise from motorway).

Image above demonstrates improvement in thermal performance.

Image below demonstrates effects when secondary glazing is opened.

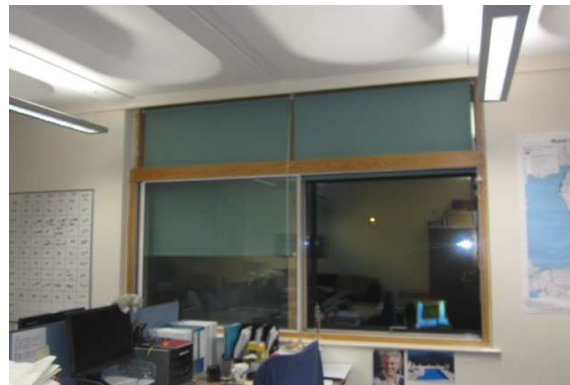
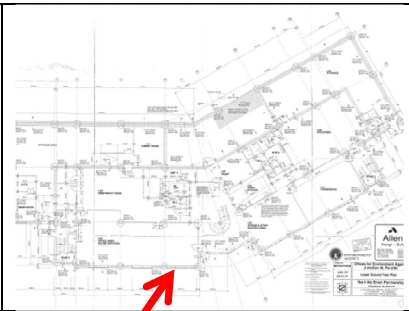
Area: Lower Ground Floor - Cornwell Breakout Room - Window

Image provided to demonstrate the significantly improved thermal performance of the window systems with secondary glazing installed. This greatly reduces air ingress from windows.

Image above shows an open secondary glazed unit.

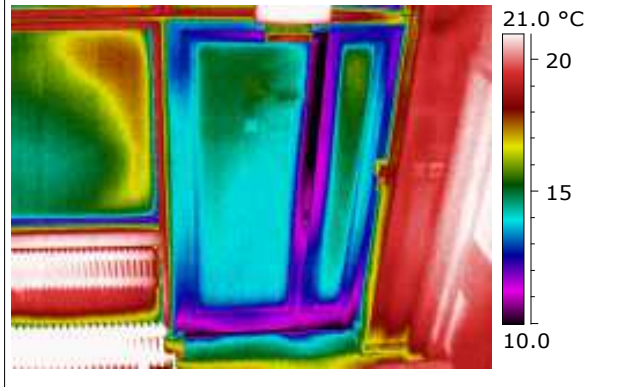
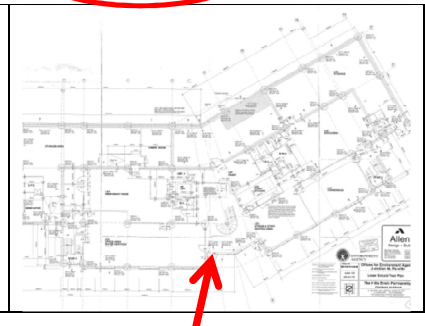
Area: Lower Ground Floor - Atrium - Rear Exit Door

Exit door is very poorly sealed and results in significant air ingress into the atrium area.

Draught exclusion required to reduce the cold air ingress.

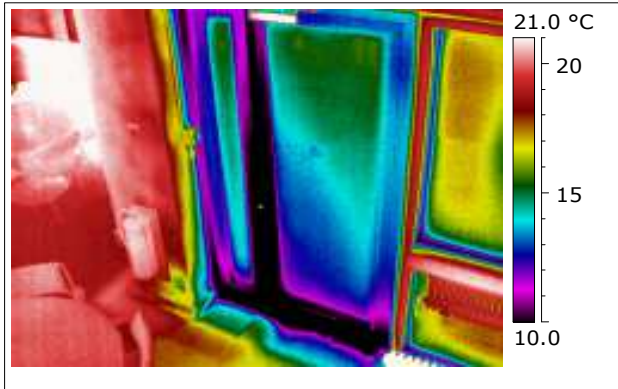
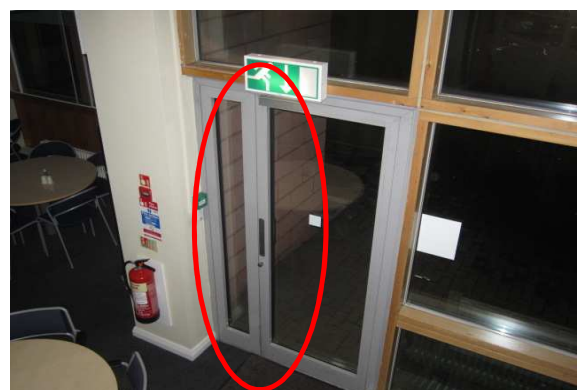
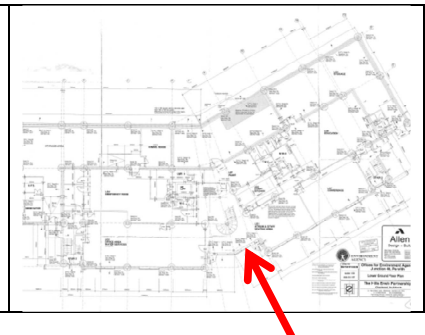
Area: Lower Ground Floor - Atrium - Rear Exit Door

Exit door is very poorly sealed and results in significant air ingress into the atrium area.

Draught exclusion required to reduce the cold air ingress.

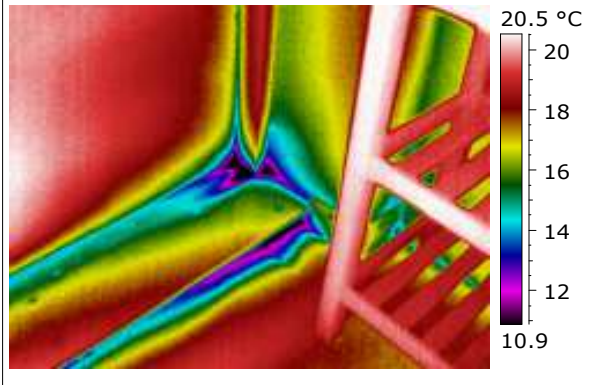
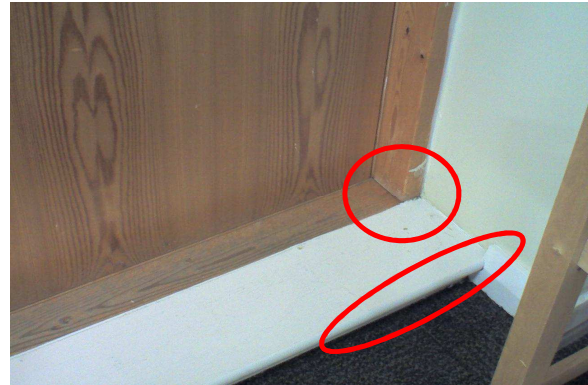
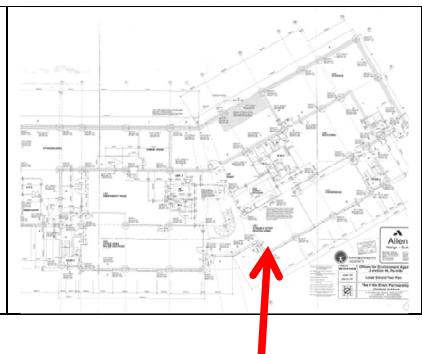
Area: Lower Ground Floor - Seating Area By Atrium

Visible gaps in wood paneling frames allow cold air ingress to enter the area.

Suitable silicone sealant could be used to seal any gaps.

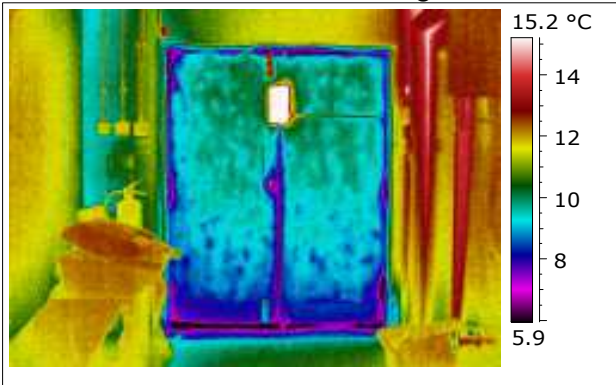
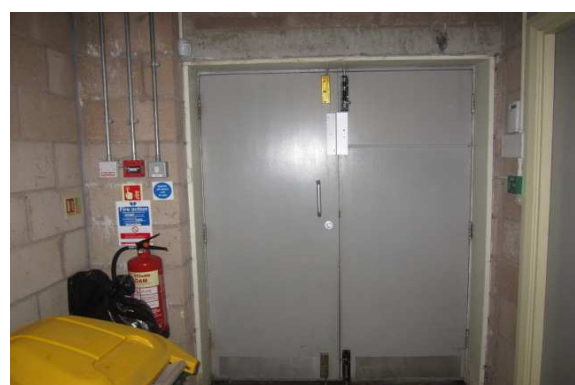
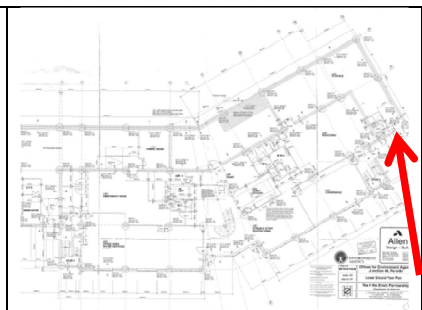
Area: Lower Ground Floor - Storage Area - Rear Doors

Door is poorly sealed – better draught exclusion would reduce cold air ingress into the area.

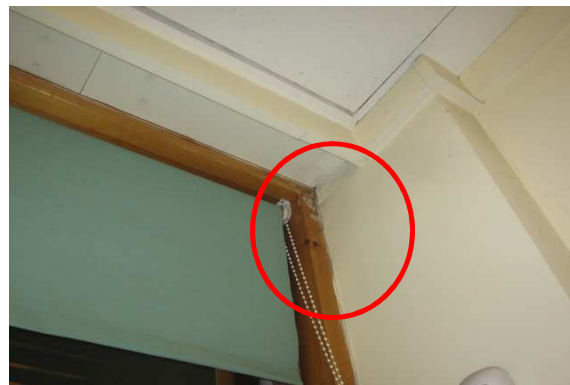
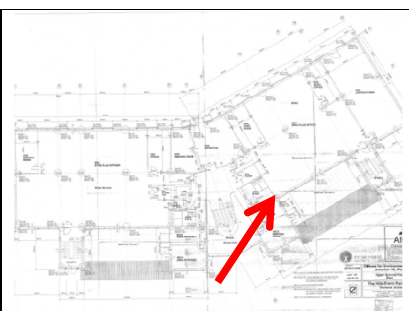
Area: Upper Ground Floor - Open Plan Office (UG7) - Window Frames

Visible gaps around window frames allow cold air to enter the room.

Applying suitable silicone sealant around the edges of window frames will greatly reduce the cold air and the cooling effects of this air.

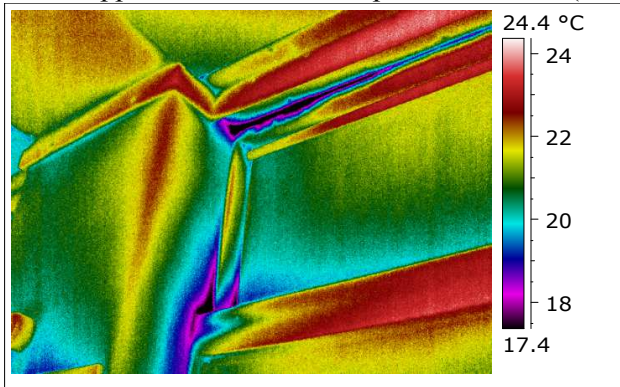
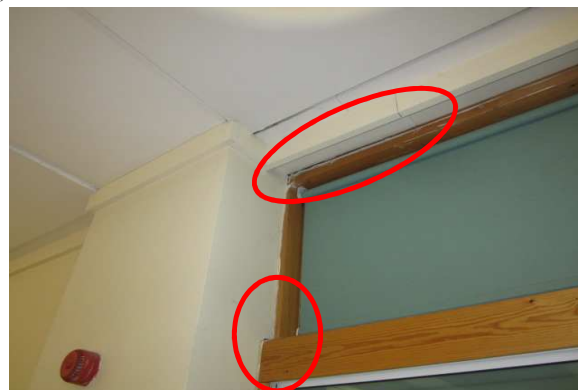
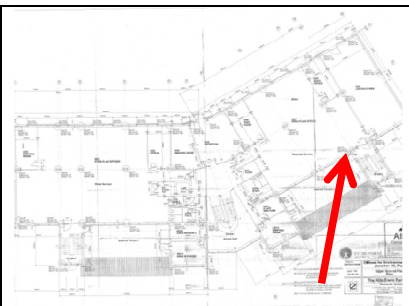
Area: Upper Ground Floor - Open Plan Office (UG7) - Window Frames

Visible gaps around window frames allow cold air to enter the room.

Applying suitable silicone sealant around the edges of window frames will greatly reduce the cold air and the cooling effects of this air.

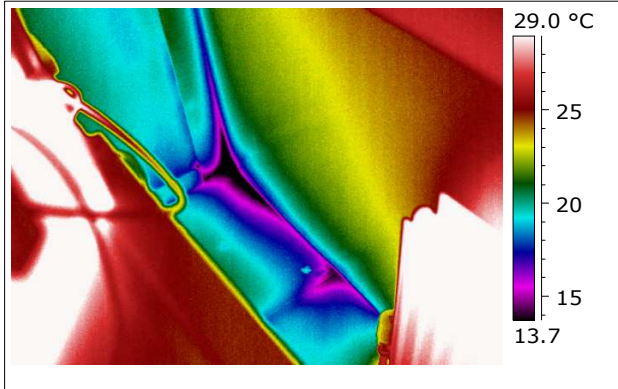
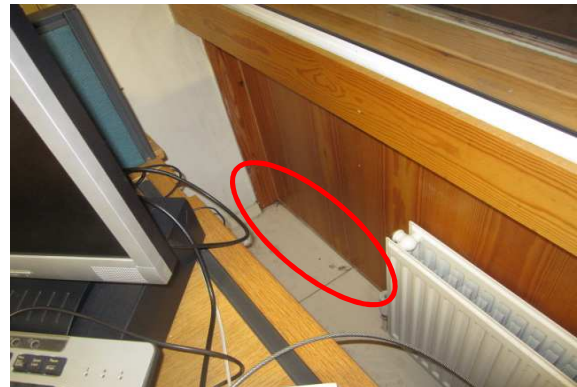
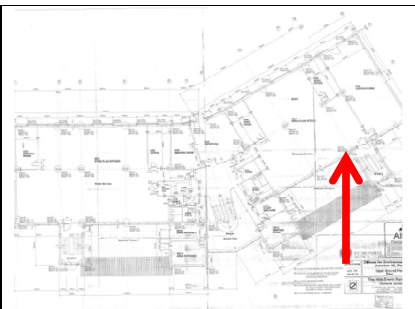
Area: Upper Ground Floor - Open Plan Office (UG7) - Wood Panelling

Visible gaps in wood paneling frames allow cold air ingress to enter the area.

Suitable silicone sealant could be used to seal any gaps.

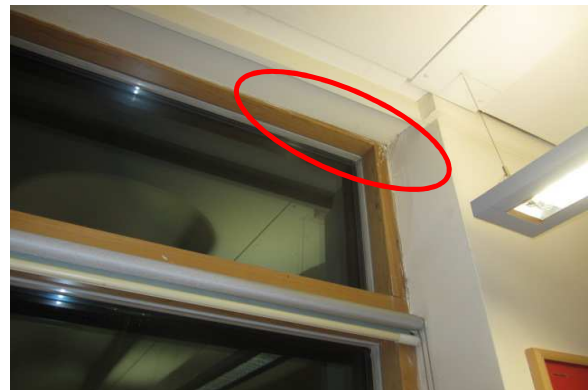
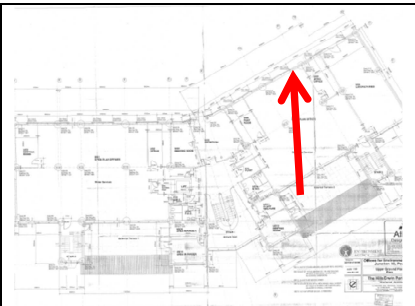
Area: Upper Ground Floor - Open Plan Office (UG7) - Window Frames

Visible gaps around window frames allow cold air to enter the room.

Applying suitable silicone sealant around the edges of window frames will greatly reduce the cold air and the cooling effects of this air.

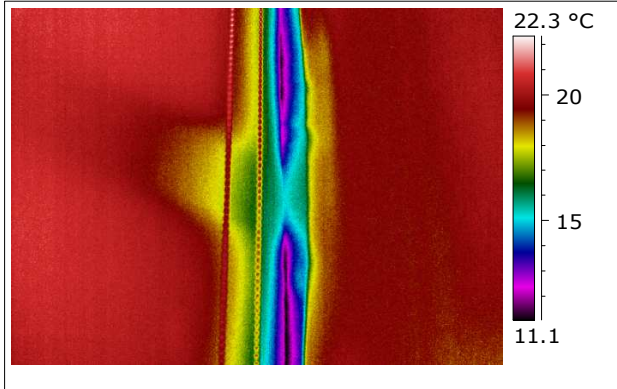
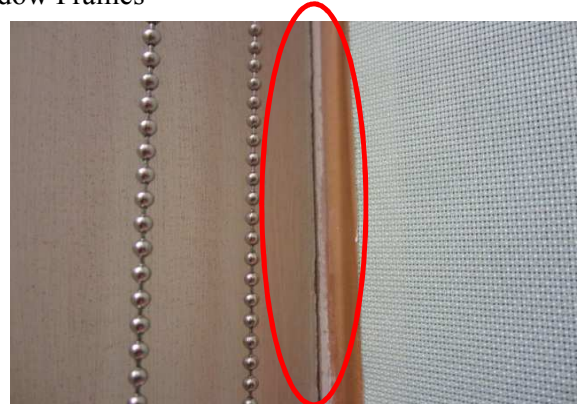
Area: Upper Ground Floor - Open Post Room - Window Frames

Visible gaps in window frames allow cold air to enter room.

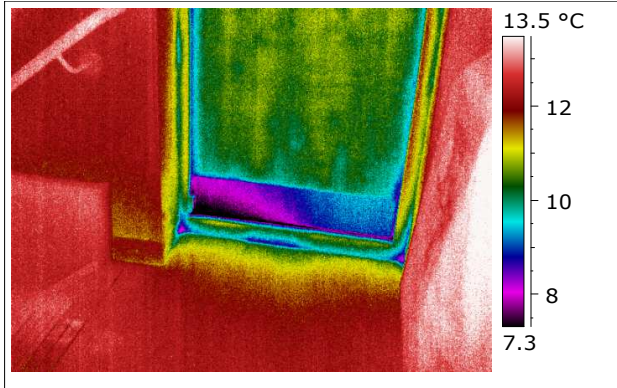
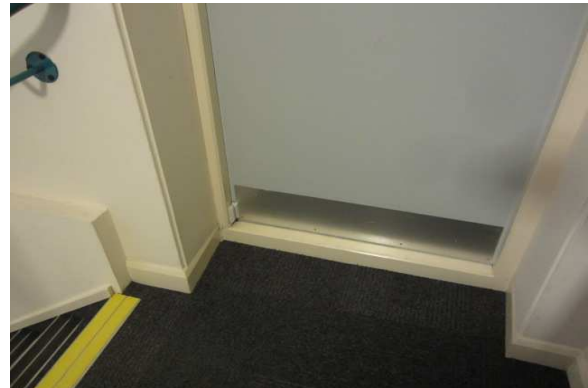
Area: Upper Ground Floor - East Stairwell - Door to Balcony

Door is poorly sealed – better draught exclusion would reduce cold air ingress into the area.

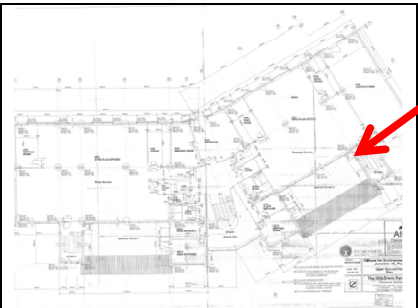
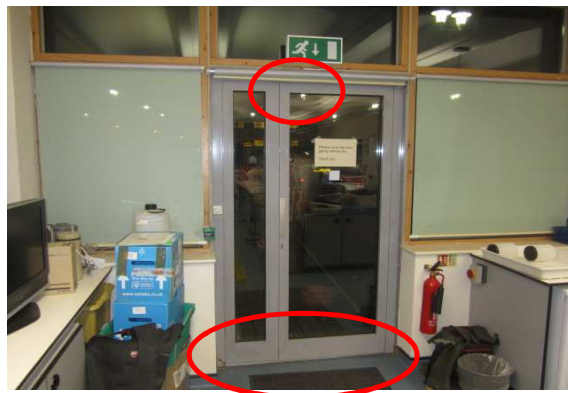
Area: Upper Ground Floor - Laboratory - Door

Door is poorly sealed – better draught exclusion would reduce cold air ingress into the area.

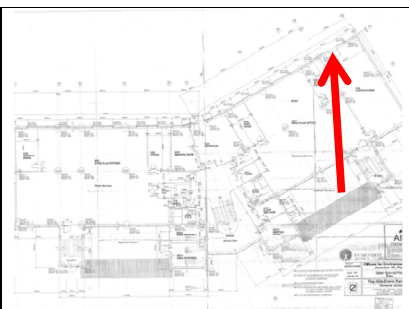
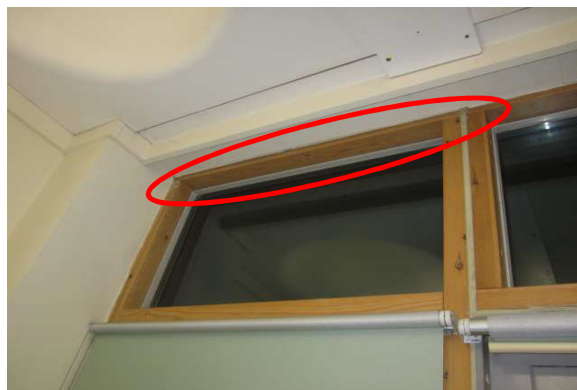
Area: Upper Ground Floor - Laboratory - Window Frames

Visible gaps around window frames allow cold air to enter the room.

Applying suitable silicone sealant around the edges of window frames will greatly reduce the cold air and the cooling effects of this air.

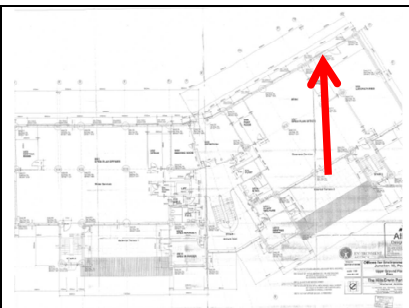
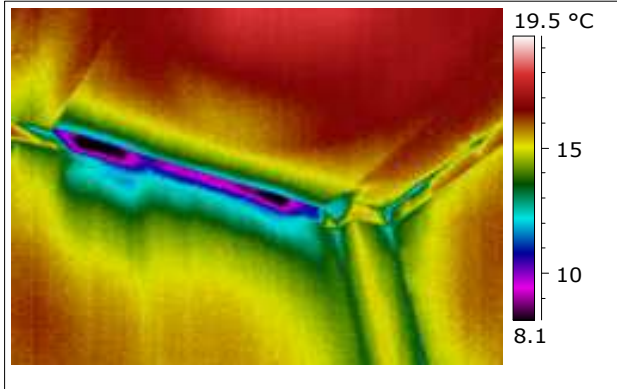
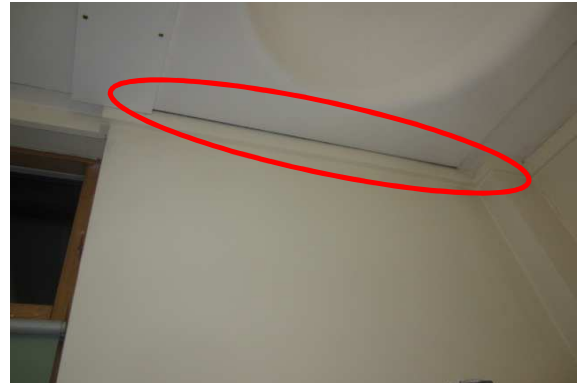
Area: Upper Ground Floor - Laboratory - Ceiling

Visible gap in ceiling allows cold air to enter.

Sealing the gap will prevent the cold air entering the room.

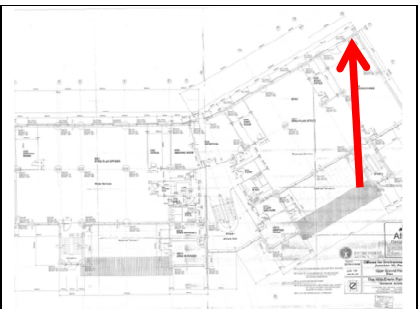
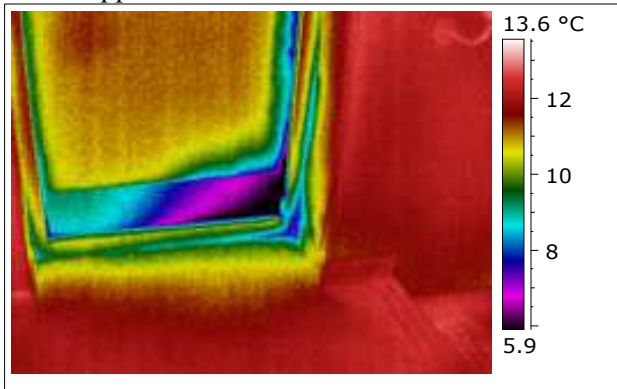
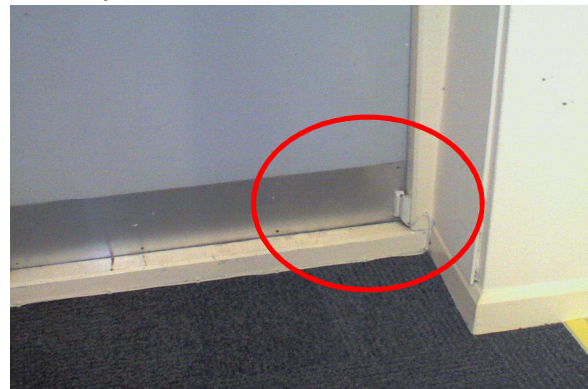
Area: Upper Ground Floor - West Stairwell - Door to Balcony

Door is poorly sealed – better draught exclusion would reduce cold air ingress into the area.

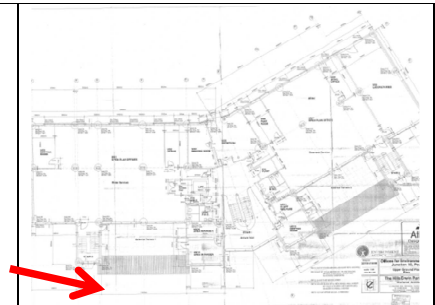
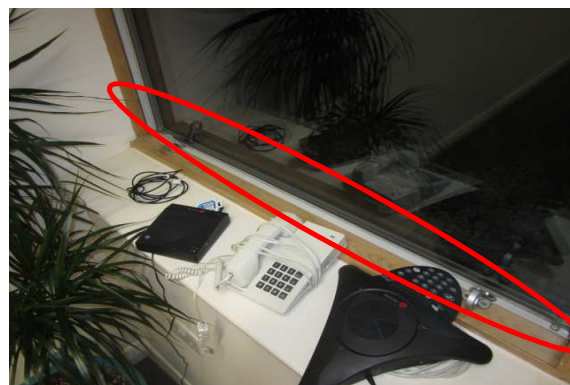
Area: Upper Ground Floor - Coniston Meeting Room - Window Frames

This window is typical of all windows throughout the building and highlights that the seals do not perform particularly well and allow air to enter the room.

The secondary glazing installed on the motorway side of the building greatly reduces the cooling effects of this air ingress.

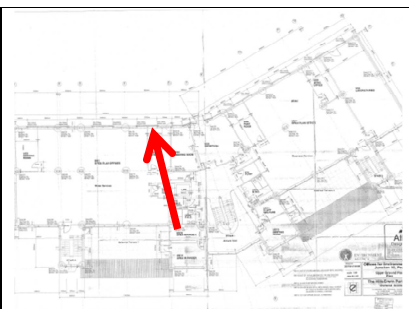
Area: Upper Ground Floor - Main Entrance Doors

Cold air ingress noted on main entrance doors which appear poorly sealed.

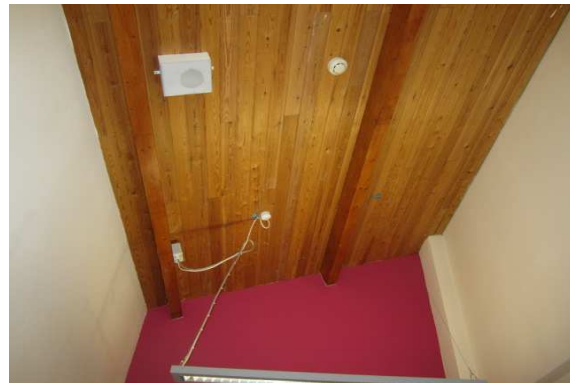
Area: Upper Ground Floor - Area Manager Office (UG15) - Ceiling

Thermal image highlights significant cold air ingress (shown as dark colours) from the roof paneling.

Air entering the roof systems should be prevented and realistically can only be done externally by visual inspection of edge / corner details and for sealing to take place where gaps are present.

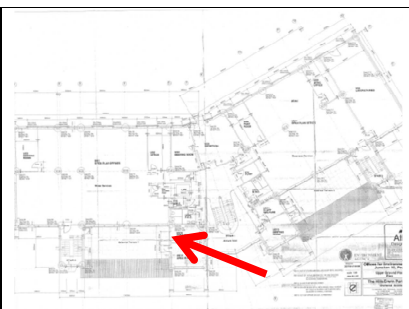
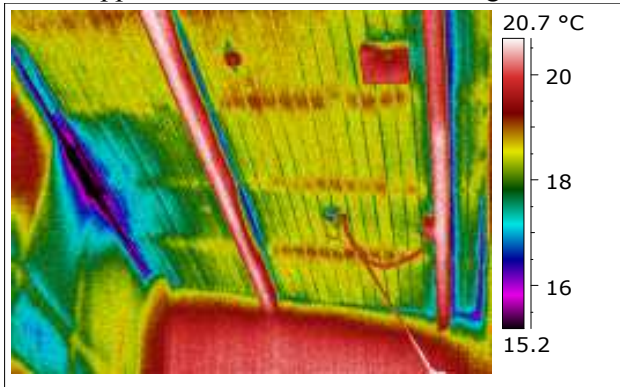
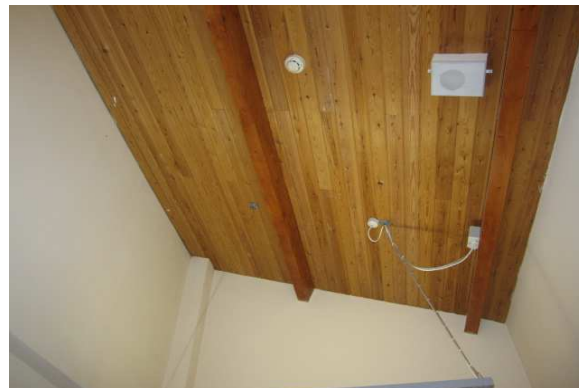
Area: Upper Ground Floor - Area Manager Office (UG15) - Ceiling

Thermal image highlights significant cold air ingress (shown as dark colours) from the roof paneling.

Air entering the roof systems should be prevented and realistically can only be done externally by visual inspection of edge / corner details and for sealing to take place where gaps are present.

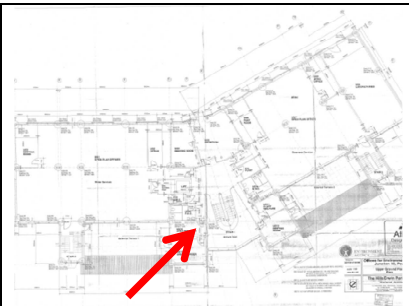
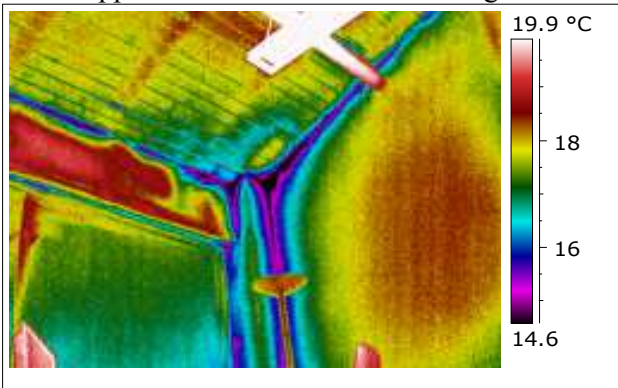
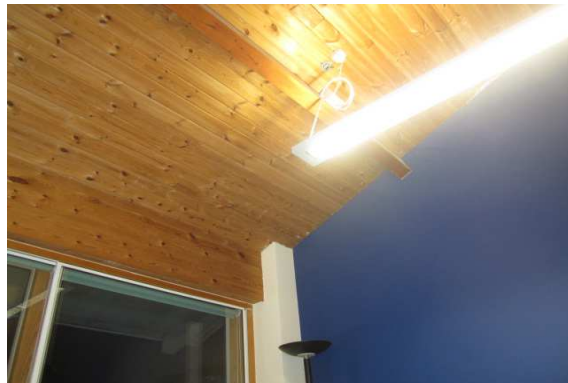
Area: Upper Ground Floor - Area Manager Office (UG14) - Ceiling

Thermal image highlights significant cold air ingress (shown as dark colours) from the roof paneling.

Air entering the roof systems should be prevented and realistically can only be done externally by visual inspection of edge / corner details and for sealing to take place where gaps are present.

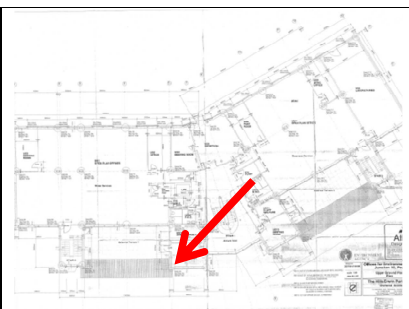
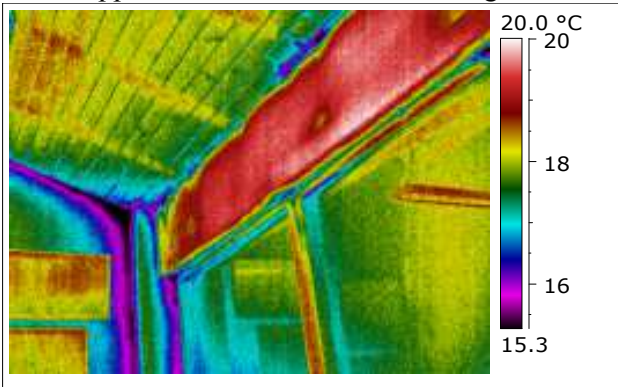
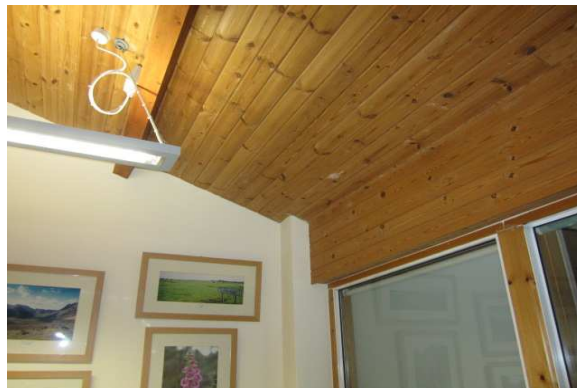
Area: Upper Ground Floor - Area Manager Office (UG14) - Ceiling

Thermal image highlights significant cold air ingress (shown as dark colours) from the roof paneling.

Air entering the roof systems should be prevented and realistically can only be done externally by visual inspection of edge / corner details and for sealing to take place where gaps are present.

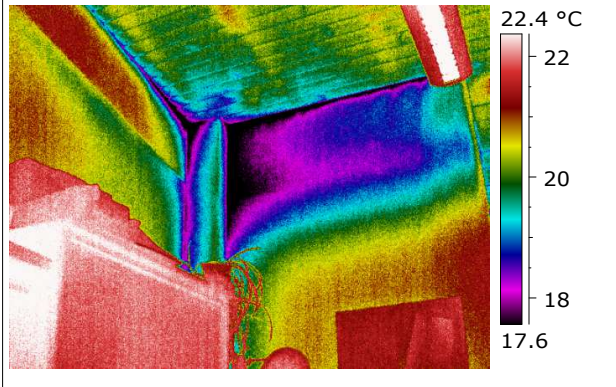
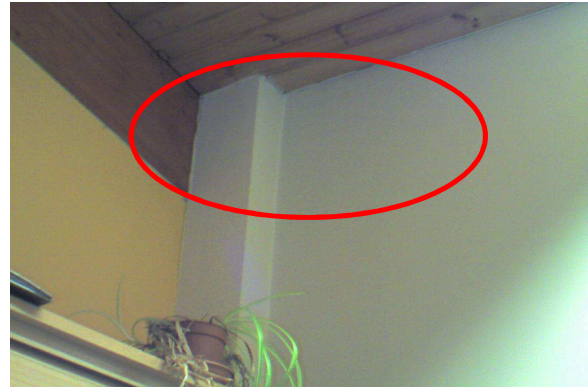
Area: First Floor - Upon Plan Office (West) - Wall / Ceiling

The cool (dark) colour indicates cold air movement behind wall.

Air appears to enter via the corner detail externally which should be inspected and any gaps sealed to prevent ingress.

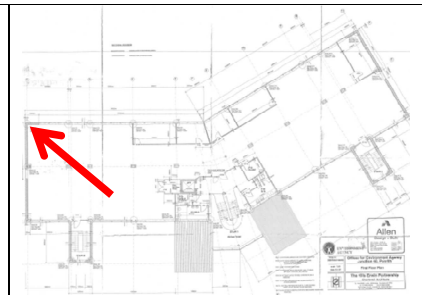
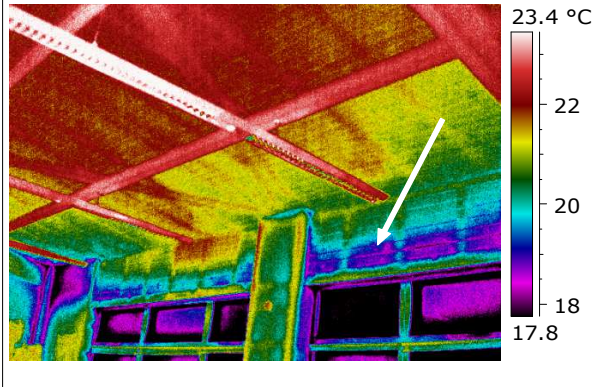
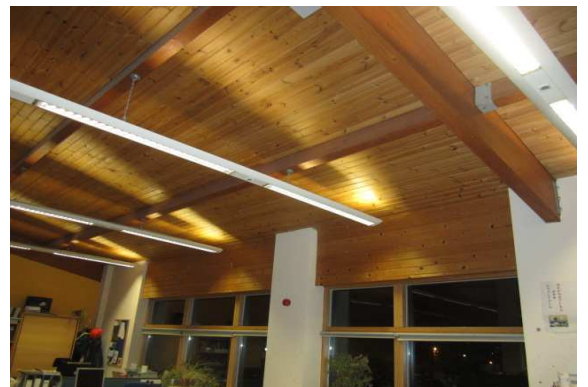
Area: First Floor - Upon Plan Office (West) - Window Frames

The thermal image highlights cold air ingress into wood paneling above the windows.

Air is suspected as entering via the roof support beam penetrations (see external imaging on earlier pages of this report).

Inspecting and sealing gaps outside would greatly reduce the cold air ingress and the cooling effects.

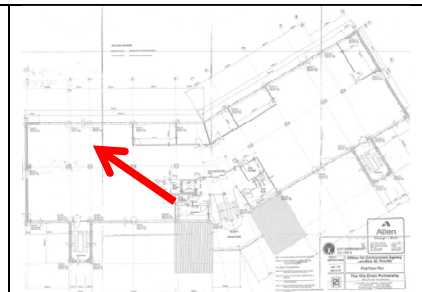
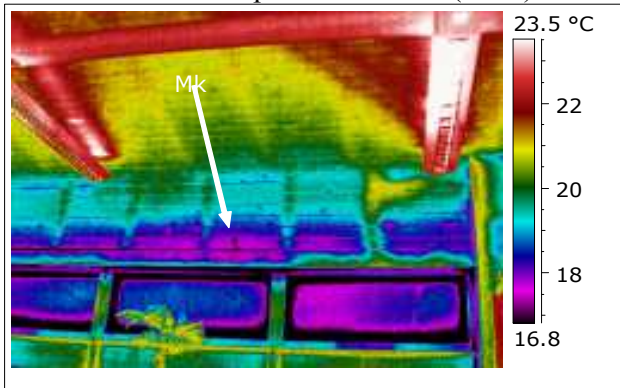
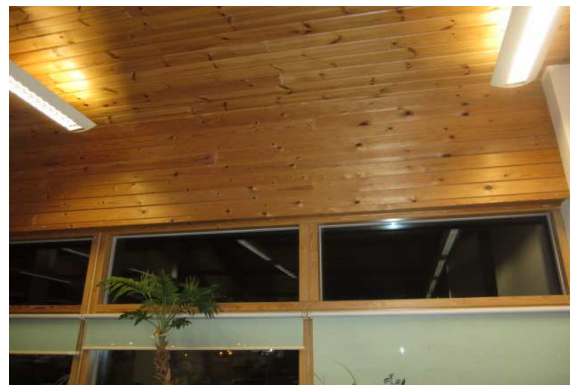
Area: First Floor - Upon Plan Office (West) - Window Frames

The thermal image highlights cold air ingress into wood paneling above the windows.

Air is suspected as entering via the roof support beam penetrations (see external imaging on earlier pages of this report).

Inspecting and sealing gaps outside would greatly reduce the cold air ingress and the cooling effects.

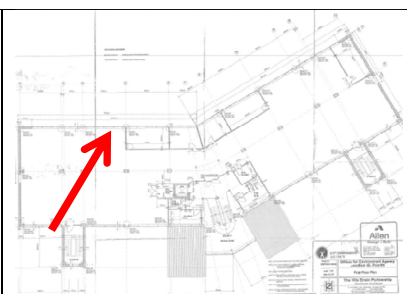
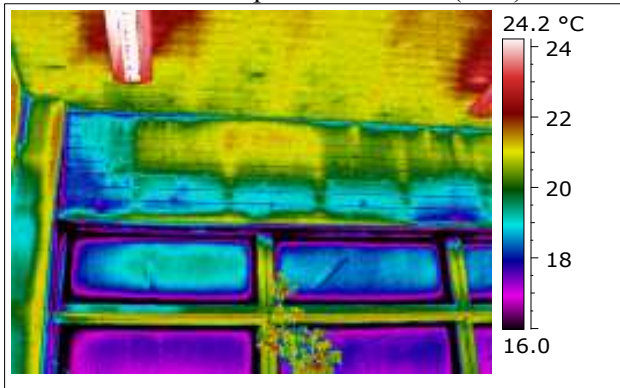
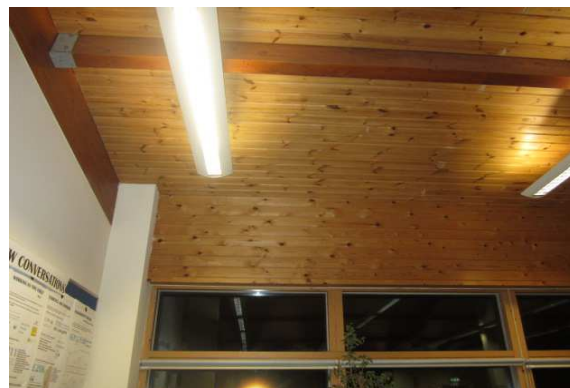
Area: First Floor - Upon Plan Office (East) - Window Frames

The thermal image highlights cold air ingress into wood paneling above the windows.

Air is suspected as entering via the roof support beam penetrations (see external imaging on earlier pages of this report).

Inspecting and sealing gaps outside would greatly reduce the cold air ingress and the cooling effects.

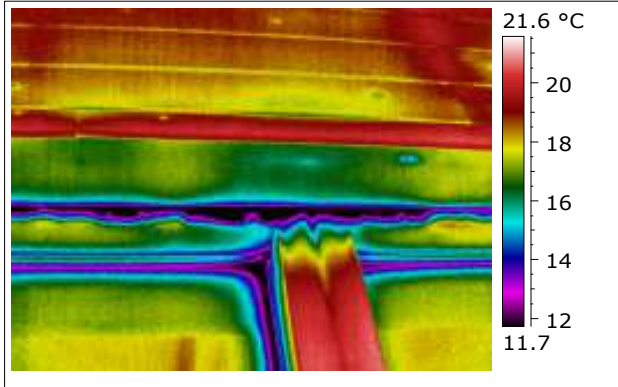
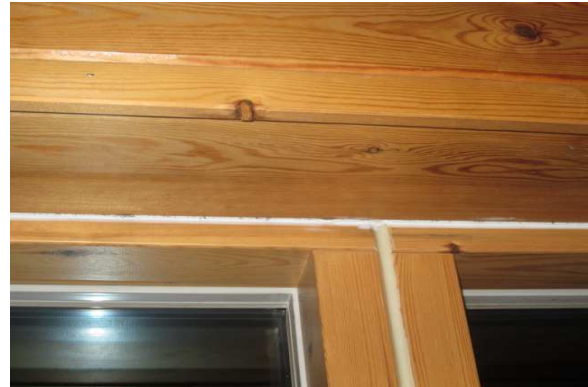
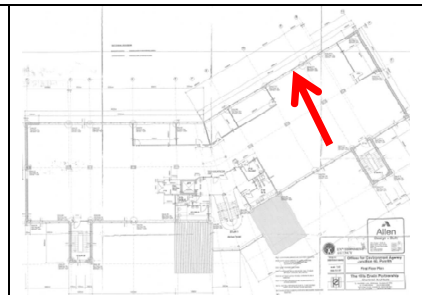
Area: First Floor - Upon Plan Office (East) - Window Frames

Visible gaps around window frames allow cold air to enter the room.

Applying suitable silicone sealant around the edges of window frames will greatly reduce the cold air and the cooling effects of this air.

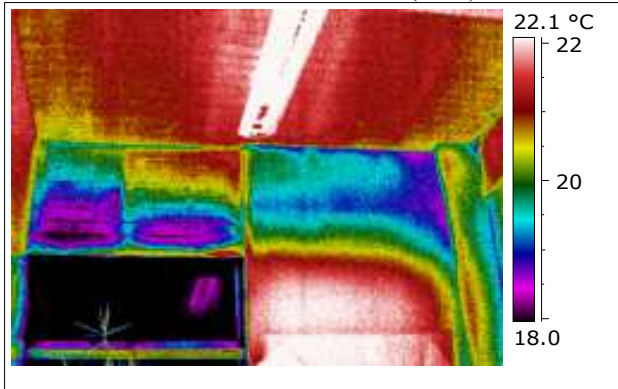
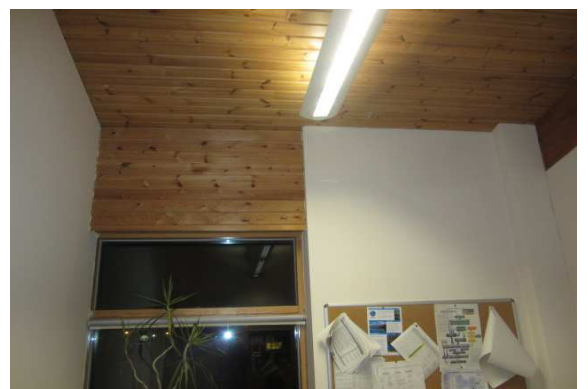
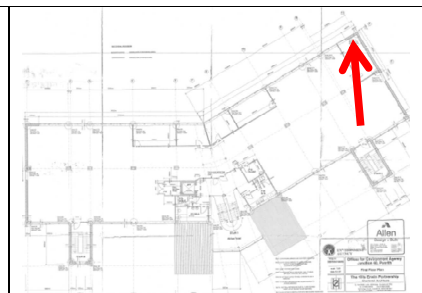
Area: First Floor - Corner Office (East) - Wall

The cool (dark) colour indicates cold air movement behind wall.

Air appears to enter via the corner detail externally which should be inspected and any gaps sealed to prevent ingress.

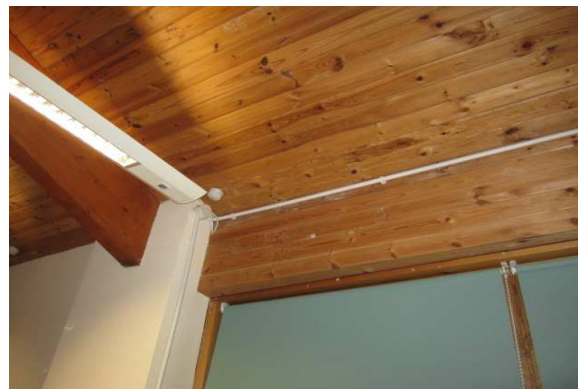
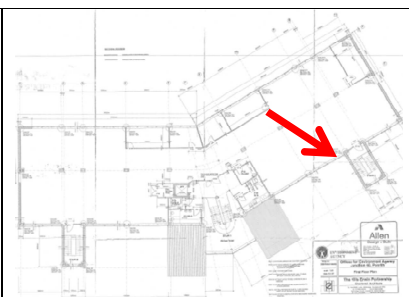
Area: First Floor - Upon Plan Office (East) - Window Frames

The thermal image highlights cold air ingress into wood paneling above the windows.

Air is suspected as entering via the roof support beam penetrations (see external imaging on earlier pages of this report).

Inspecting and sealing gaps outside would greatly reduce the cold air ingress and the cooling effects.

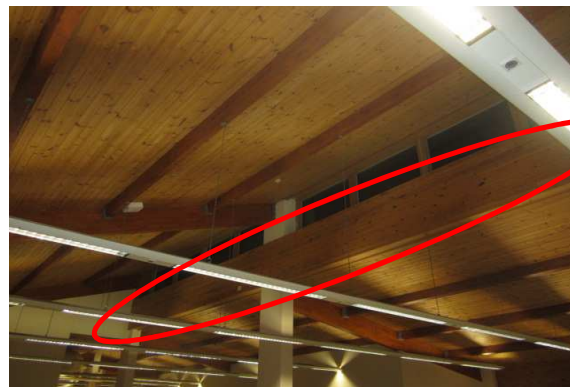
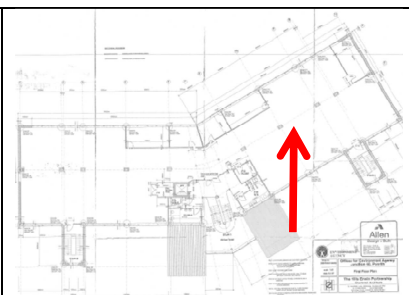
Area: First Floor - Upon Plan Office (East) - High Level Windows

The thermal image highlights cold air movement behind the wooden high level paneling.

Air is suspected as entering the fabric of the building via gaps in the external window and cladded areas.

Visual inspection required to locate gaps which should be suitably sealed.

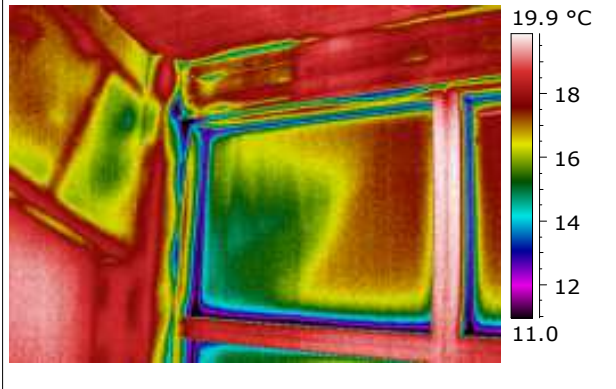
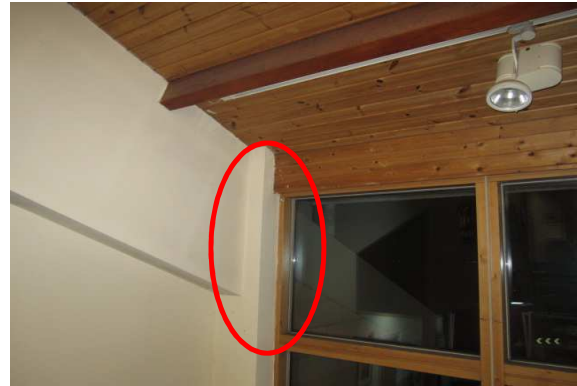
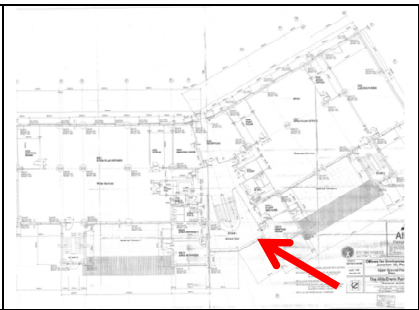
Area: First Floor - Atrium - Window Frame

Visible gaps around atrium window frames allow cold air to enter the room.

Applying suitable silicone sealant around the edges of window frames will greatly reduce the cold air and the cooling effects of this air.
