Infrared thermography for the building industry

Infrared thermography, the perfect tool for building diagnostics

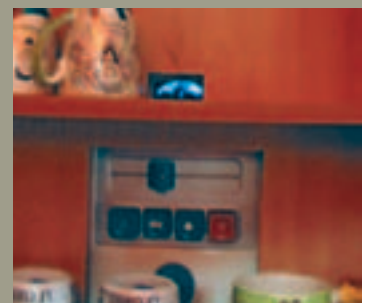
Gas heater built too closely to surrounding material provokes fire hazard

Thanks to infrared thermography, crevices, leaking joints and loosening stones in chimneys and exhaust sections of heating systems can be effortlessly discovered when they occur. Overheated locations, which can create chimney fires, become immediately visible on the infrared image. The danger of a fire due to building on too closely to hot heating and exhaust areas can also be recognized at once.

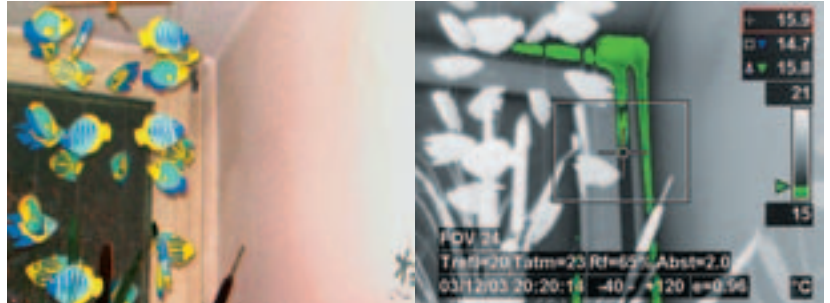
Visual and infrared image of a bedroom. The infrared image clearly shows the areas that are susceptible for mold build-up

Mold makes not only the building structure suffer. Health dangers and allergies develop in living and office spaces where mold build-up is present. Fungus spores find the best preconditions for growth in locations where humidity from the ambient air forms droplets and can precipitate. Mineral substances from walls, wallpaper and paint are excellent breeding grounds. Infrared cameras, with special software functions for dew point visualization, indicate endangered locations automatically on inspection via a color alarm in the image. Potential damage is recognized early and on the spot.

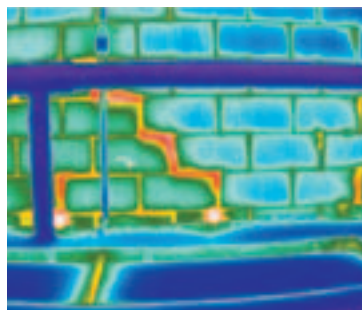
Cracked chimney

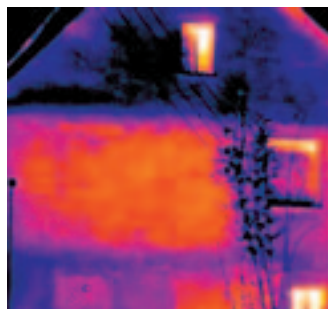
Badly insulated wall

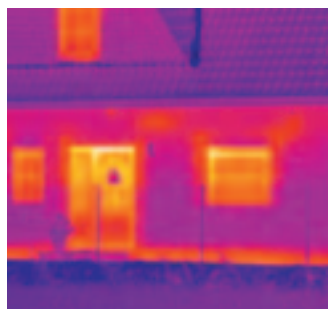
Heat losses at doors and windows
